**CC-37 Stream and Fish Habitat Restoration Completion Photos**

**BPA Project # 1992-026-01**

**Contract # 58036**

Catherine Creek Mile 37 GRMW, Union Soil Water Conservation District contract 58036

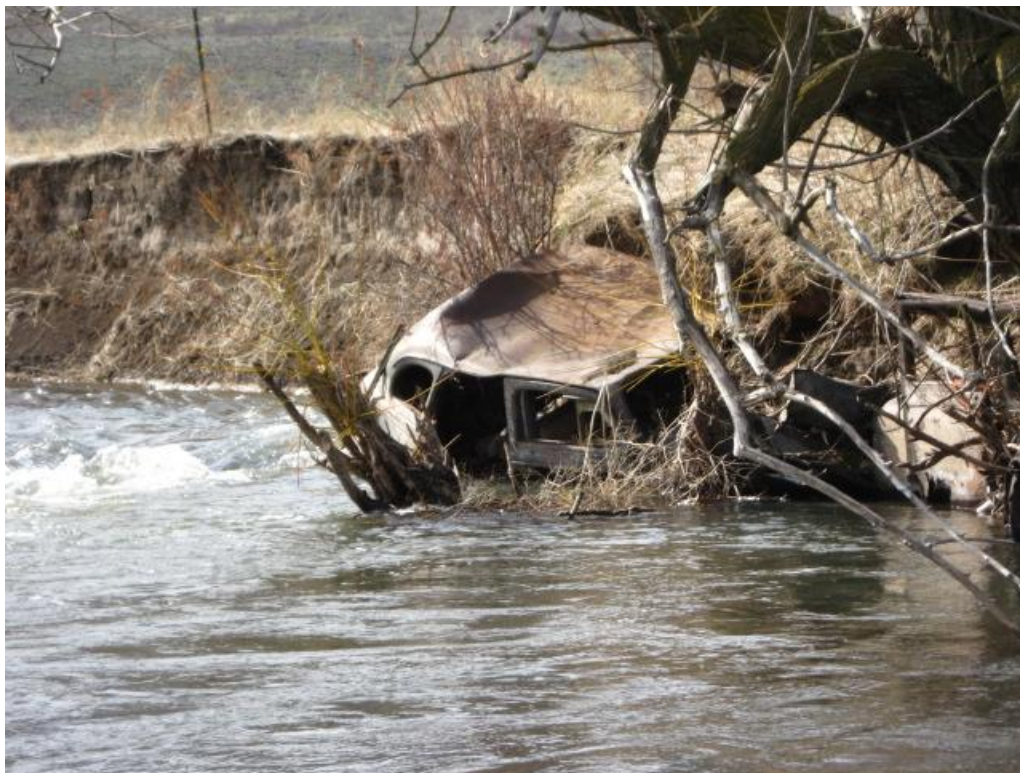
Photo 1. Vertical banks and car body “bank stabilization” pre-construction.

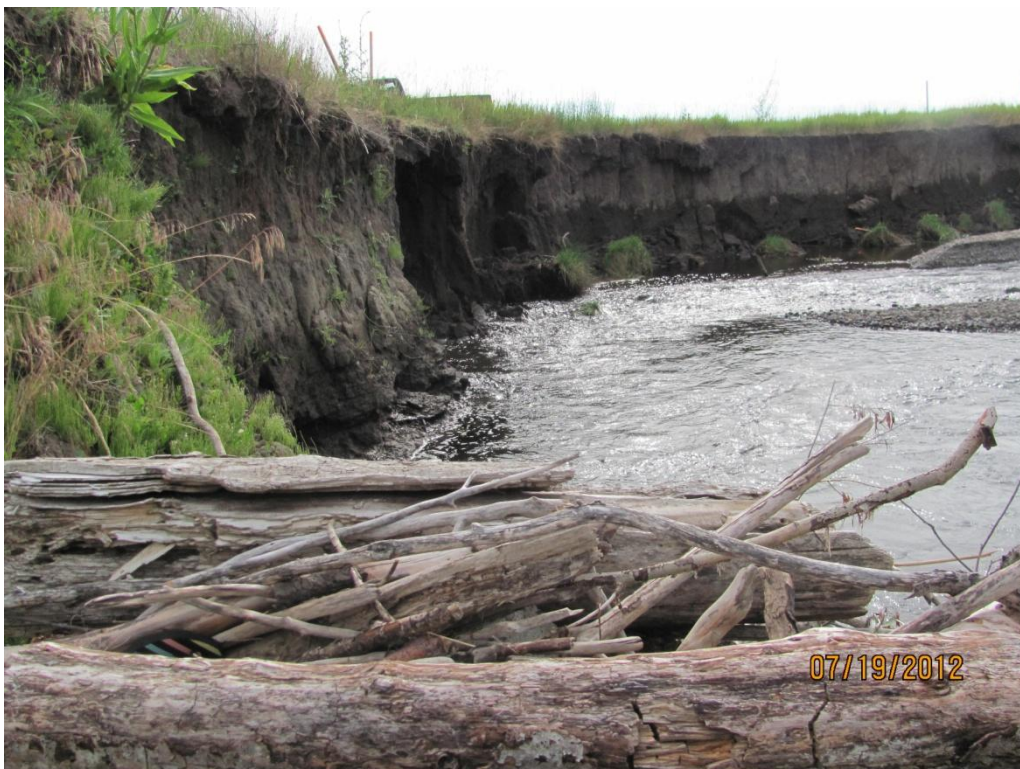
Photo 2. Vertical banks, pre-construction.

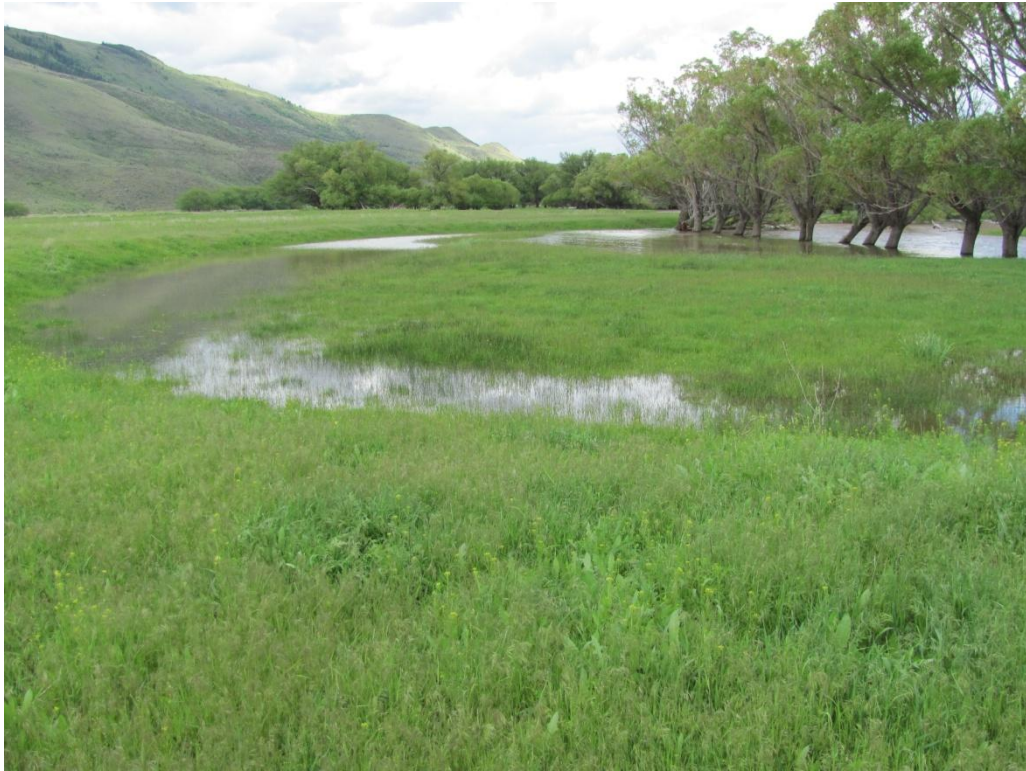
Photo 3. Southside location of upper side channel, pre-construction.

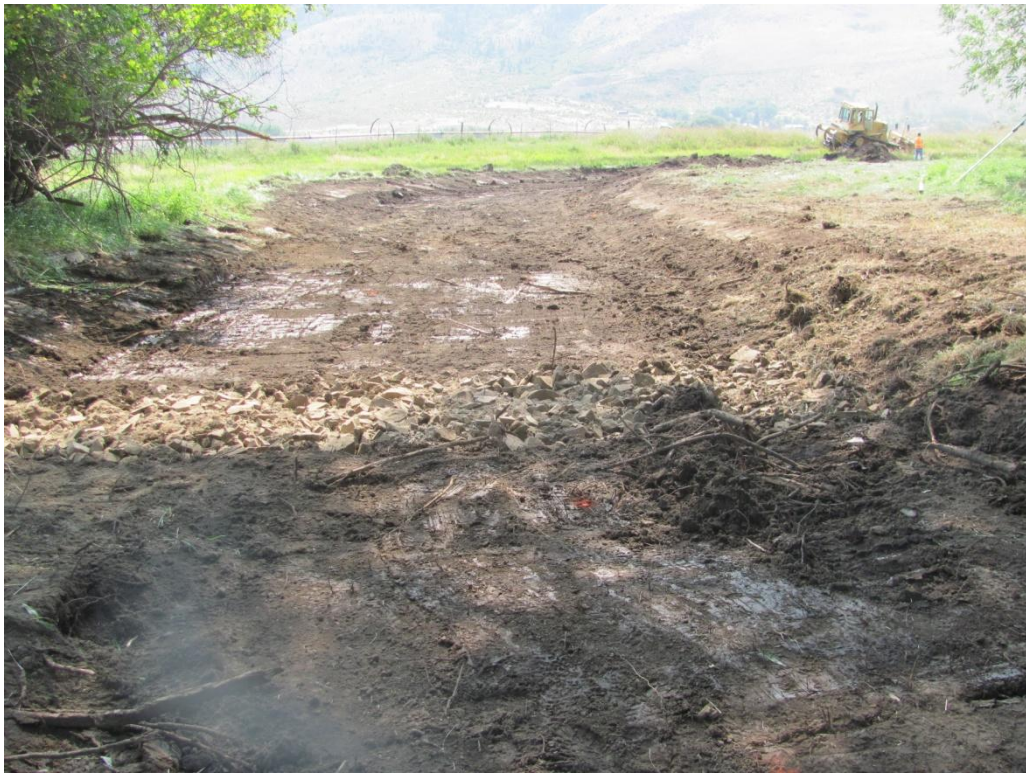
Photo 4. Completed upper side channel with entrance rock sill for sediment and flow control.

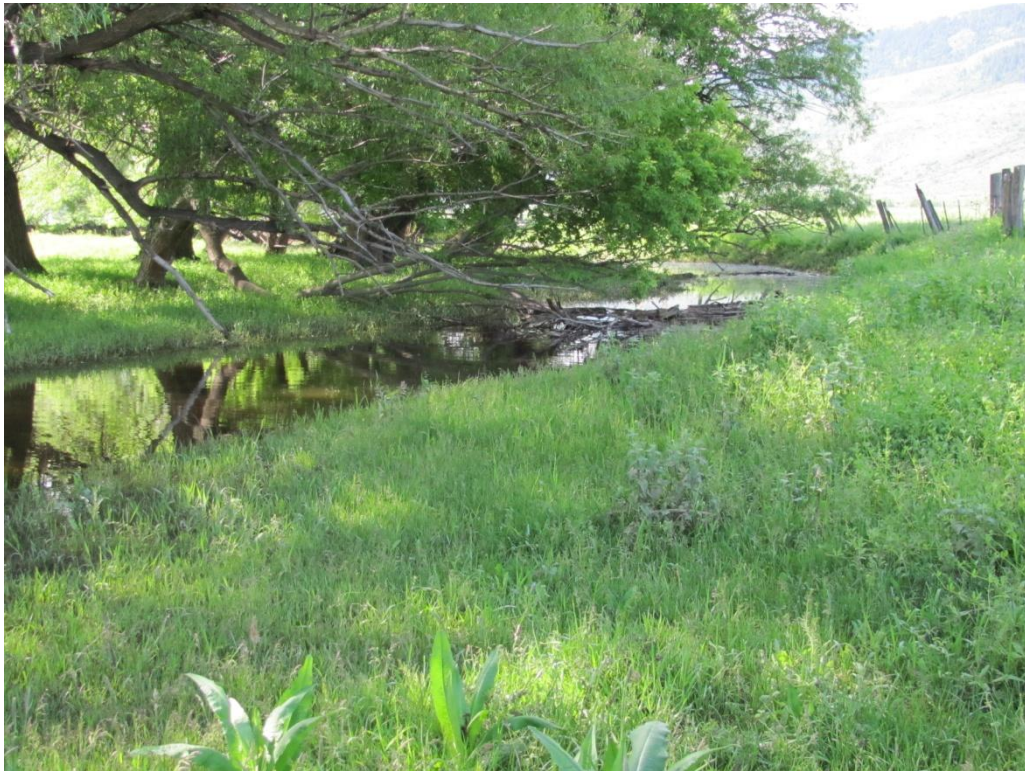
Photo 5. Location of disconnected old meander, pre-construction.

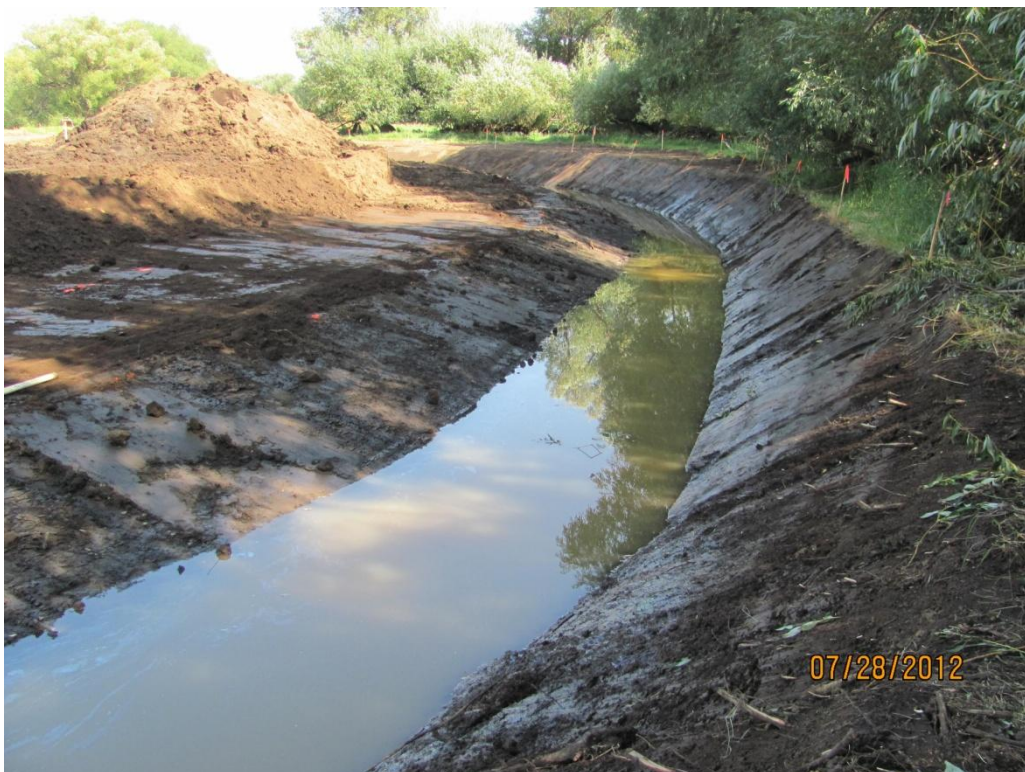
Photo 6. Excavation of new meander.

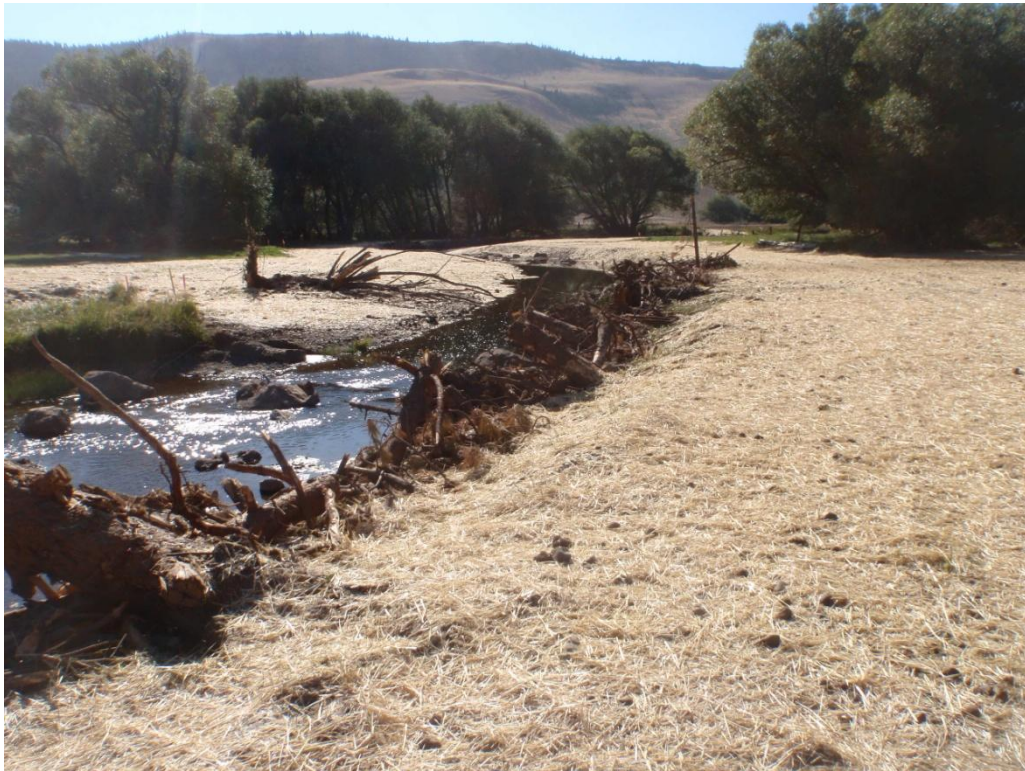
Photo 7. Upstream end of new meander. Excavated and re-sloped (3:1) vertical banks and widened floodplain. In-stream boulders, large wood structures, racking materials, and sedge mat placement. Banks were re-seeded, mulched, and planted with whips, container plants, and protected with panel pods.

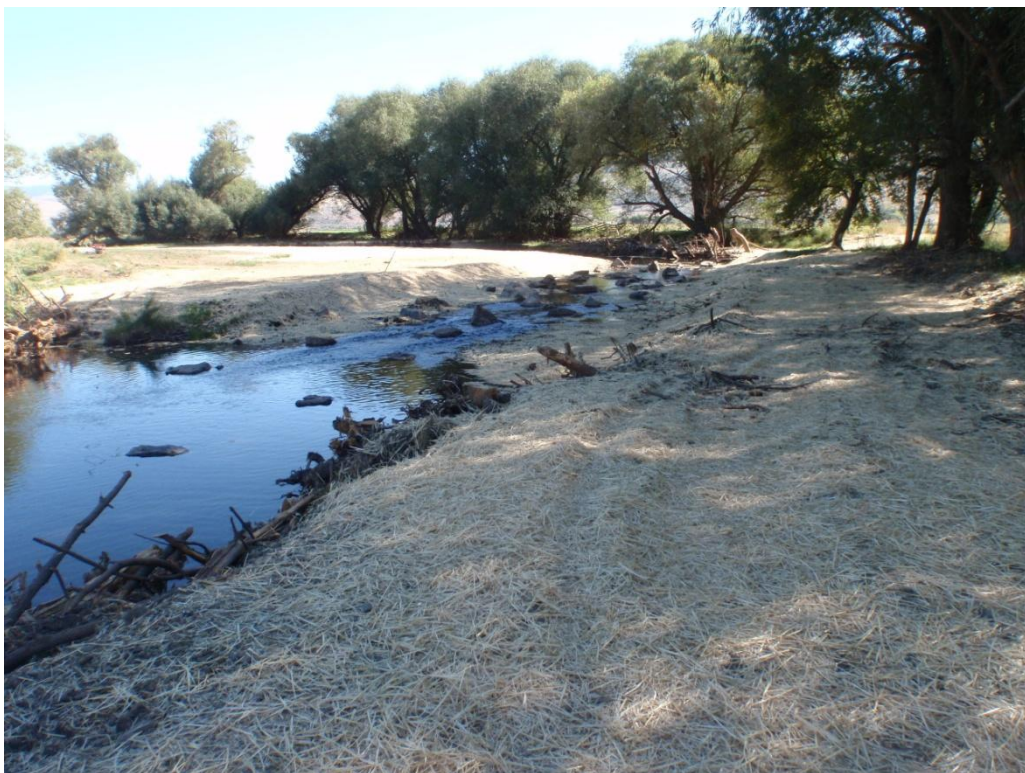
Photo 8. Downstream end of new meander. Excavated and re-sloped (3:1) vertical banks and widened floodplain. In-stream boulders, large wood structures, racking materials, and sedge mat placement. Banks were re-seeded, mulched, and planted with whips, container plants, and protected with panel pods.

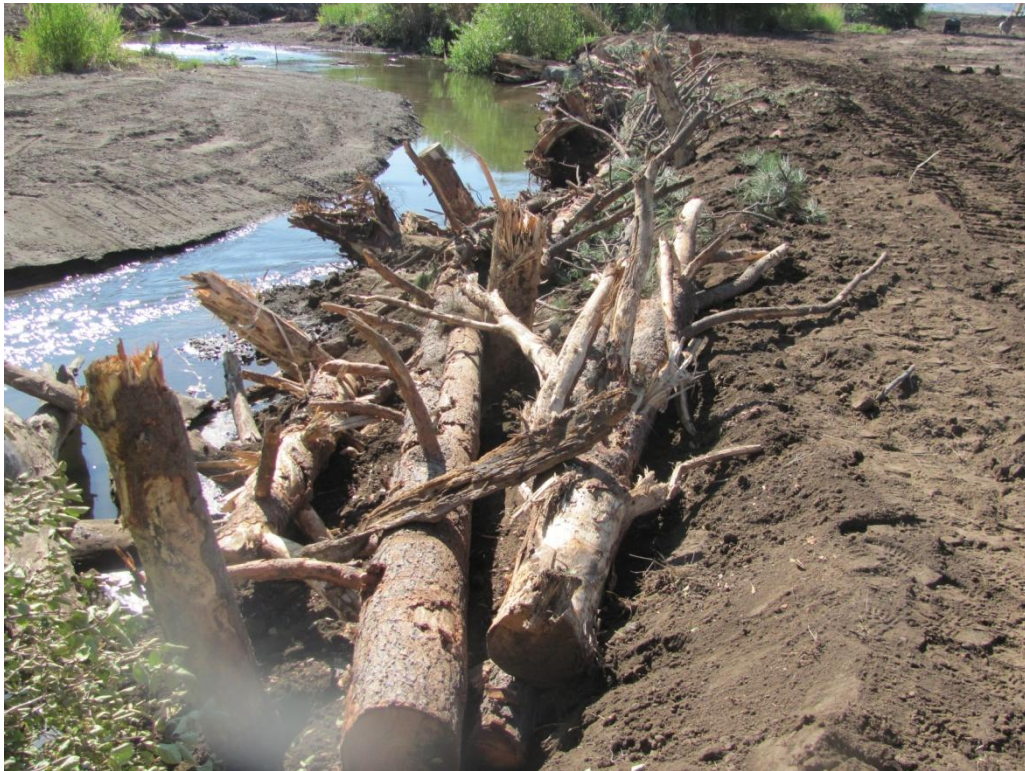
Photo 9. Typical large wood structure and racking material placement throughout project area.

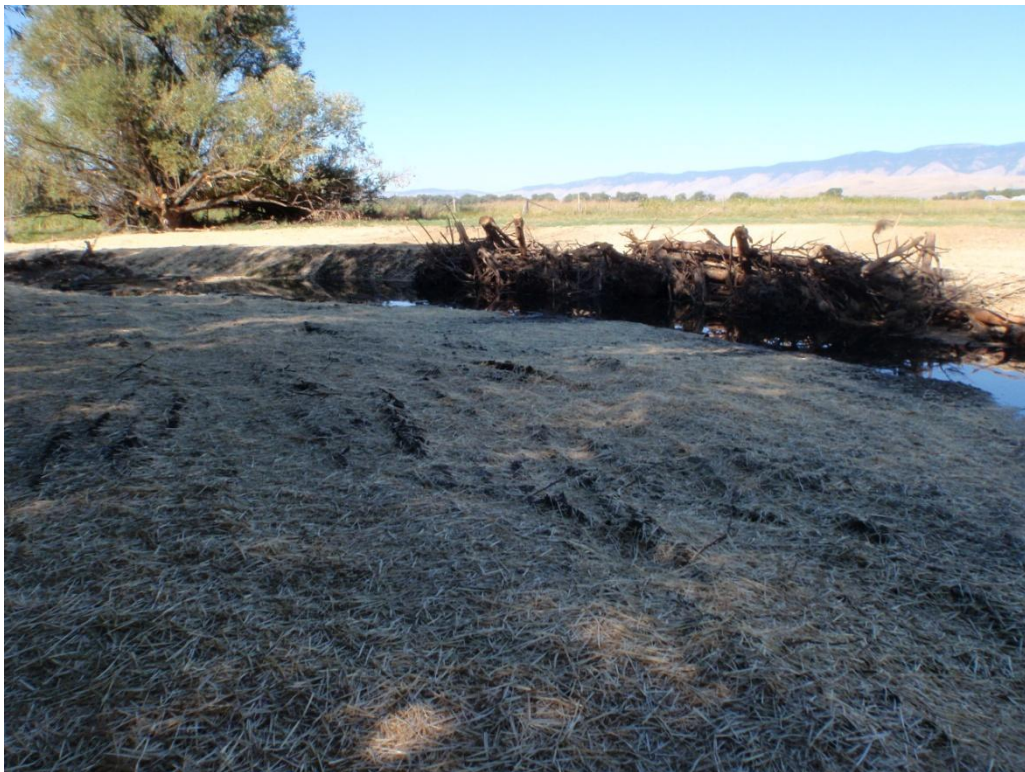
Photo 10. New meander. Excavated and re-sloped (3:1) vertical banks and widened floodplain. Large wood structures and racking materials placement. Banks were re-seeded, mulched, and planted with whips, container plants, and protected with panel pods.

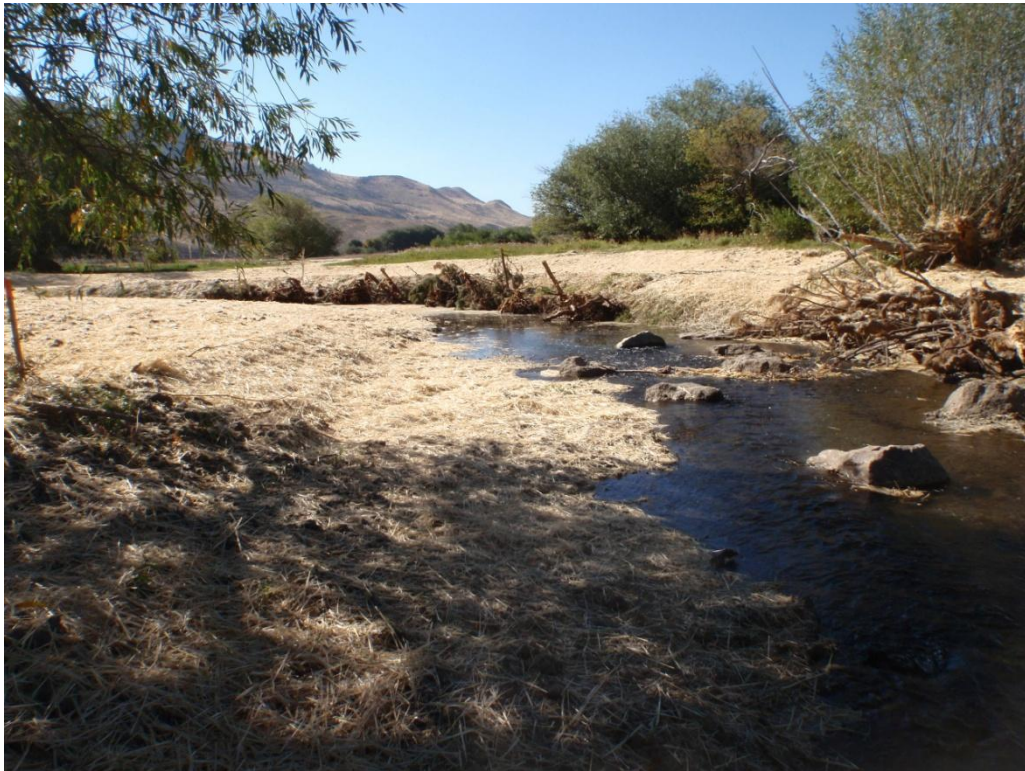
Photo 11. Excavated and re-sloped (3:1) vertical banks and widened floodplain. In-stream boulders, large wood structures, racking materials, and sedge mat placement. Banks were re-seeded, mulched, and planted with whips, container plants and protected with panel pods.

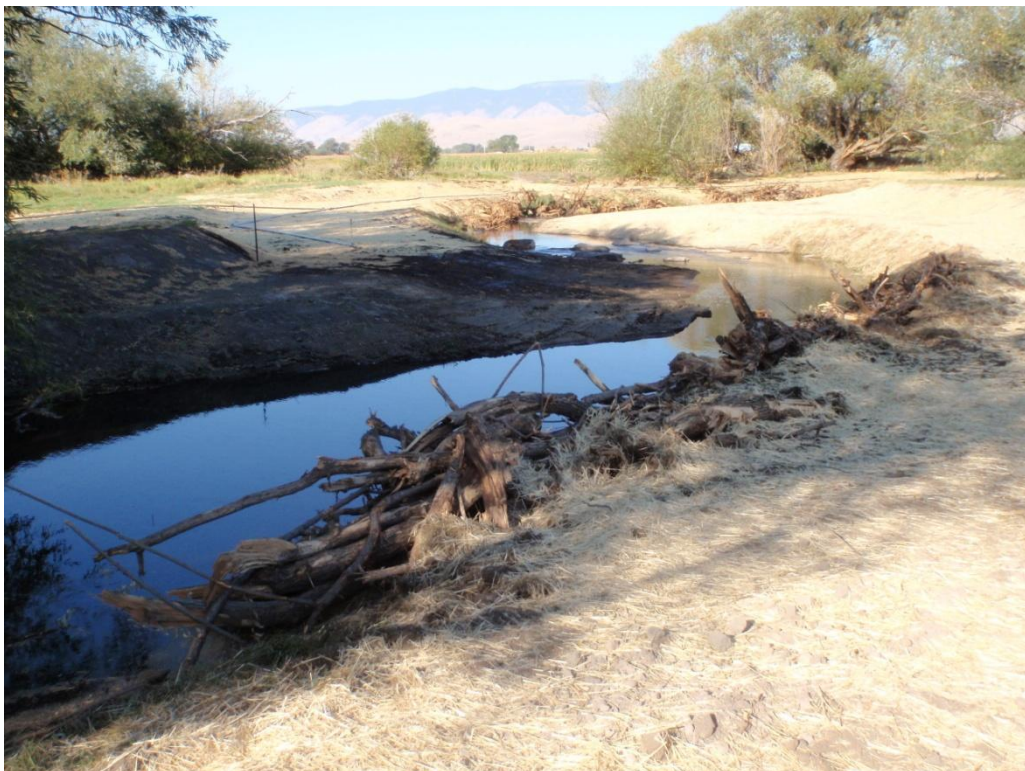
Photo 12. New meander. Excavated and re-sloped (3:1) vertical banks and widened floodplain. Large wood structures and racking materials placement. Banks were mulched, re-seeded, and planted with whips, container plants and protected with panel pods.

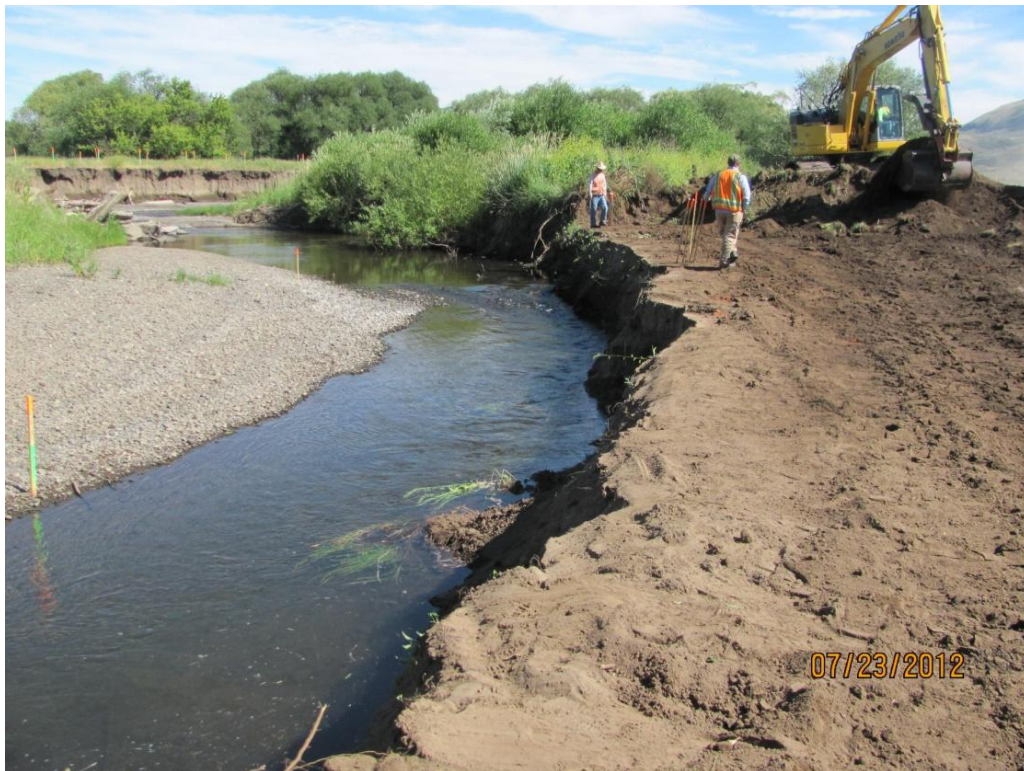
Photo 13. Vertical Banks prior to construction re-sloping and setback.

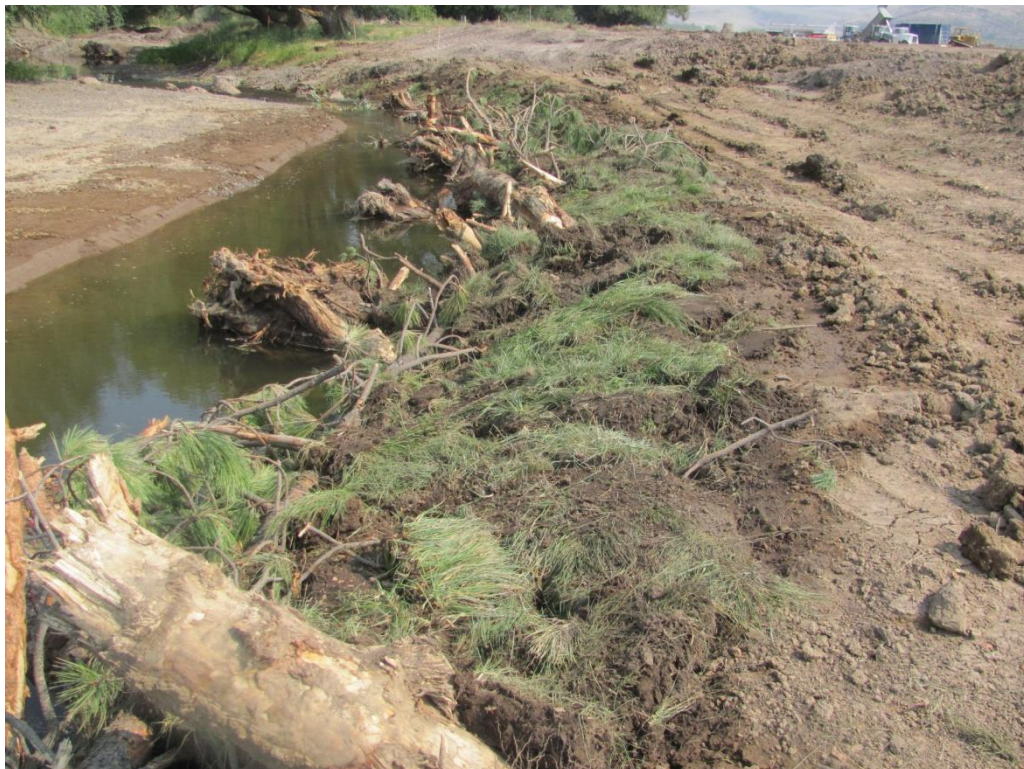
Photo 14. Excavated and re-sloped (3:1) vertical banks and widened floodplain. Large wood structures, racking materials, and sedge mat placement. Banks were mulched, re-seeded, and planted with whips, container plants, and protected with panel pods.

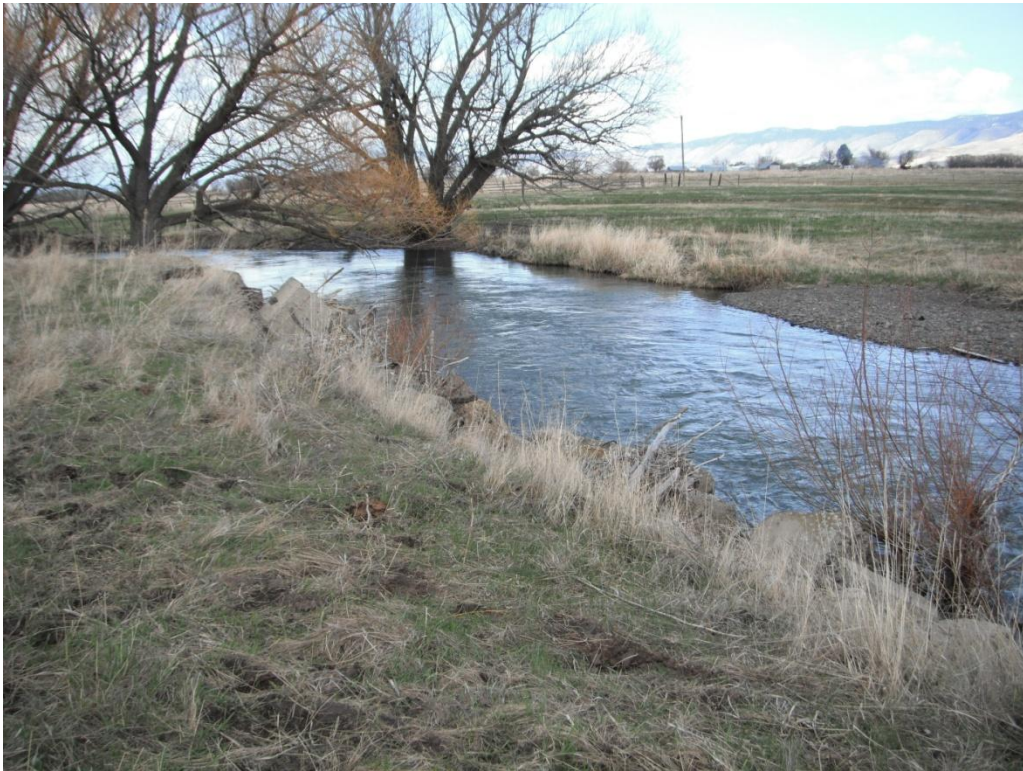
Photo 15. Eroded banks, mid-project, prior to construction.

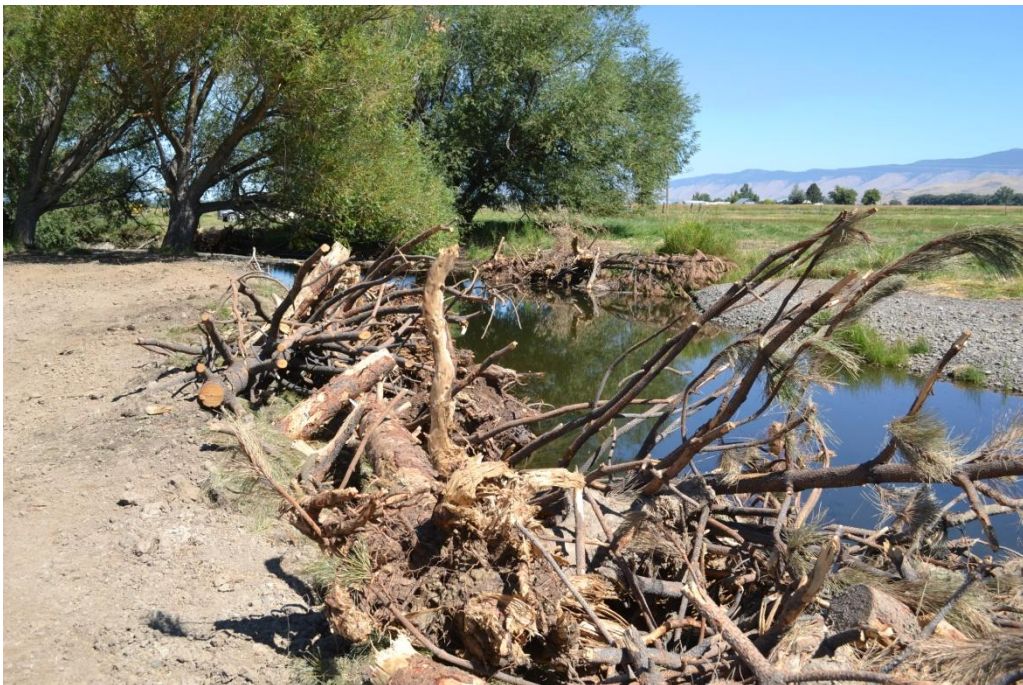
Photo 16. Excavated and re-sloped (3:1) vertical banks and widened floodplain. Large wood structures, racking materials, and sedge mat placement. Banks were mulched, re-seeded, and planted with whips, container plants, and protected with panel pods.

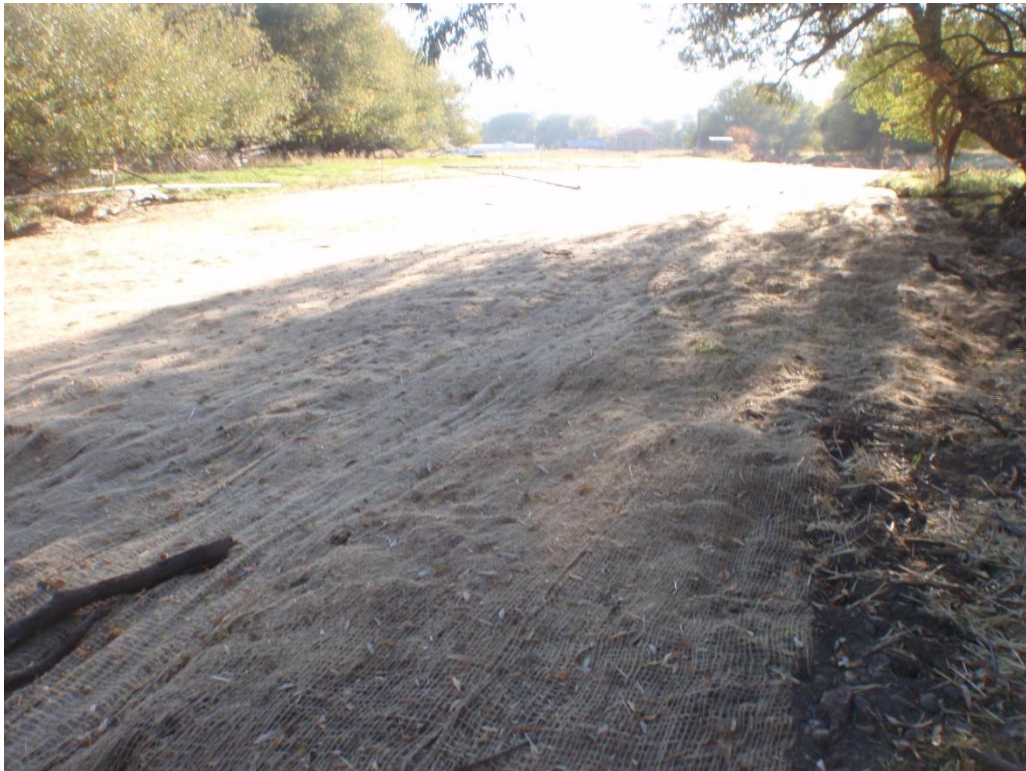
Photo 17. High water alcove with erosion control blanket, re-seeded, mulched, re-planted with whips, container plants, and protected with panel pods.

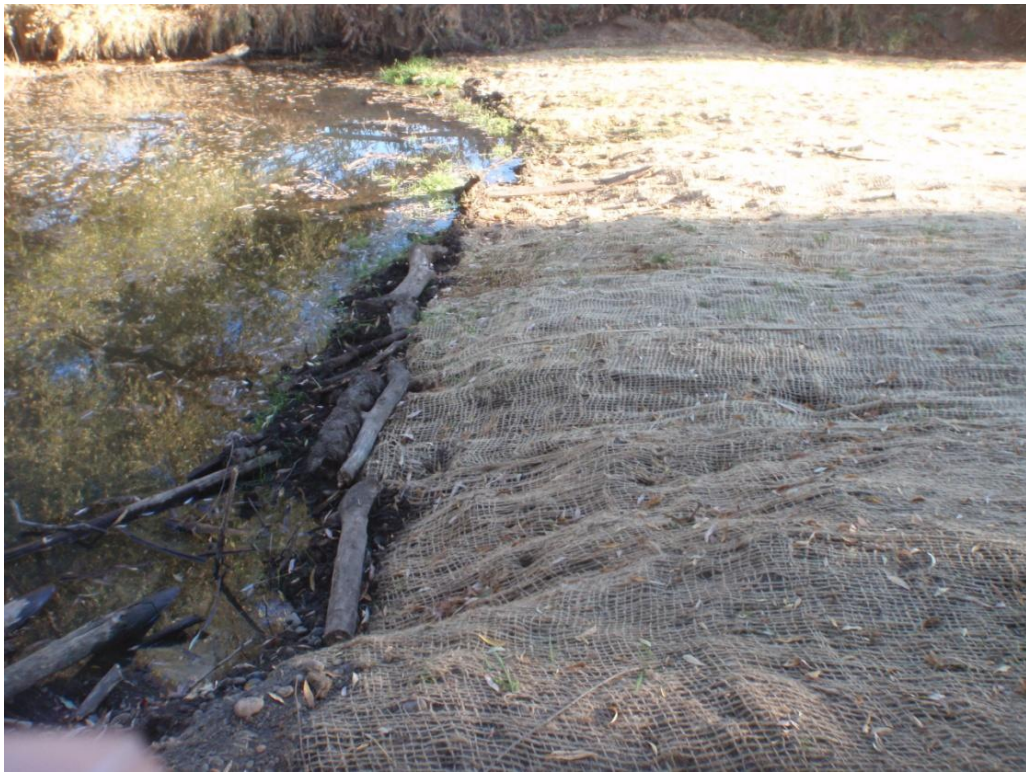
Photo 18. High water alcove with erosion control blanket, re-seeded, mulched, re-planted with whips, container plants, and protected with panel pods.

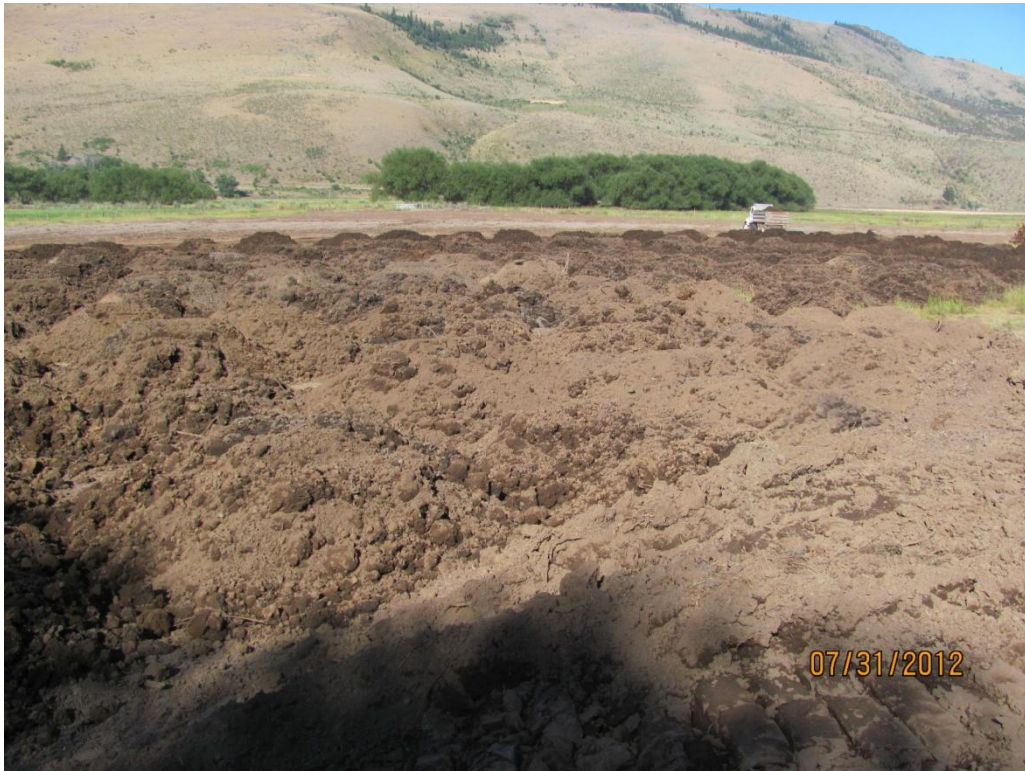
Photo 19. Excavated spoils material placed on pasture.

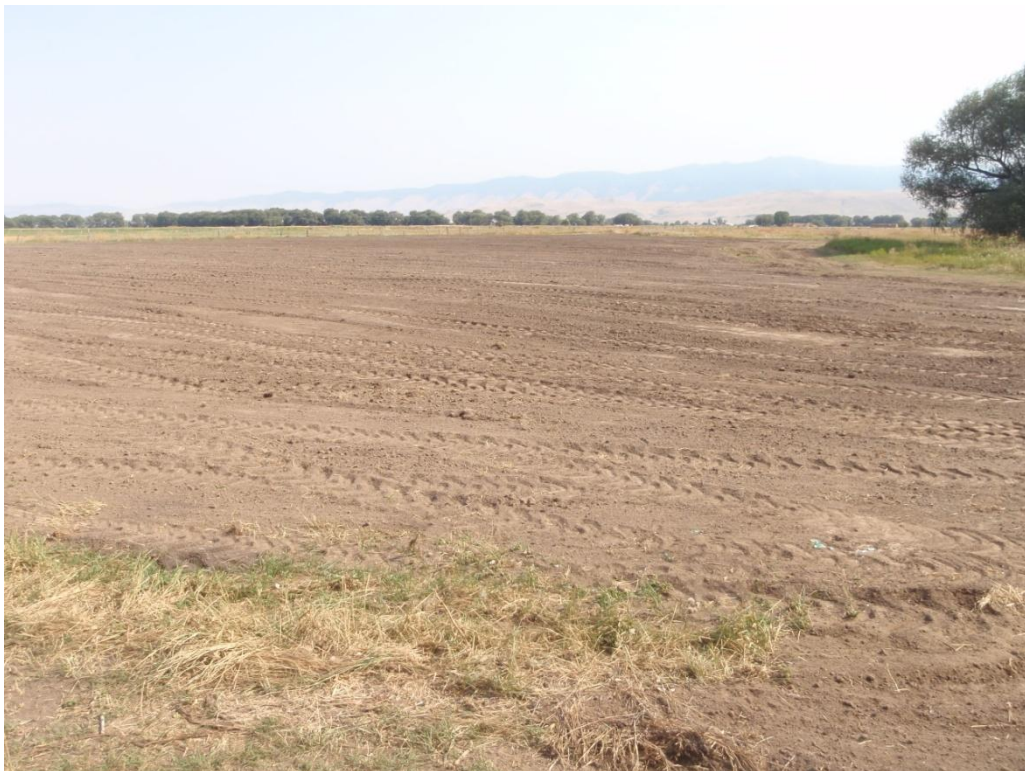
Photo 20. Completed excavated soils material leveled, mulched, and re-seeded on pasture.

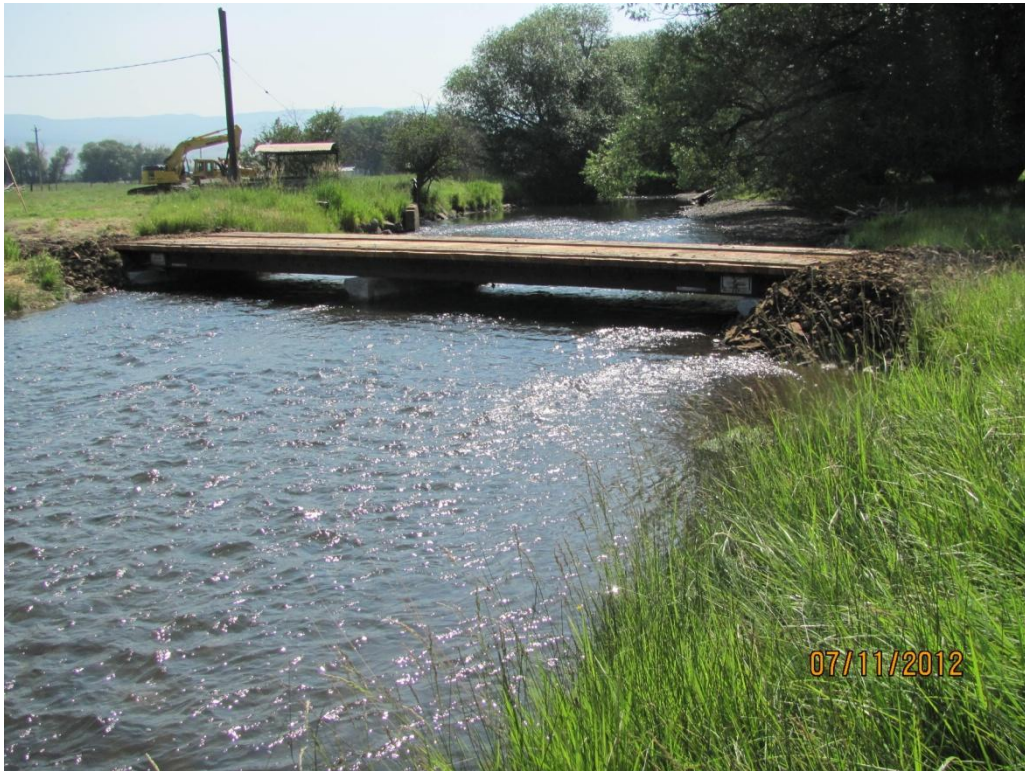
Photo 21. Temporary bridge crossing for construction equipment, protecting valuable fish habitat and passage.

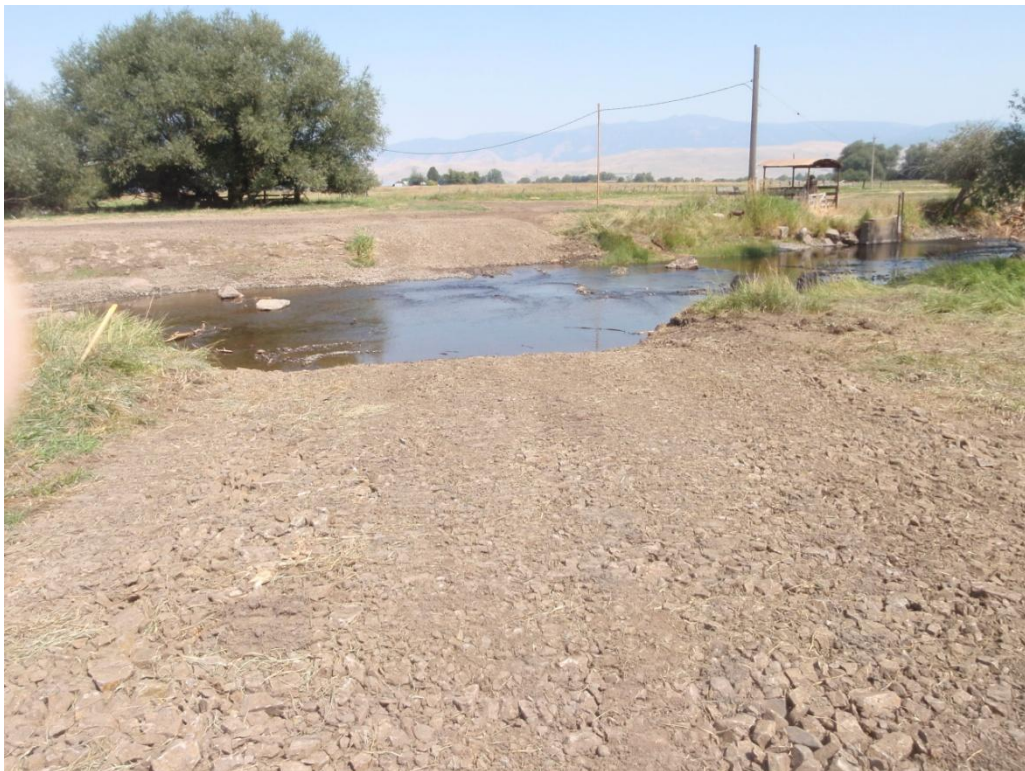
Photo 22. Completed hardened water crossing.

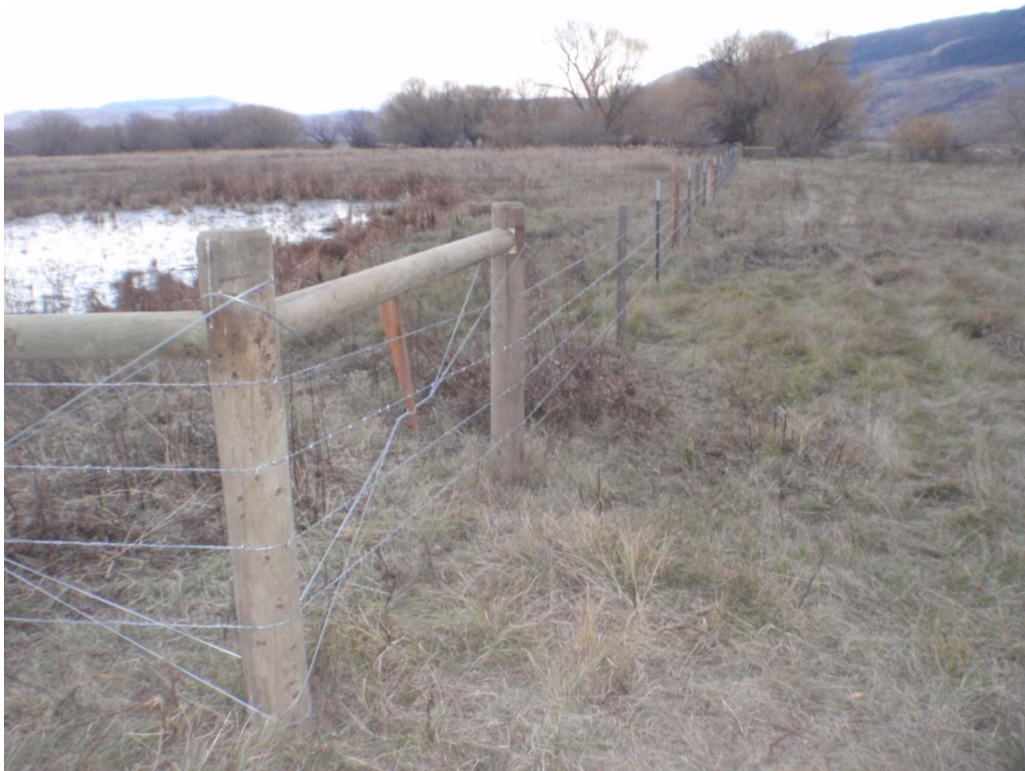
Photo 23. 15 year enclosure fencing protecting wetland area.

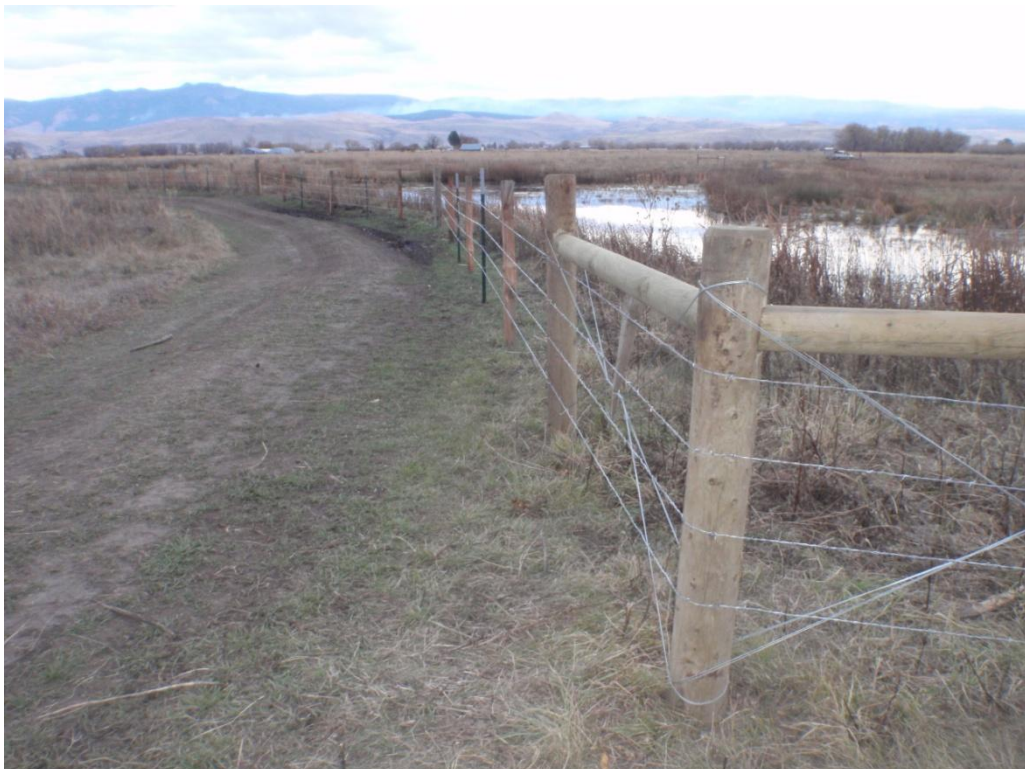
Photo 24. 15 year enclosure fencing protecting wetland area.
