Lostine River/Tulley-Hill Fish Passage Improvement
Post Implementation Status Report

OWEB Project # 217-5028-14142
Restoration

Performance Period April 26, 2017 to October 31, 2019

Submitted by Montana Pagano, Nez Perce Tribe
On behalf of Grande Ronde Model Watershed
September 2019

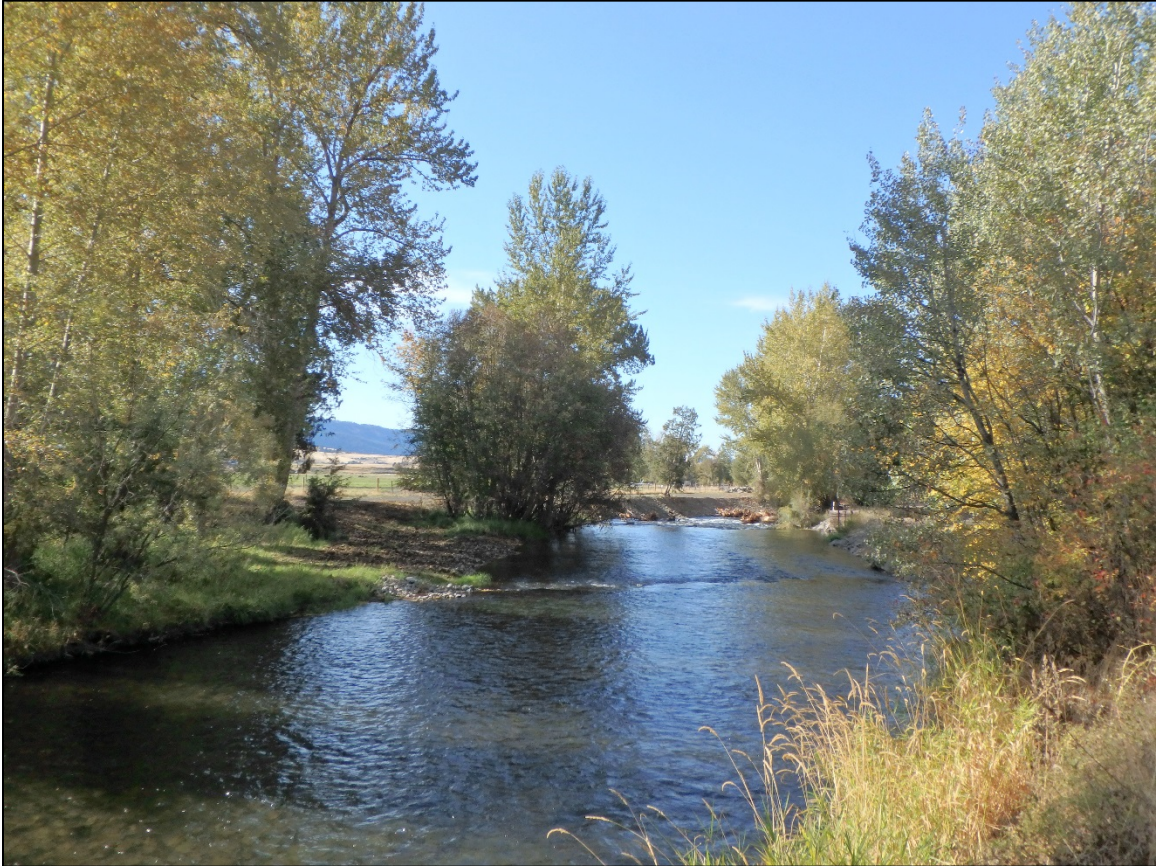
Photo 1. Photo taken upstream of the project reach looking downstream through the roughened channel.

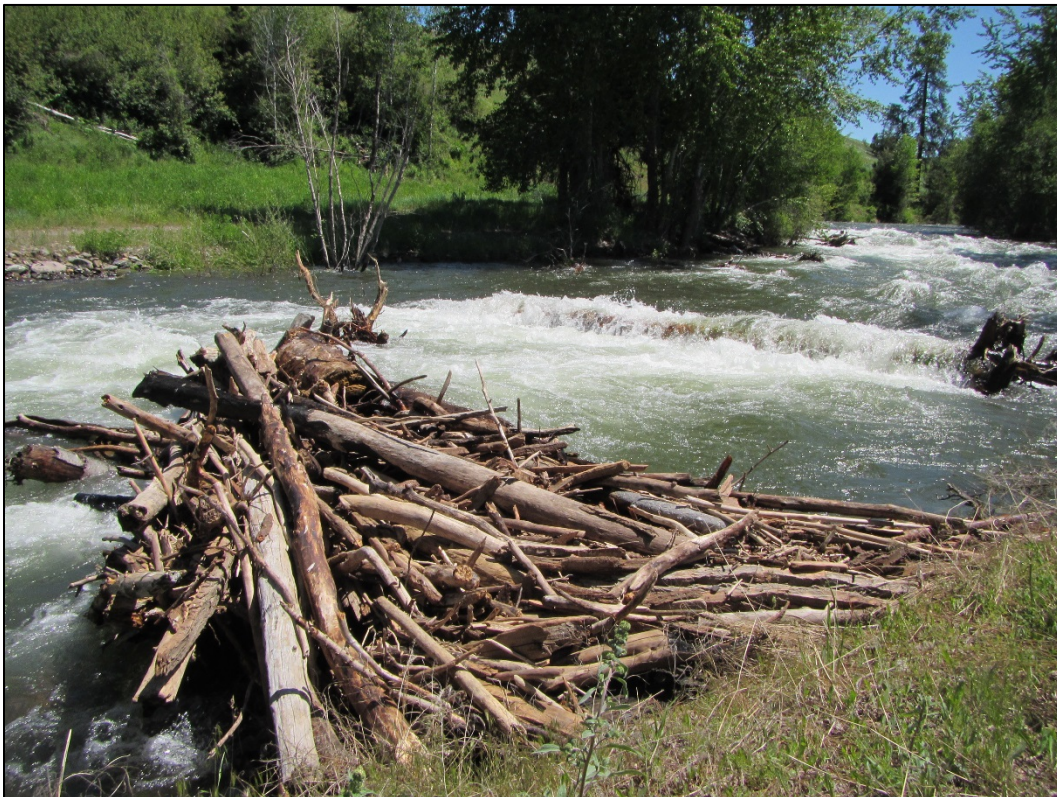
project sponsor regarding his concerns about the erosion continuing to deteriorate the road prism. The project sponsor quickly addressed his concern by hiring a contractor to install rip rap at the two locations through a DSL emergency authorization permit (see Exhibit D #4 narrative below for details). During high flows in June, 2019, the second and final log from the uppermost left bank large wood structure dislodged from the bank and was captured in the large wood structures just downstream. The structure that trapped this log has acquired a fair amount of other drift wood, significantly increasing its size since its placement in 2017 (Photo 2). The same can be said for the two left and right bank wood structures immediately downstream located in the large pool. These increases in large wood accumulation on these structures is a positive result further enhancing their benefits to fish habitat.

Photo 2. Photo taken June 4, 2019 showing increased size of second and third large wood structures on river left due to naturally occurring racking.

The restored diversion continues, two years post-implementation, to function as designed. Although the low flow channel has shifted toward river left in the bottom 1/3 of the project reach as a result of a gravel bar formation adjacent to the large wood structure in Photo 2, this action does not appear to have impacted the overall performance of the roughened channel. It is obvious that some boulders have shifted slightly during high flow events, and some settling has occurred around the four upper grade control structures, jump height is not an issue and multiple flow paths exist for fish passage, even at low-flow. This assumption is also supported by data collected through the Nez Perce Tribe's adult Chinook radio telemetry data (see Figure 1). Additionally, the associated head gate is still operating properly and, to our knowledge, with minimal maintenance required by the irrigator.

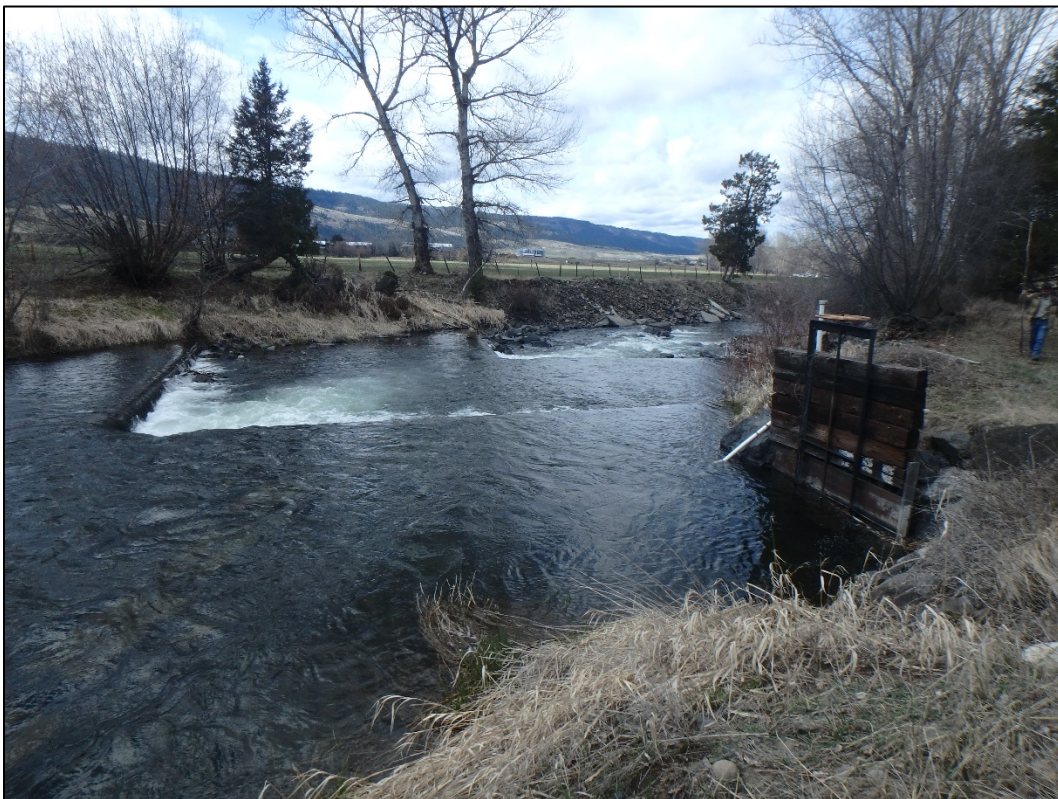
Photo 3. March 23, 2016 photo point #1 (before) looking downstream at the diversion and head gate.

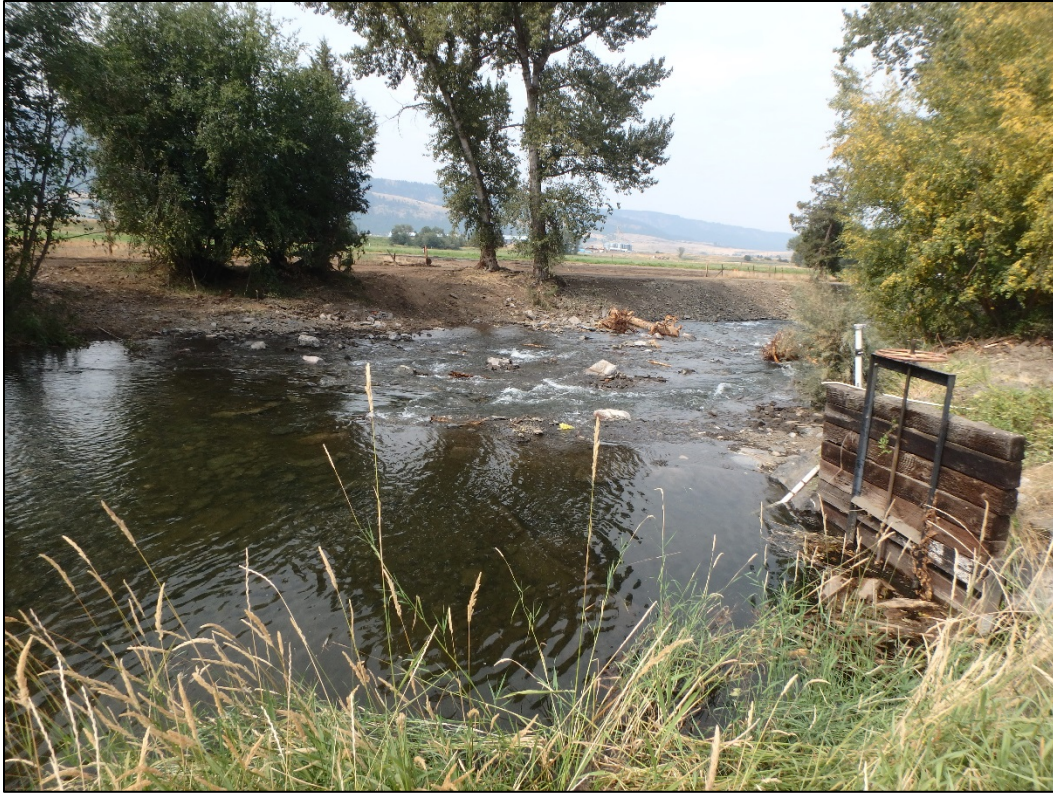
Photo 4. October 12, 2017 photo point #1 (after) looking downstream at the diversion and head gate.

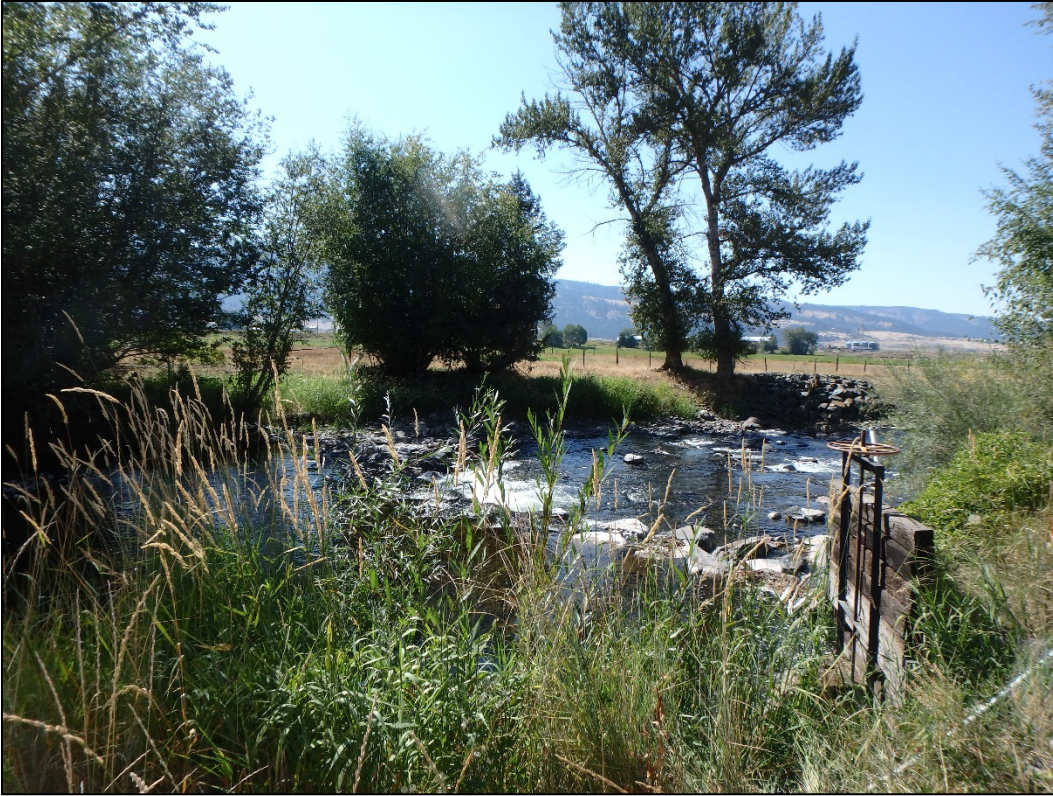
Photo 5. August 28, 2019 photo point #1, 2-years post project completion.

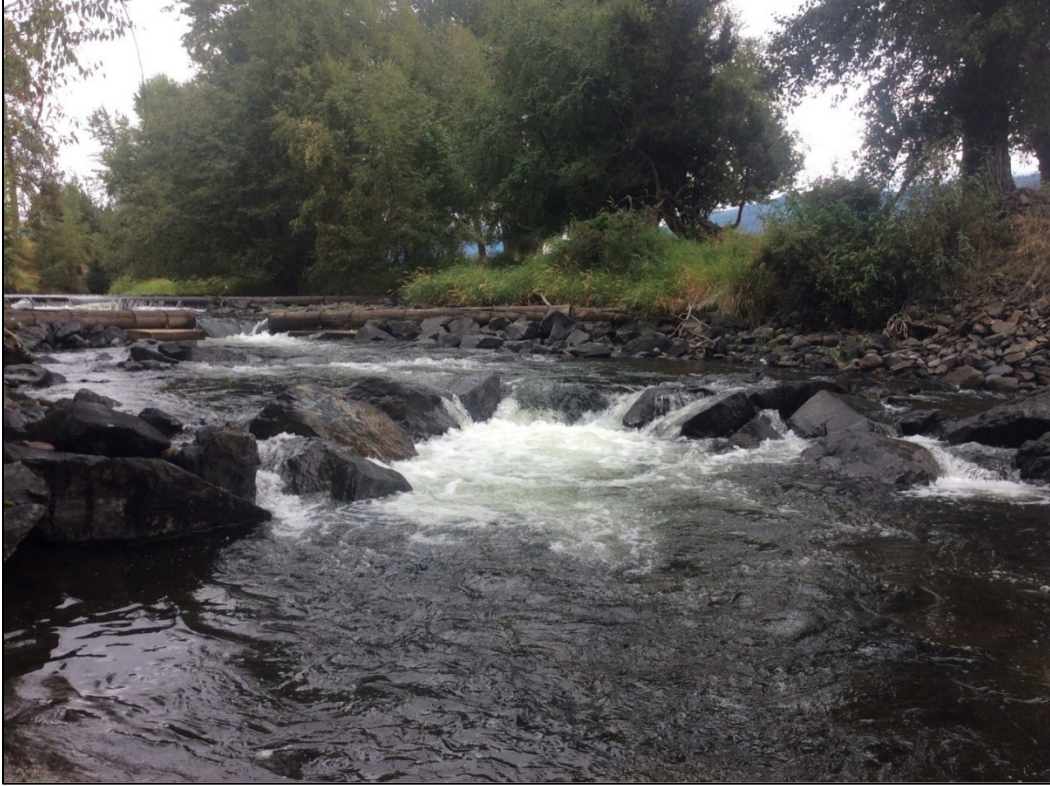
Photo 6. May 8, 2017 photo point #2 (before) from river right looking upstream through diversion, mid-project.

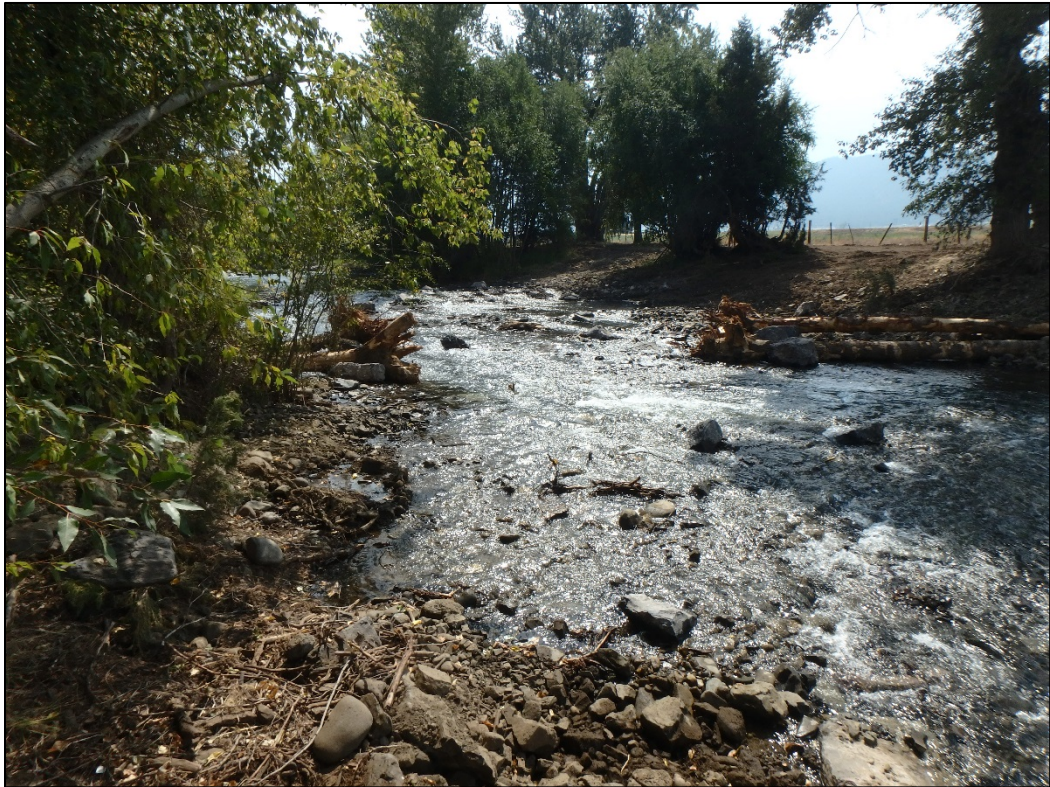
Photo 7. October 12, 2017 photo point #2 (after) from river right looking upstream through diversion, mid-project.

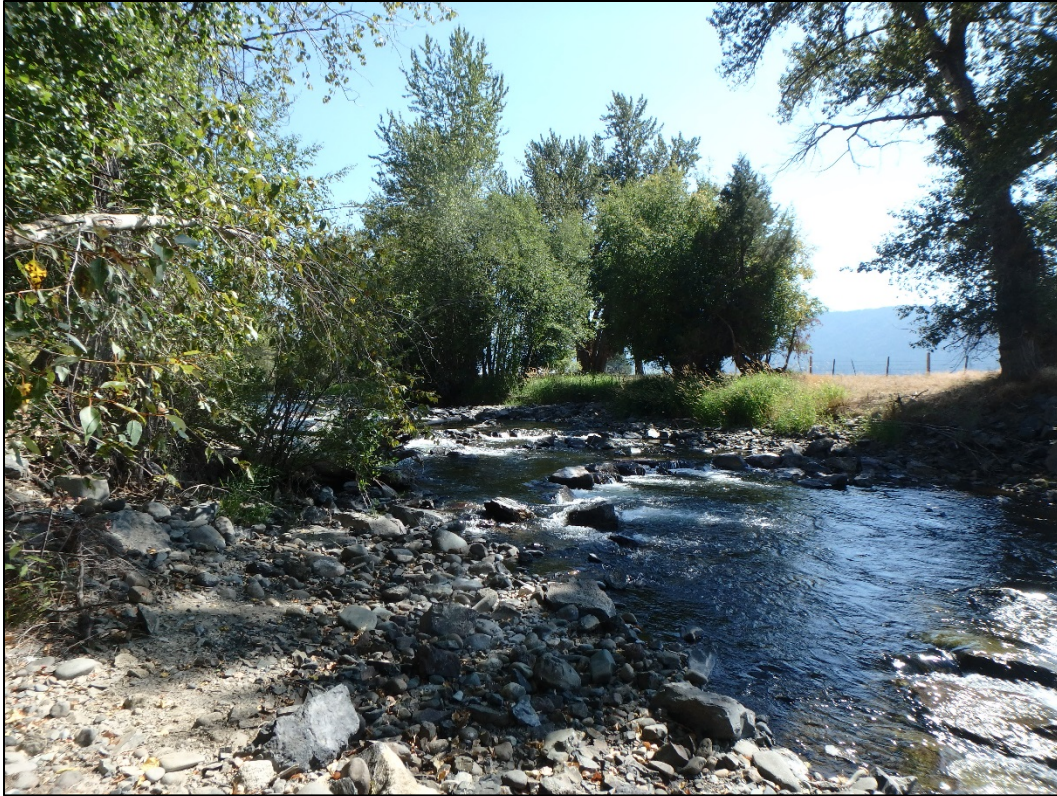
Photo 8. August 28, 2019 photo point #2, 2-years post implementation.

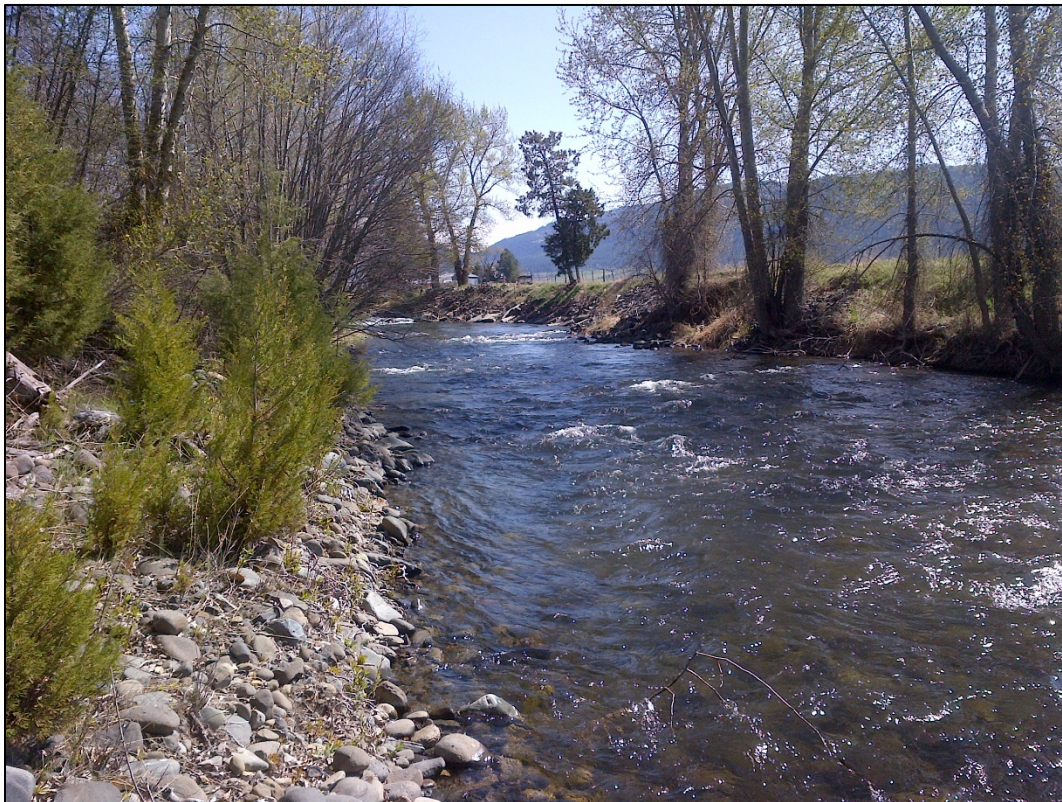
Photo 9. April 22, 2015 photo point #3 (before) from river right looking upstream from the bottom of the project reach.

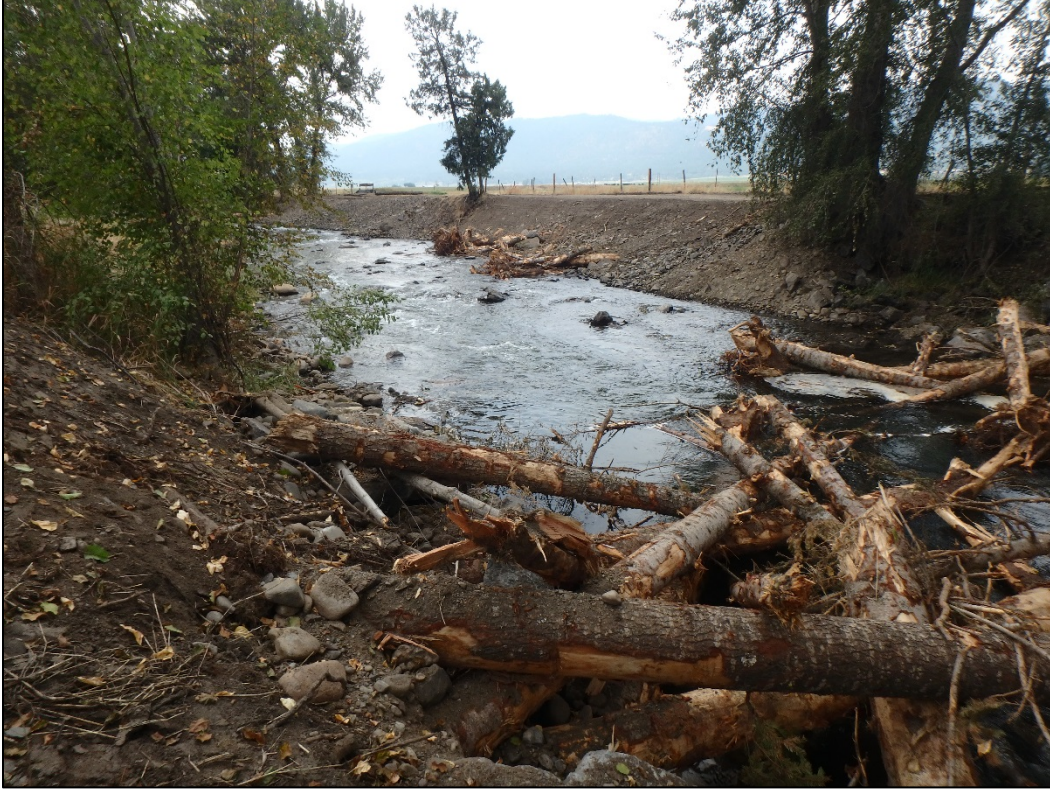
Photo 10. October 4, 2017 photo point #3 (after) from river right looking upstream from the bottom of the project reach.

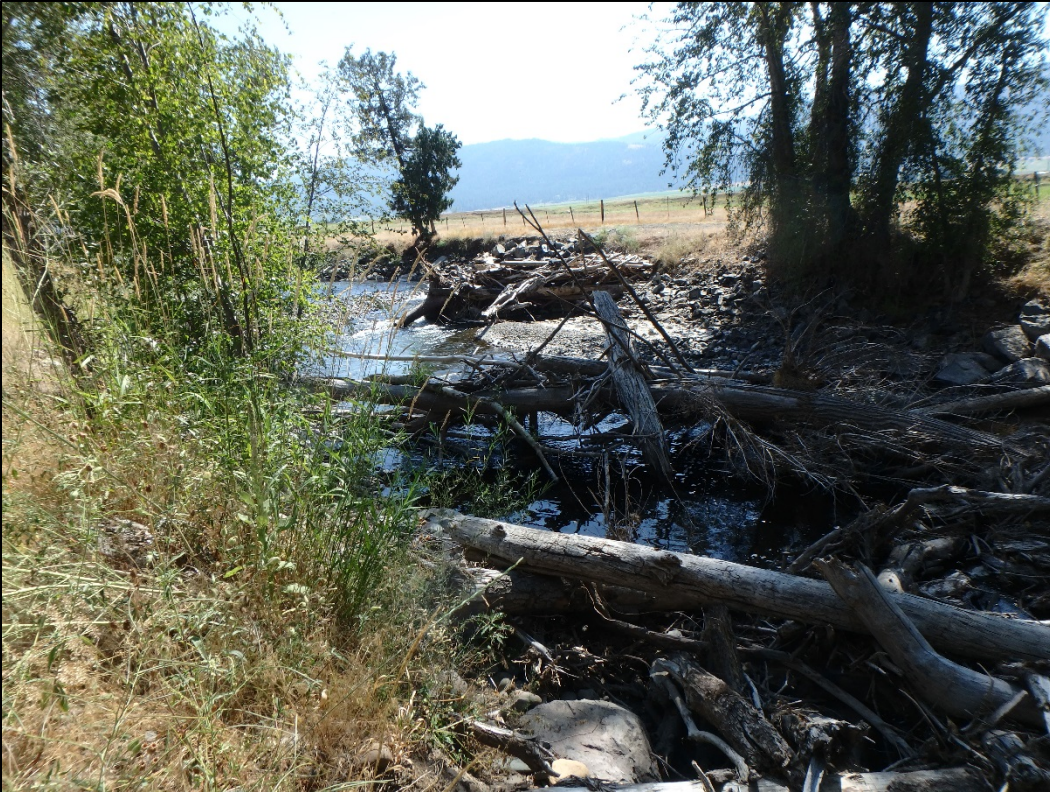
Photo 11. August 28, 2019 photo point #3 2-years post implementation.

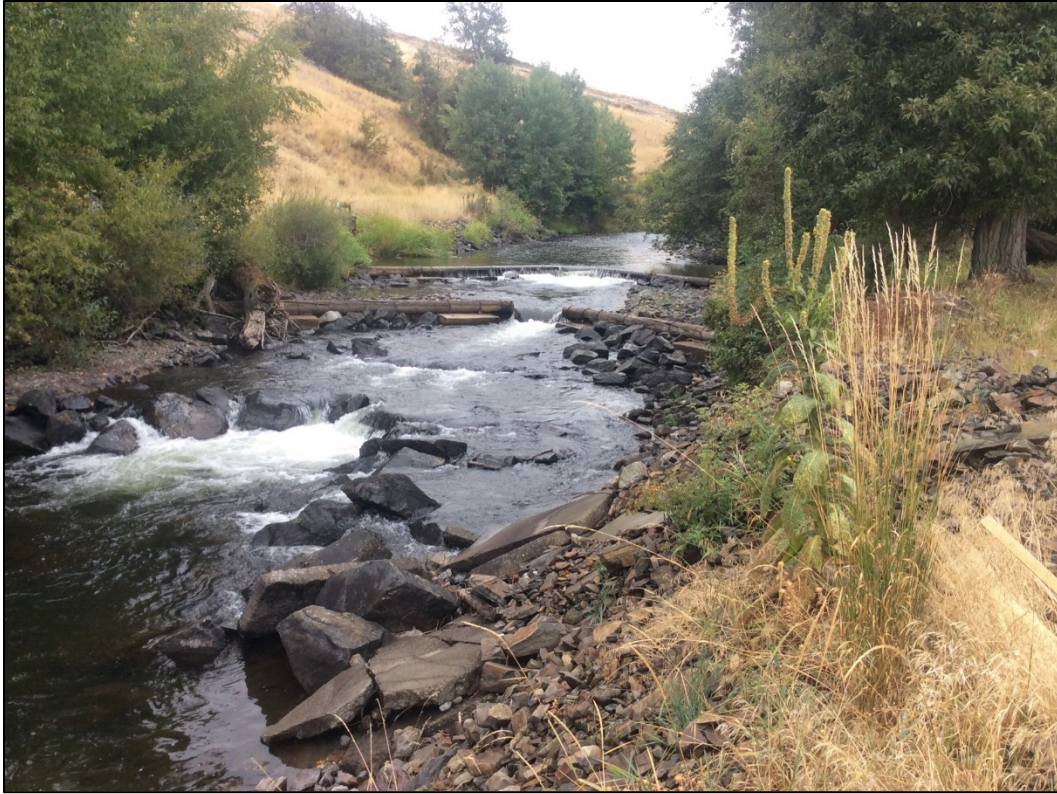
Photo 12. May 5, 2017 photo point #4 (before) from river left looking upstream, mid-project.

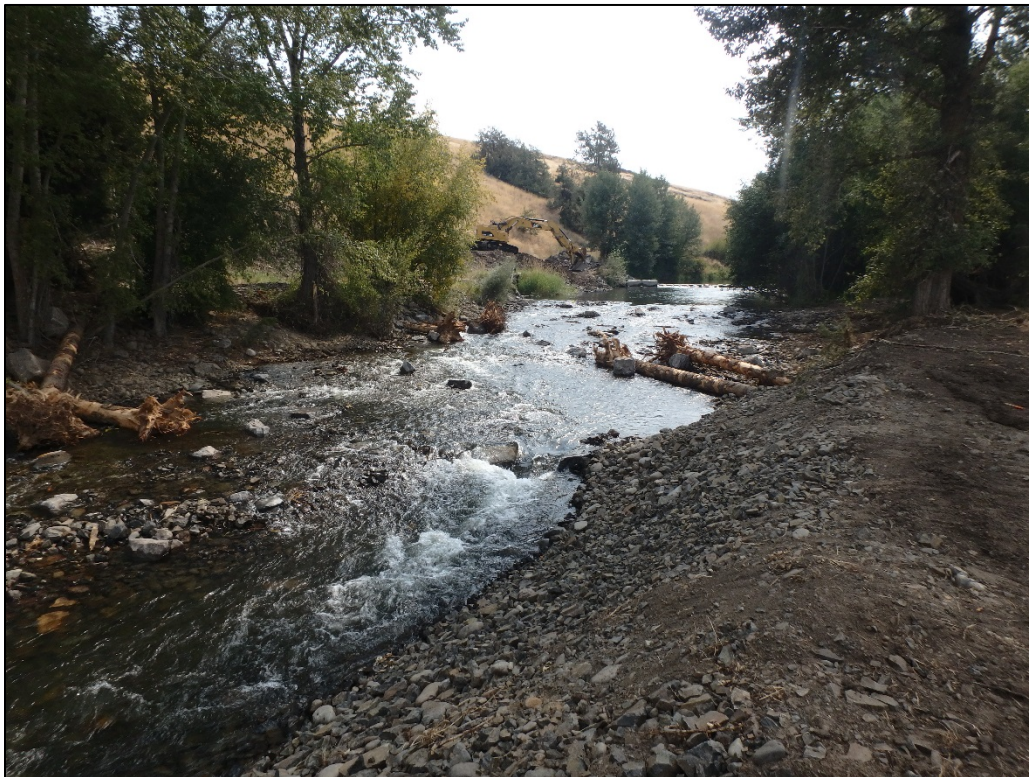
Photo 13. October 4, 2017 photo point #4 (before) from river left looking upstream, mid-project.

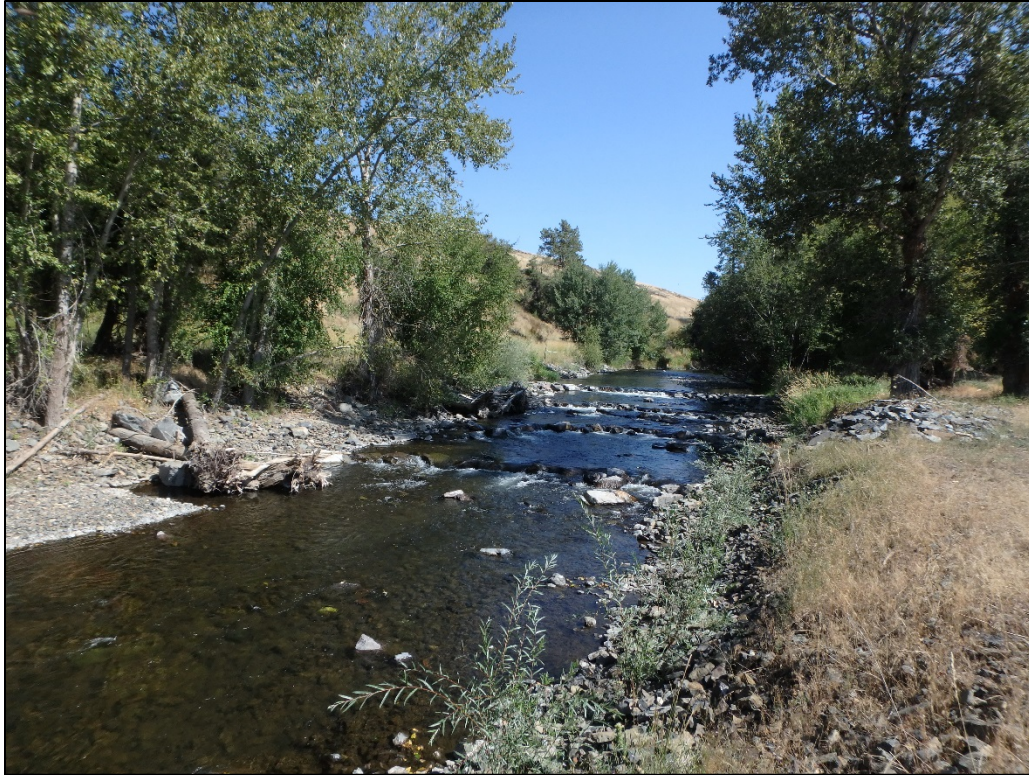
Photo 14. August 28, 2019 photo point #4, 2-years post implementation.

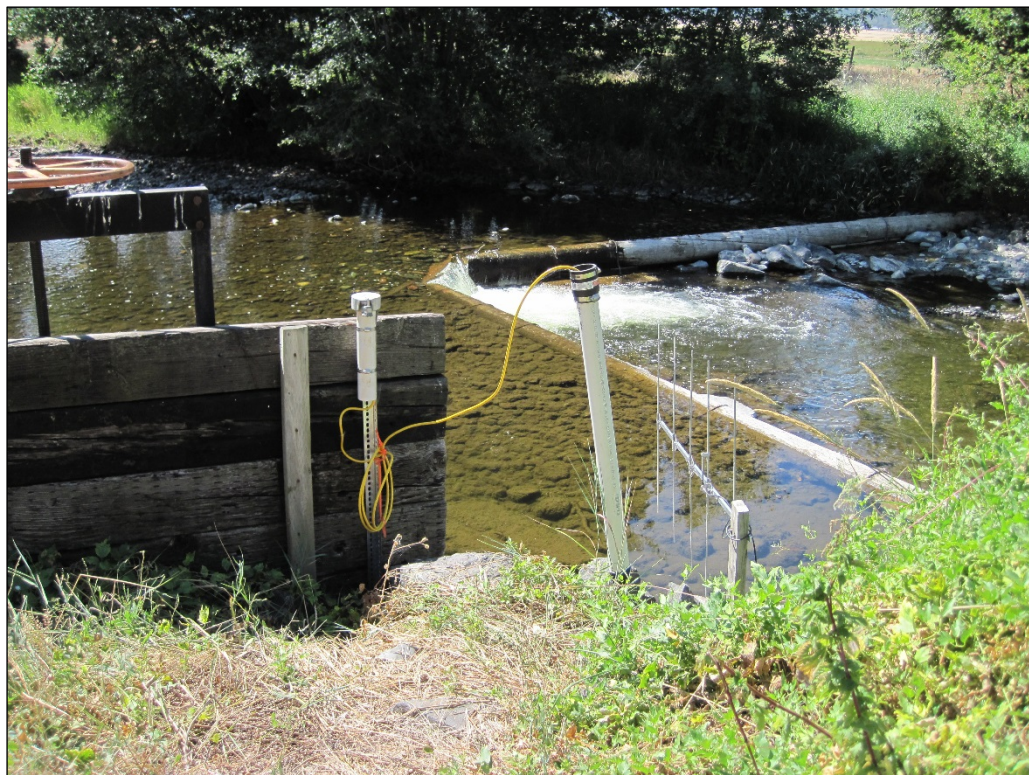
Photo 15. August 20, 2012 photo point #5 (before) from river right looking across the river below the head gate.

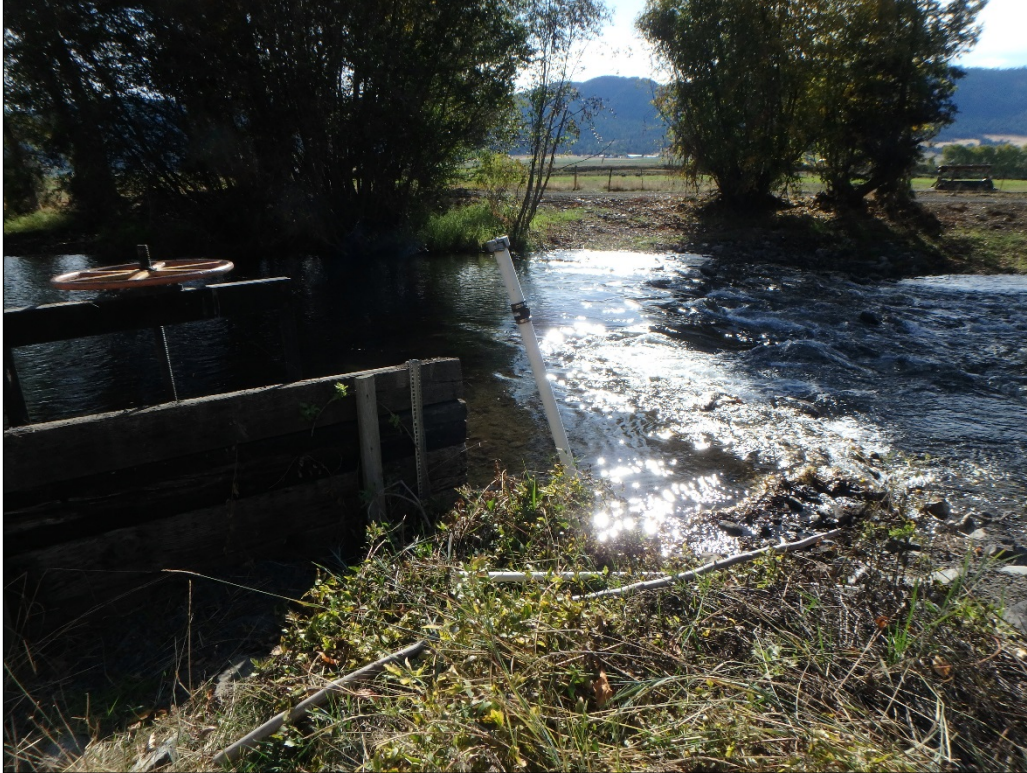
Photo 16. October 4, 2017 photo point #5 (before) from river right looking across the river below the head gate.

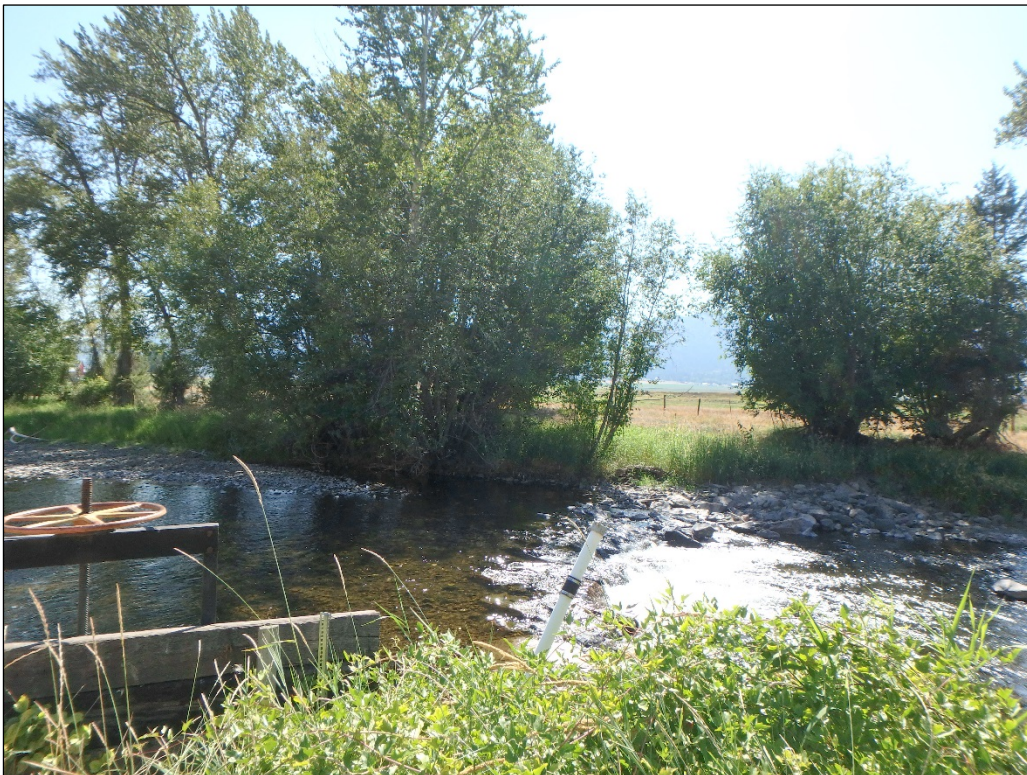
Photo 17. August 28, 2019 photo point #5, 2-years post implementation.

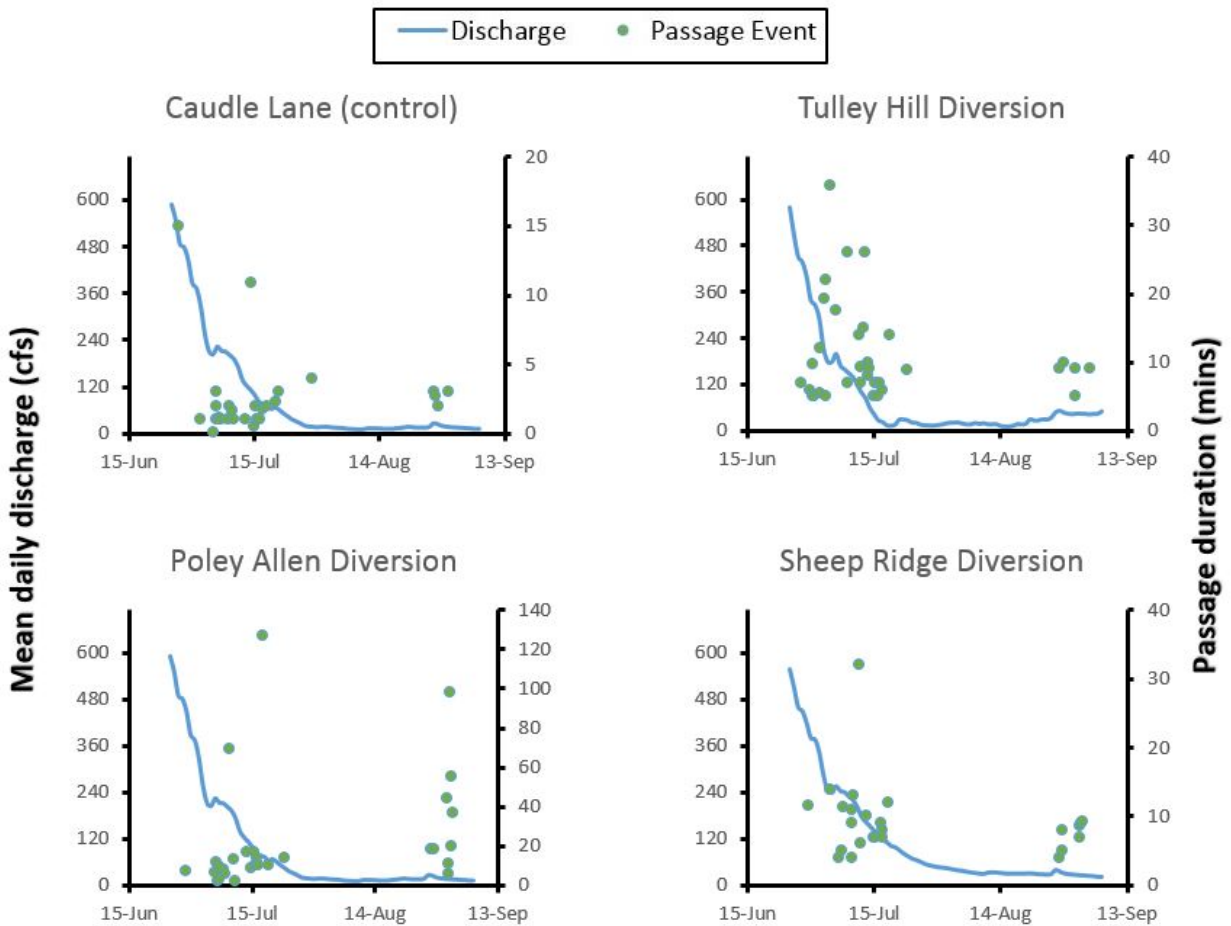
Figure 1. Discharge versus passage duration at 2018 fixed antenna sites. Green circles represent date and duration of individual passage events. Blue lines represent mean daily discharge over time.

Restoration at Tulley Hill Diversion was completed in 2017. Median passage duration at Tulley Hill was 25 minutes pre-restoration and 9 minutes post-restoration. In comparison, median passage duration at the control site was 2 minutes during both pre- and post-restoration monitoring (Table 2). Monitoring of Tulley Hill Diversion will continue in 2019 - 2020.

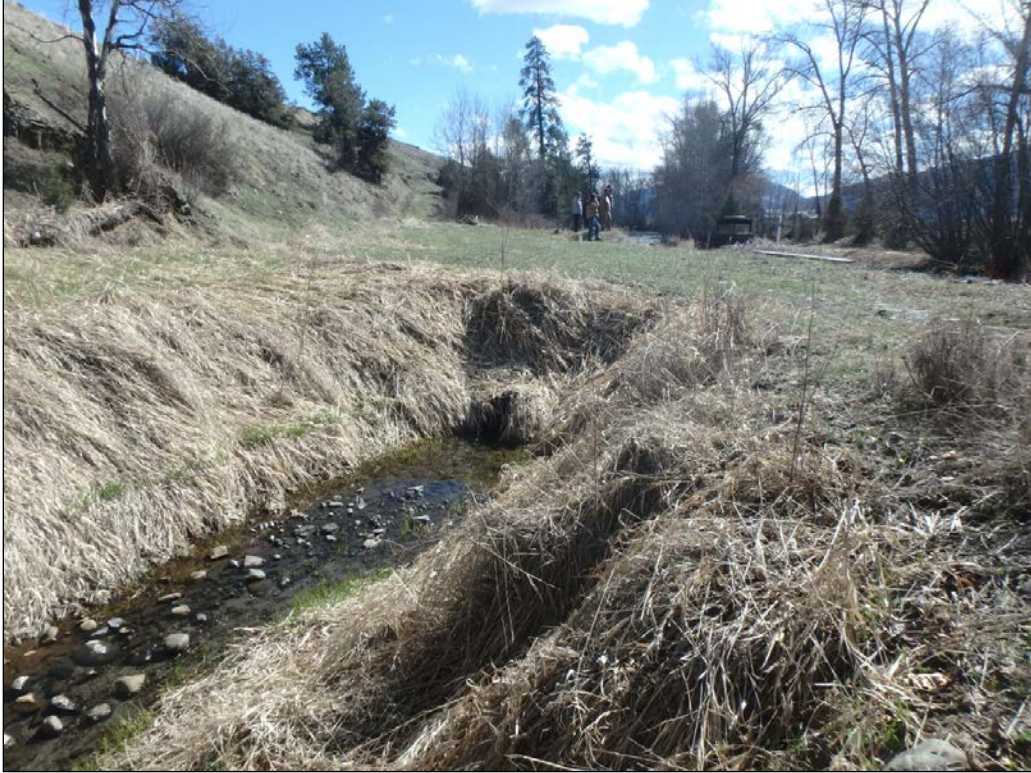
Photo 18. March 2016 photo (before) of the top end of the irrigation ditch.

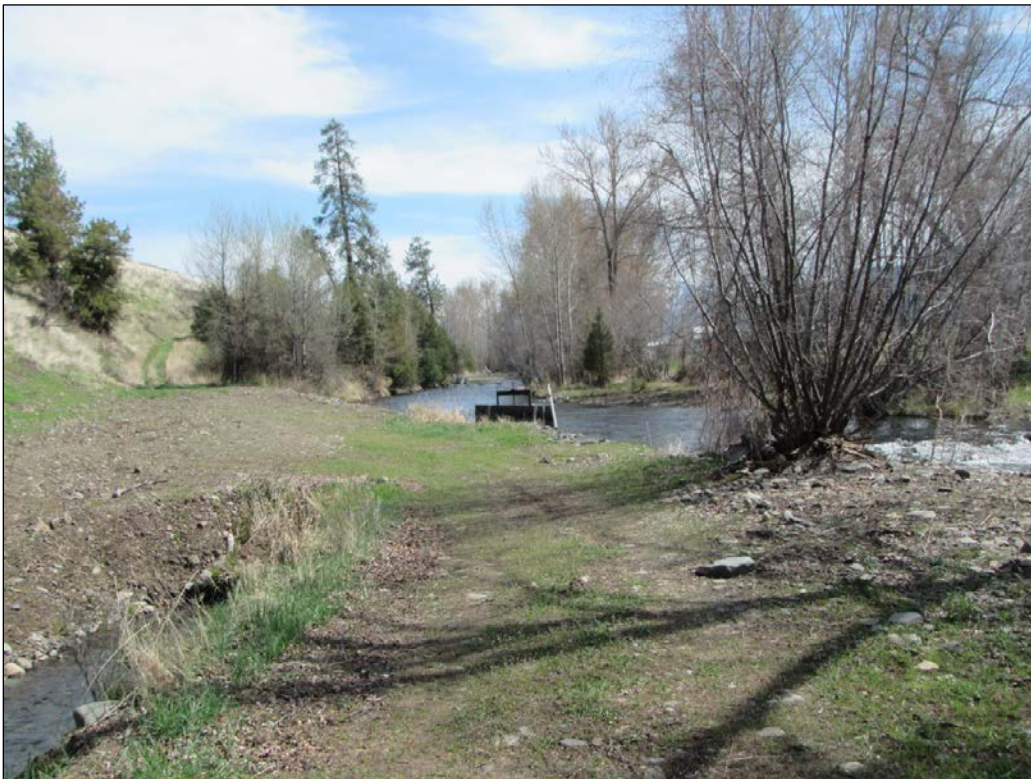
Photo 19. April 2018 photo (after) of the top end of the irrigation ditch following planting and seeding.

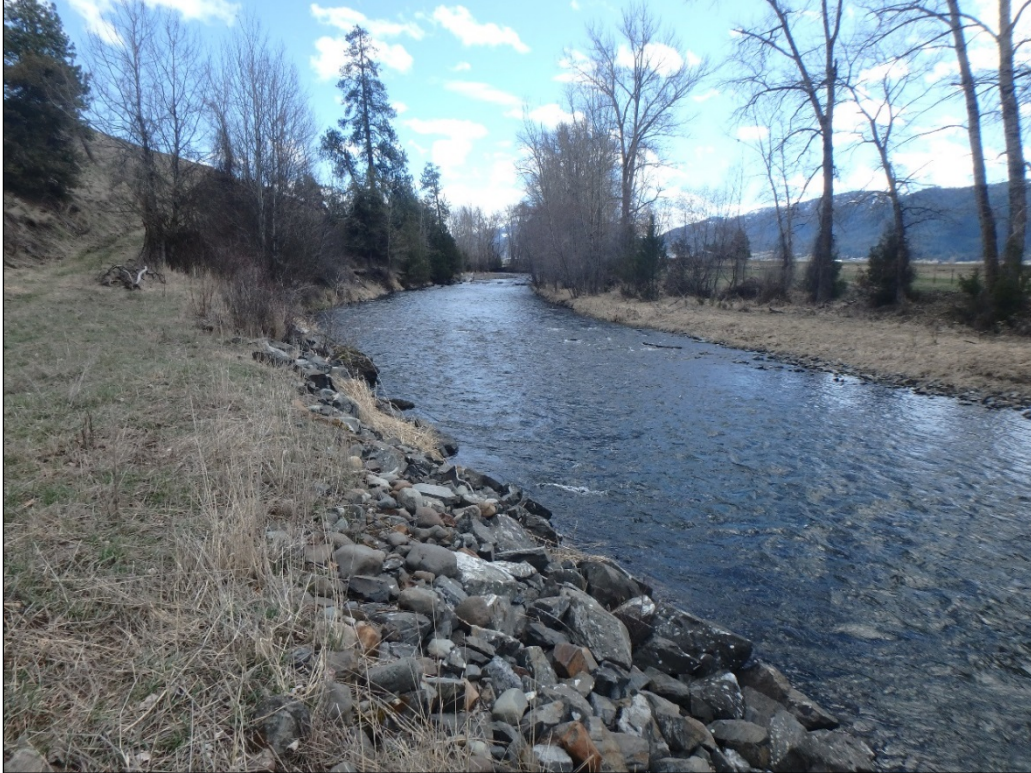
Photo 20. March 2016 photo (before) from river right looking upstream, above the head gate and diversion.

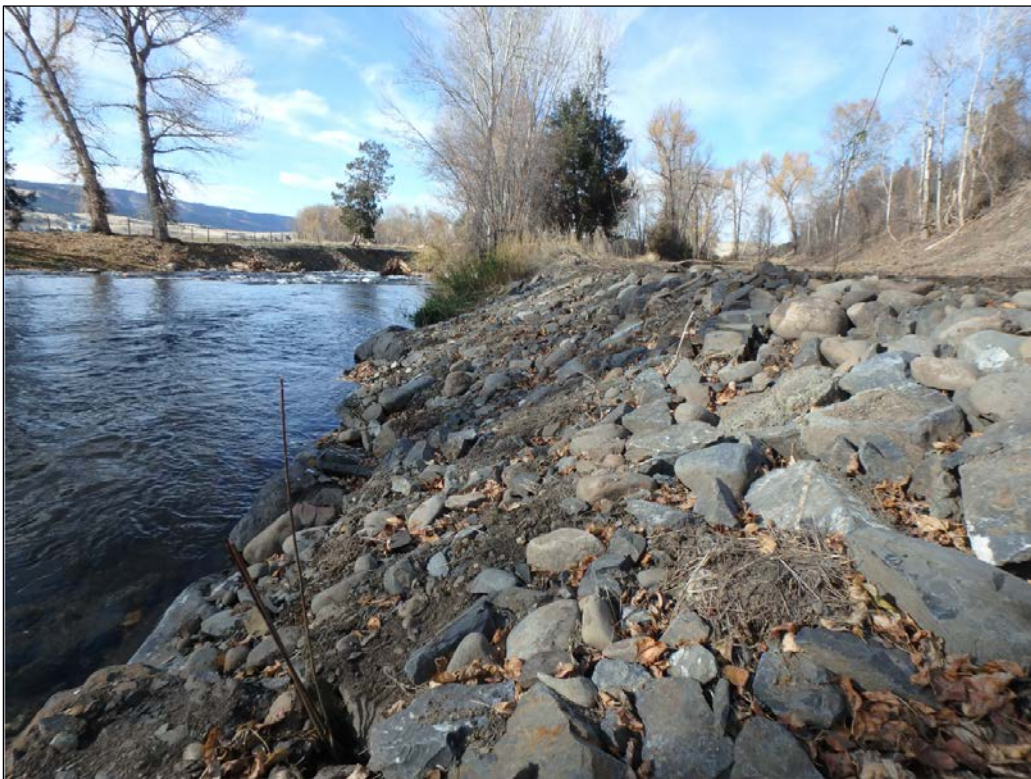
Photo 21. April 2016 photo (after) from river right looking downstream, above the head gate and diversion following planting and seeding.

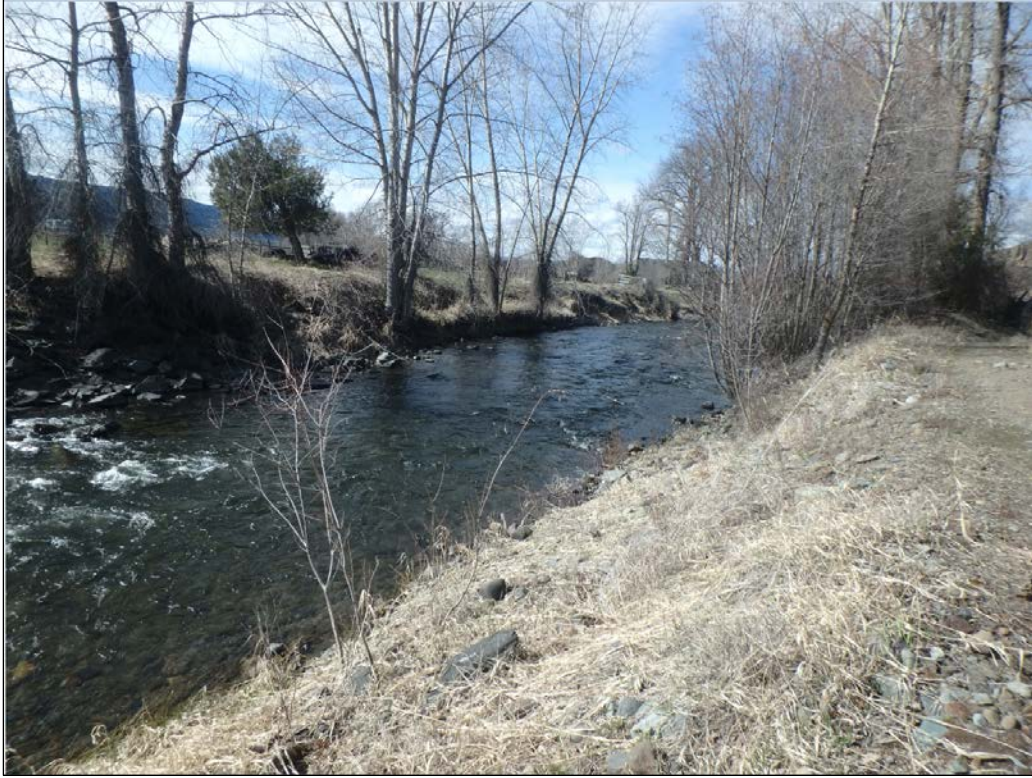
Photo 22. March 2016 photo (before) from river right looking downstream from mid-project reach.

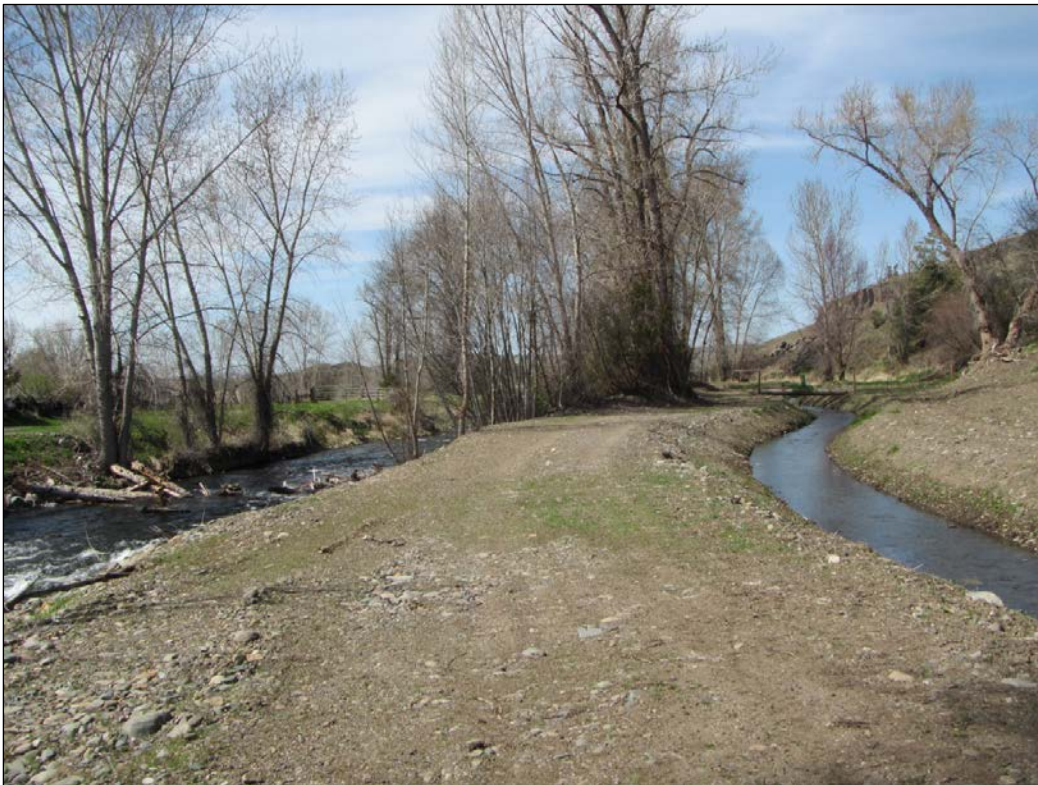
Photo 23. April 2018 photo (after) from river right looking downstream from mid-project reach following planting and seeding.
