PROJECT COMPLETION FORM

Project Title:	Wallowa River Tamkaliks Side Channel and Wetland Complex		
Date of Submittal:	3/15/2022		
BPA Project #:	1992-026-01	Contract #:	74017-51 (CR-325254)

EXHIBIT 1:

Photo Points and Photo Point Map

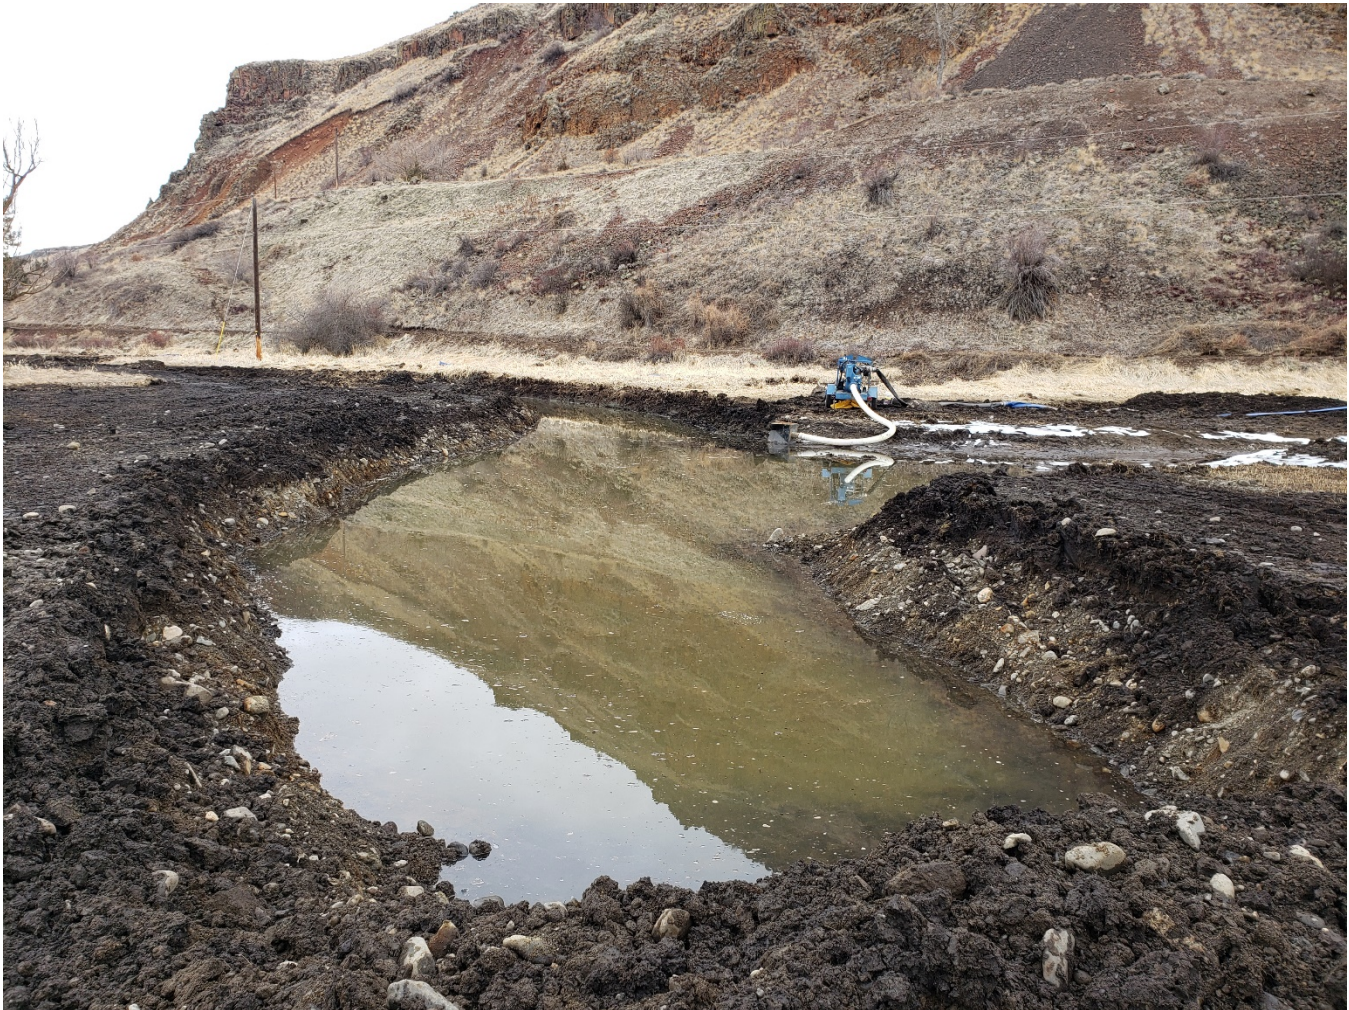
Beginning on 1/21/21, prior to connecting the side channels with the mainstem, a fish screened pump and 6" hose collected excess water within side channel 1 downstream of the alcove node feature (Figure 1). Water was discharged into the road adjacent ditch area and absorbed into the floodplain prior to reaching the mainstem. No erosion was observed.

Figure 1. Fish screened pump and 6" hose pulling water out of side channel 1 below alcove node on 1/29/21.

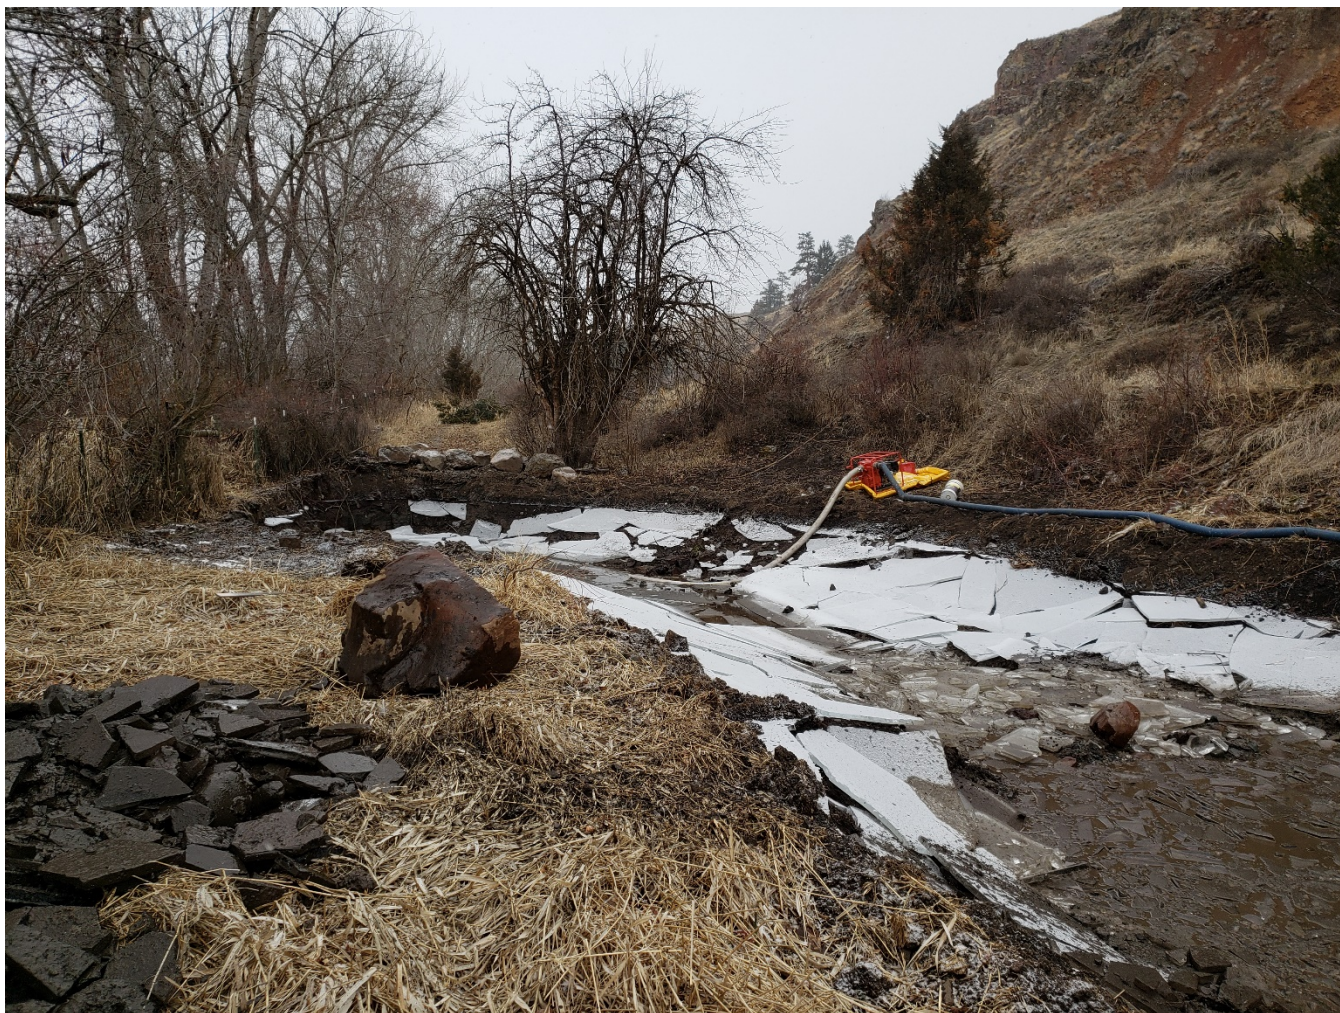
Beginning on 2/11/21, also prior to connection with the mainstem, two fish screened pumps (one with a 4" hose and one with a 6" hose) were used intermittently for dewatering localized work areas for riffle construction (Figure 2 and 3). Water was initially pumped upstream of the work site onto the floodplain, and then was moved to adjacent side channel sections where work was not taking place.

Figure 2. Fish screened pump and hose dewatering alcove area in side channel 1 and discharging pumped water upstream on the floodplain on 2/11/21.

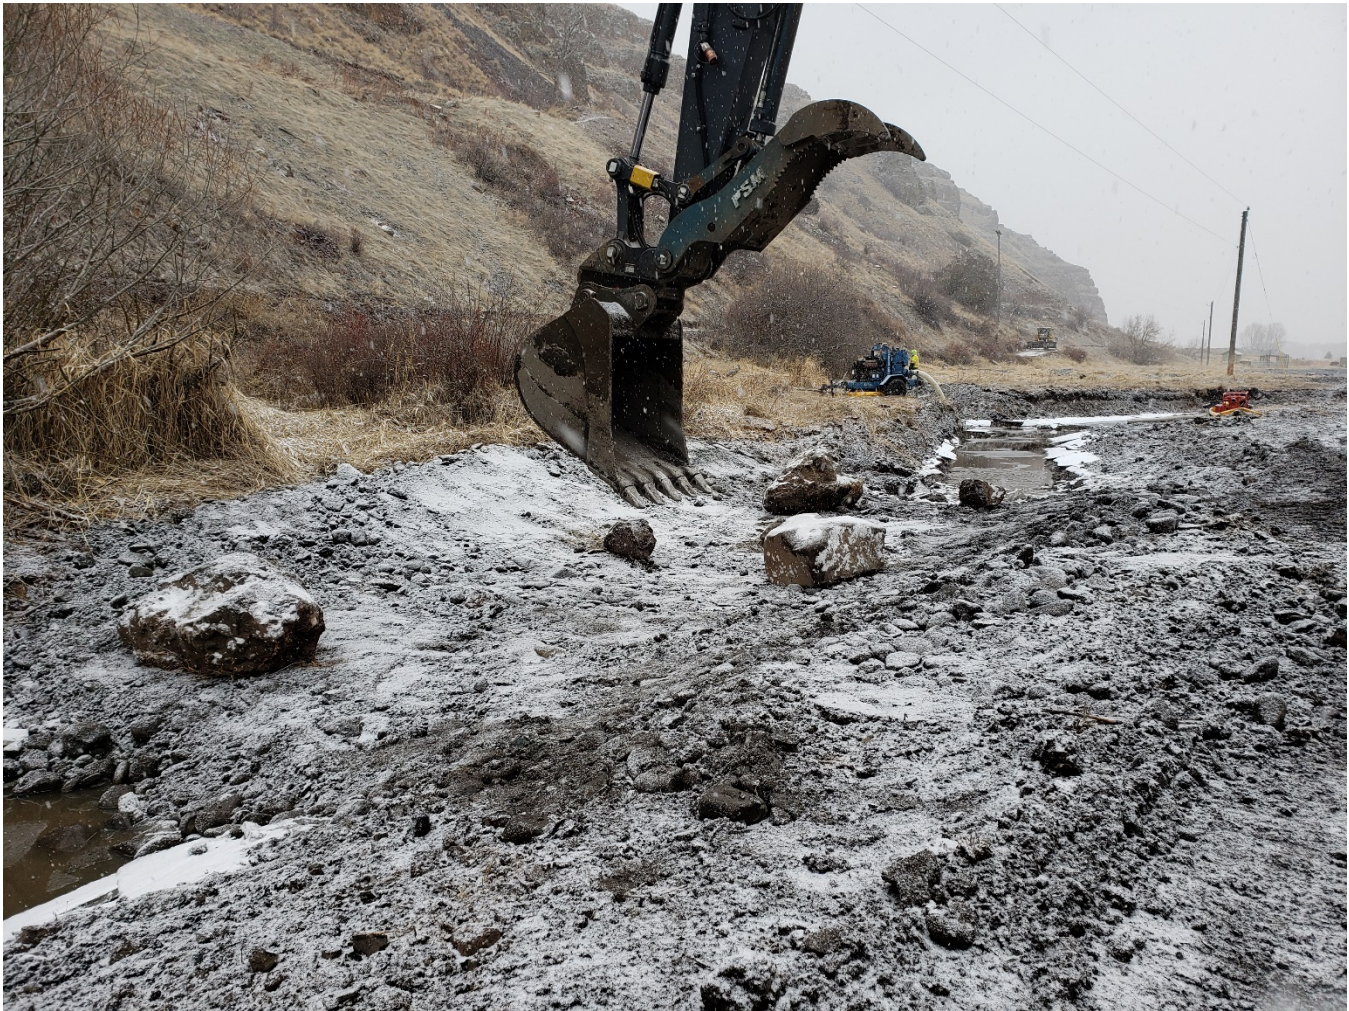
Figure 3. A fish screened pump is shown pulling water out of side channel 1 during downstream riffle construction on 2/11/21.

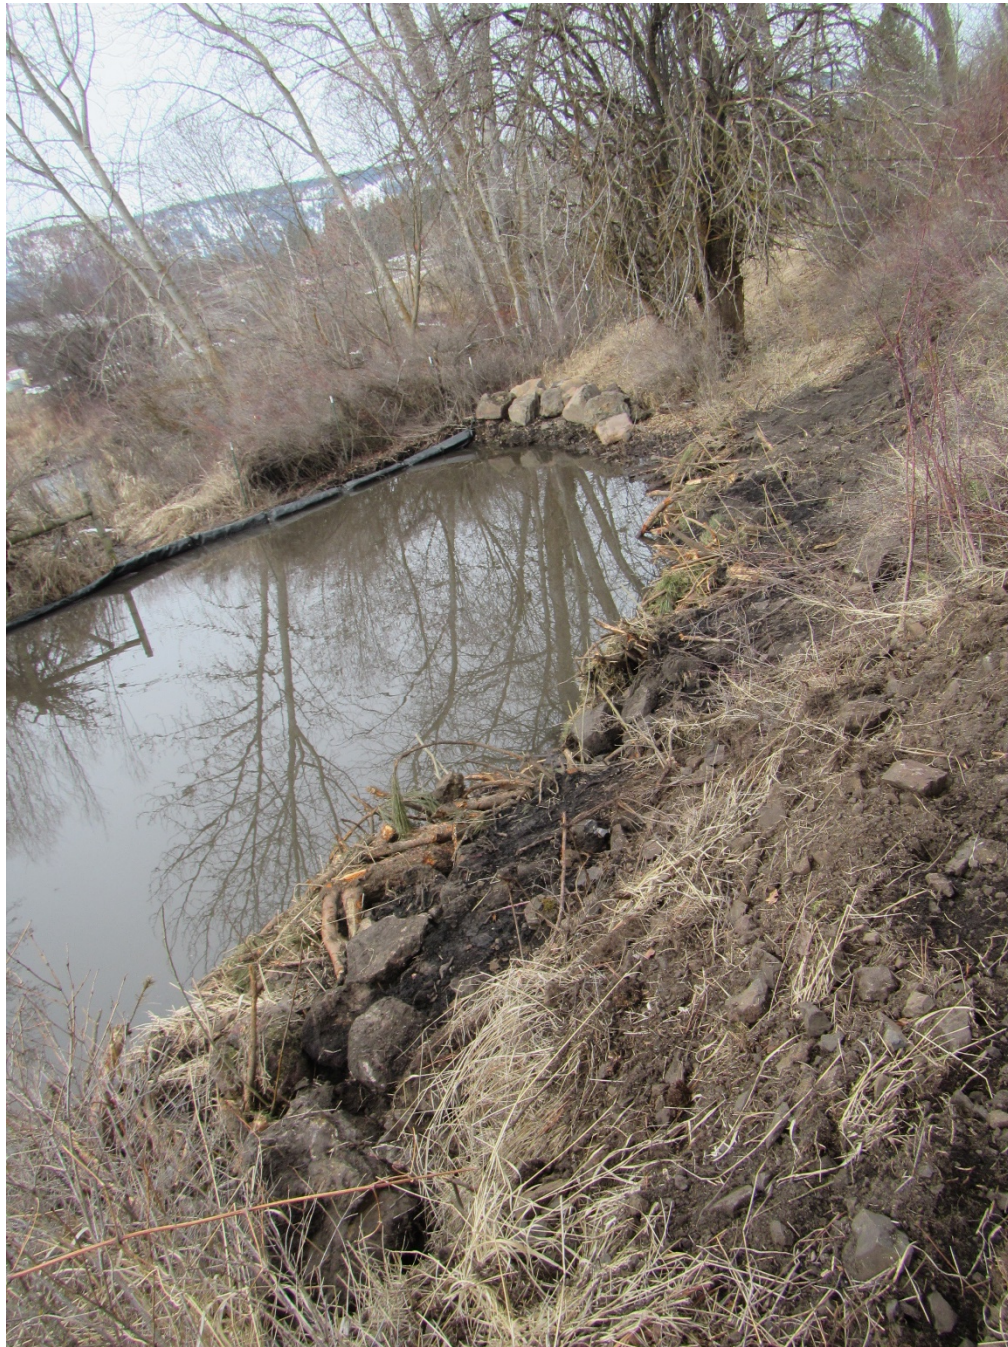
Silt fencing was placed at the downstream end of the side channel complex between the alcove and the earthen plug during the winter construction phase to prevent turbid water from leaching into the Wallowa River (Figure 4). An additional silt fence was also installed at this time, below the confluence of side channels 1 and 3 to contain turbid water above the downstream alcove (Figure 5). These silt fences were left in place over the spring and removed during the second phase of construction in the summer upon connection to the main channel.

Figure 4. Silt fence placement between excavated alcove and earthen plug/river (3/8/21).

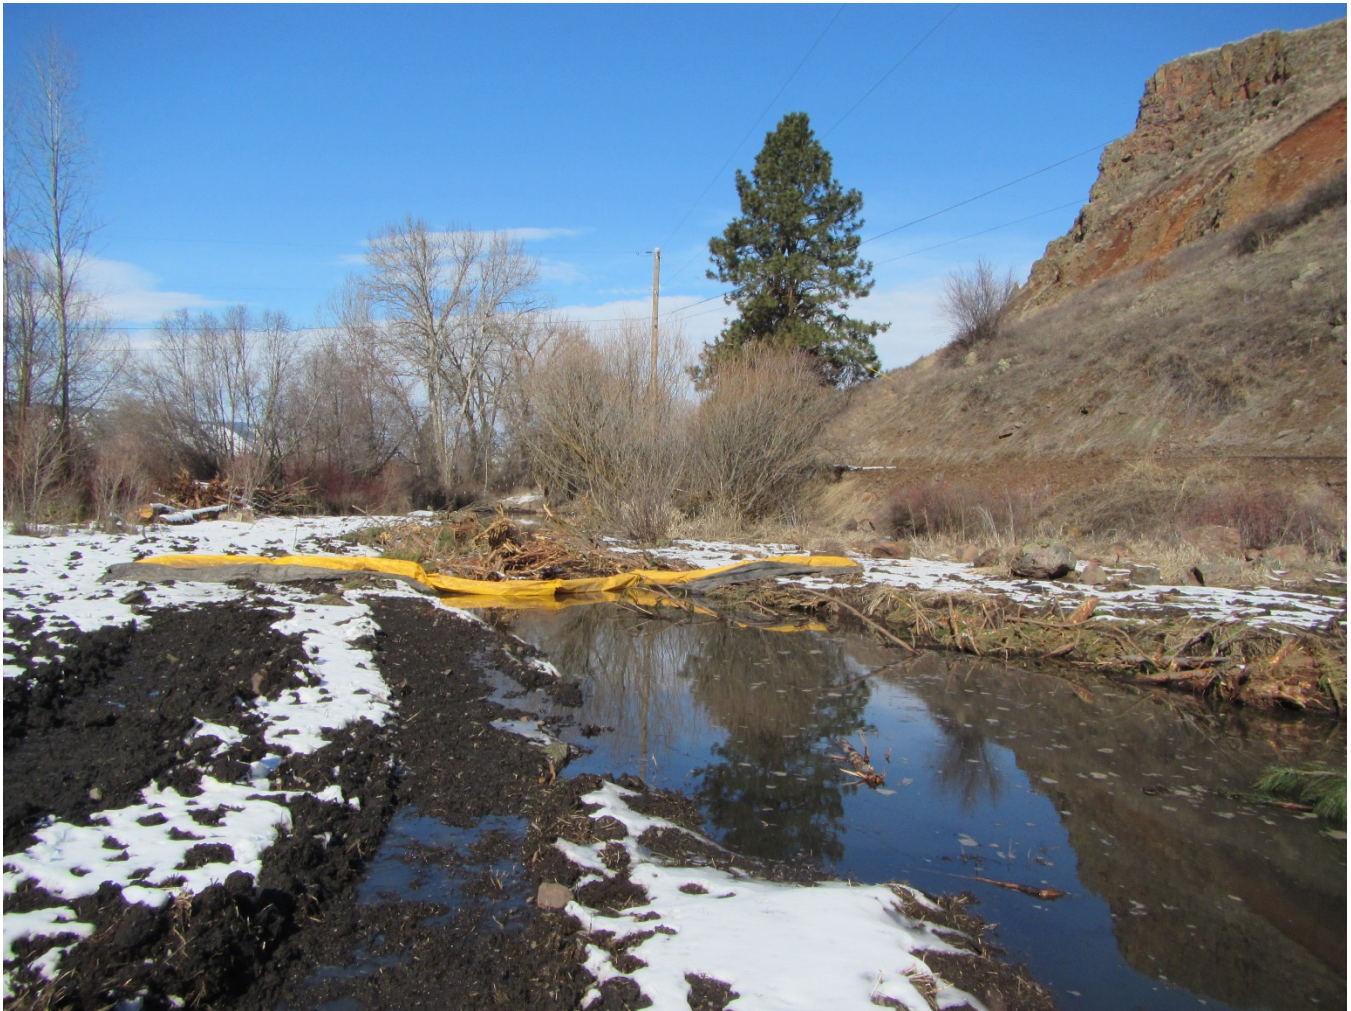
Figure 5. Silt fence placed downstream of side channel 1 and 3 confluence, upstream of alcove (3/2/21).

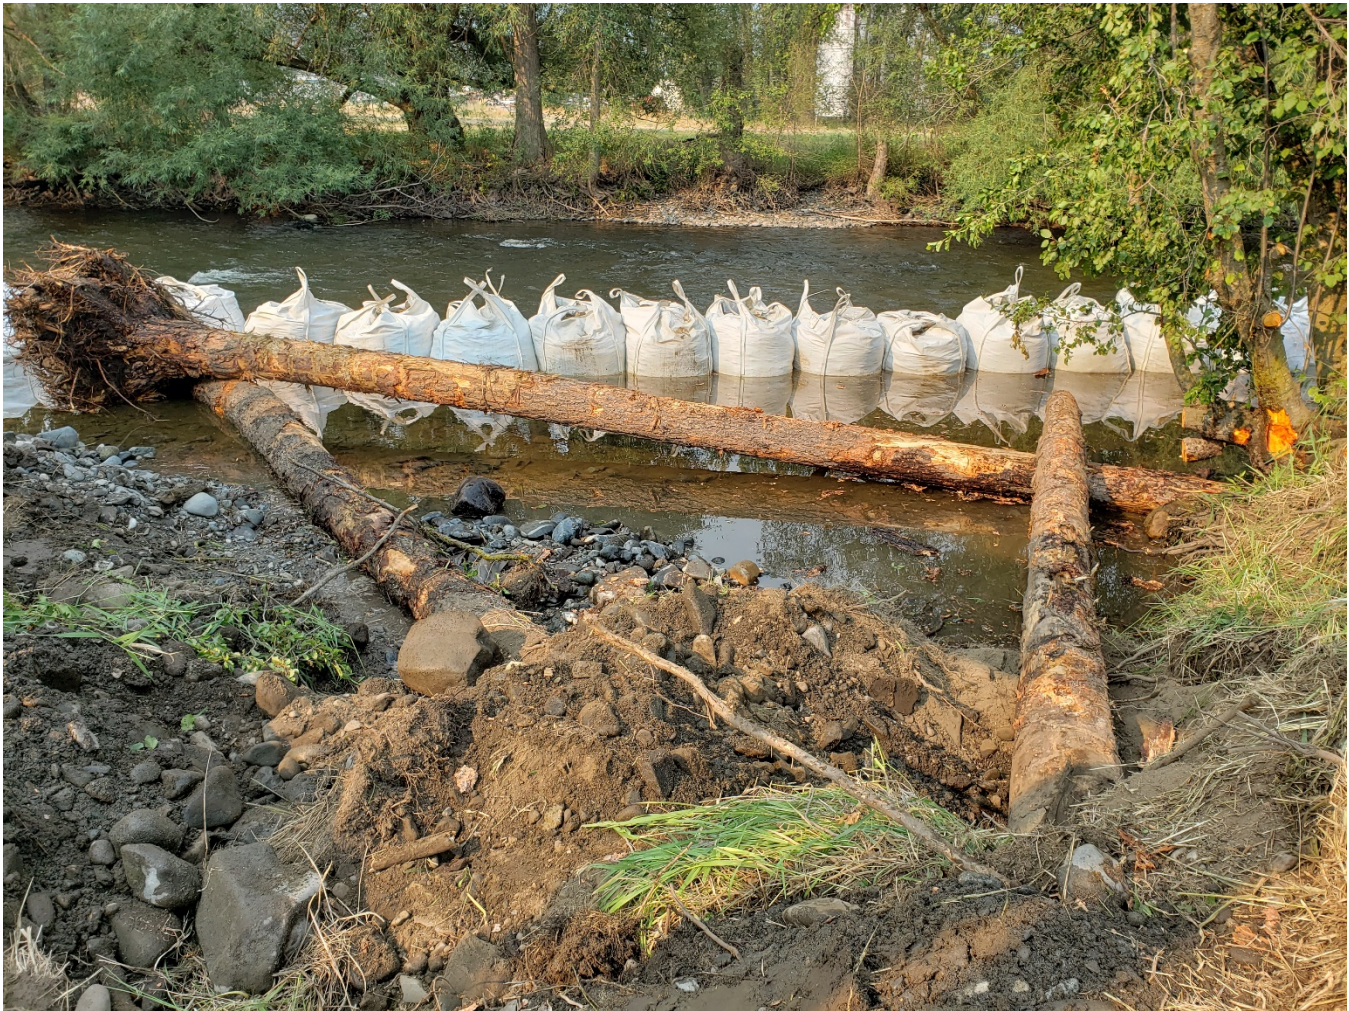
During the summer IWWW phase, the project sponsor inspected the pollution and erosion control measures implemented on site by the contractor during and following installation. Cofferdams/work isolation areas within the mainstem Wallowa River were achieved using tightly placed super sacks and plastic sheeting (Figure 6). Adjustments were made to the super sack placement and sufficient sealing with sheet plastic was accomplished by the contractor to the satisfaction of the project sponsor.

Figure 6. Super sack/sheet plastic work isolation area at channel 1 inlet and Wallowa River mainstem (8/3/21).

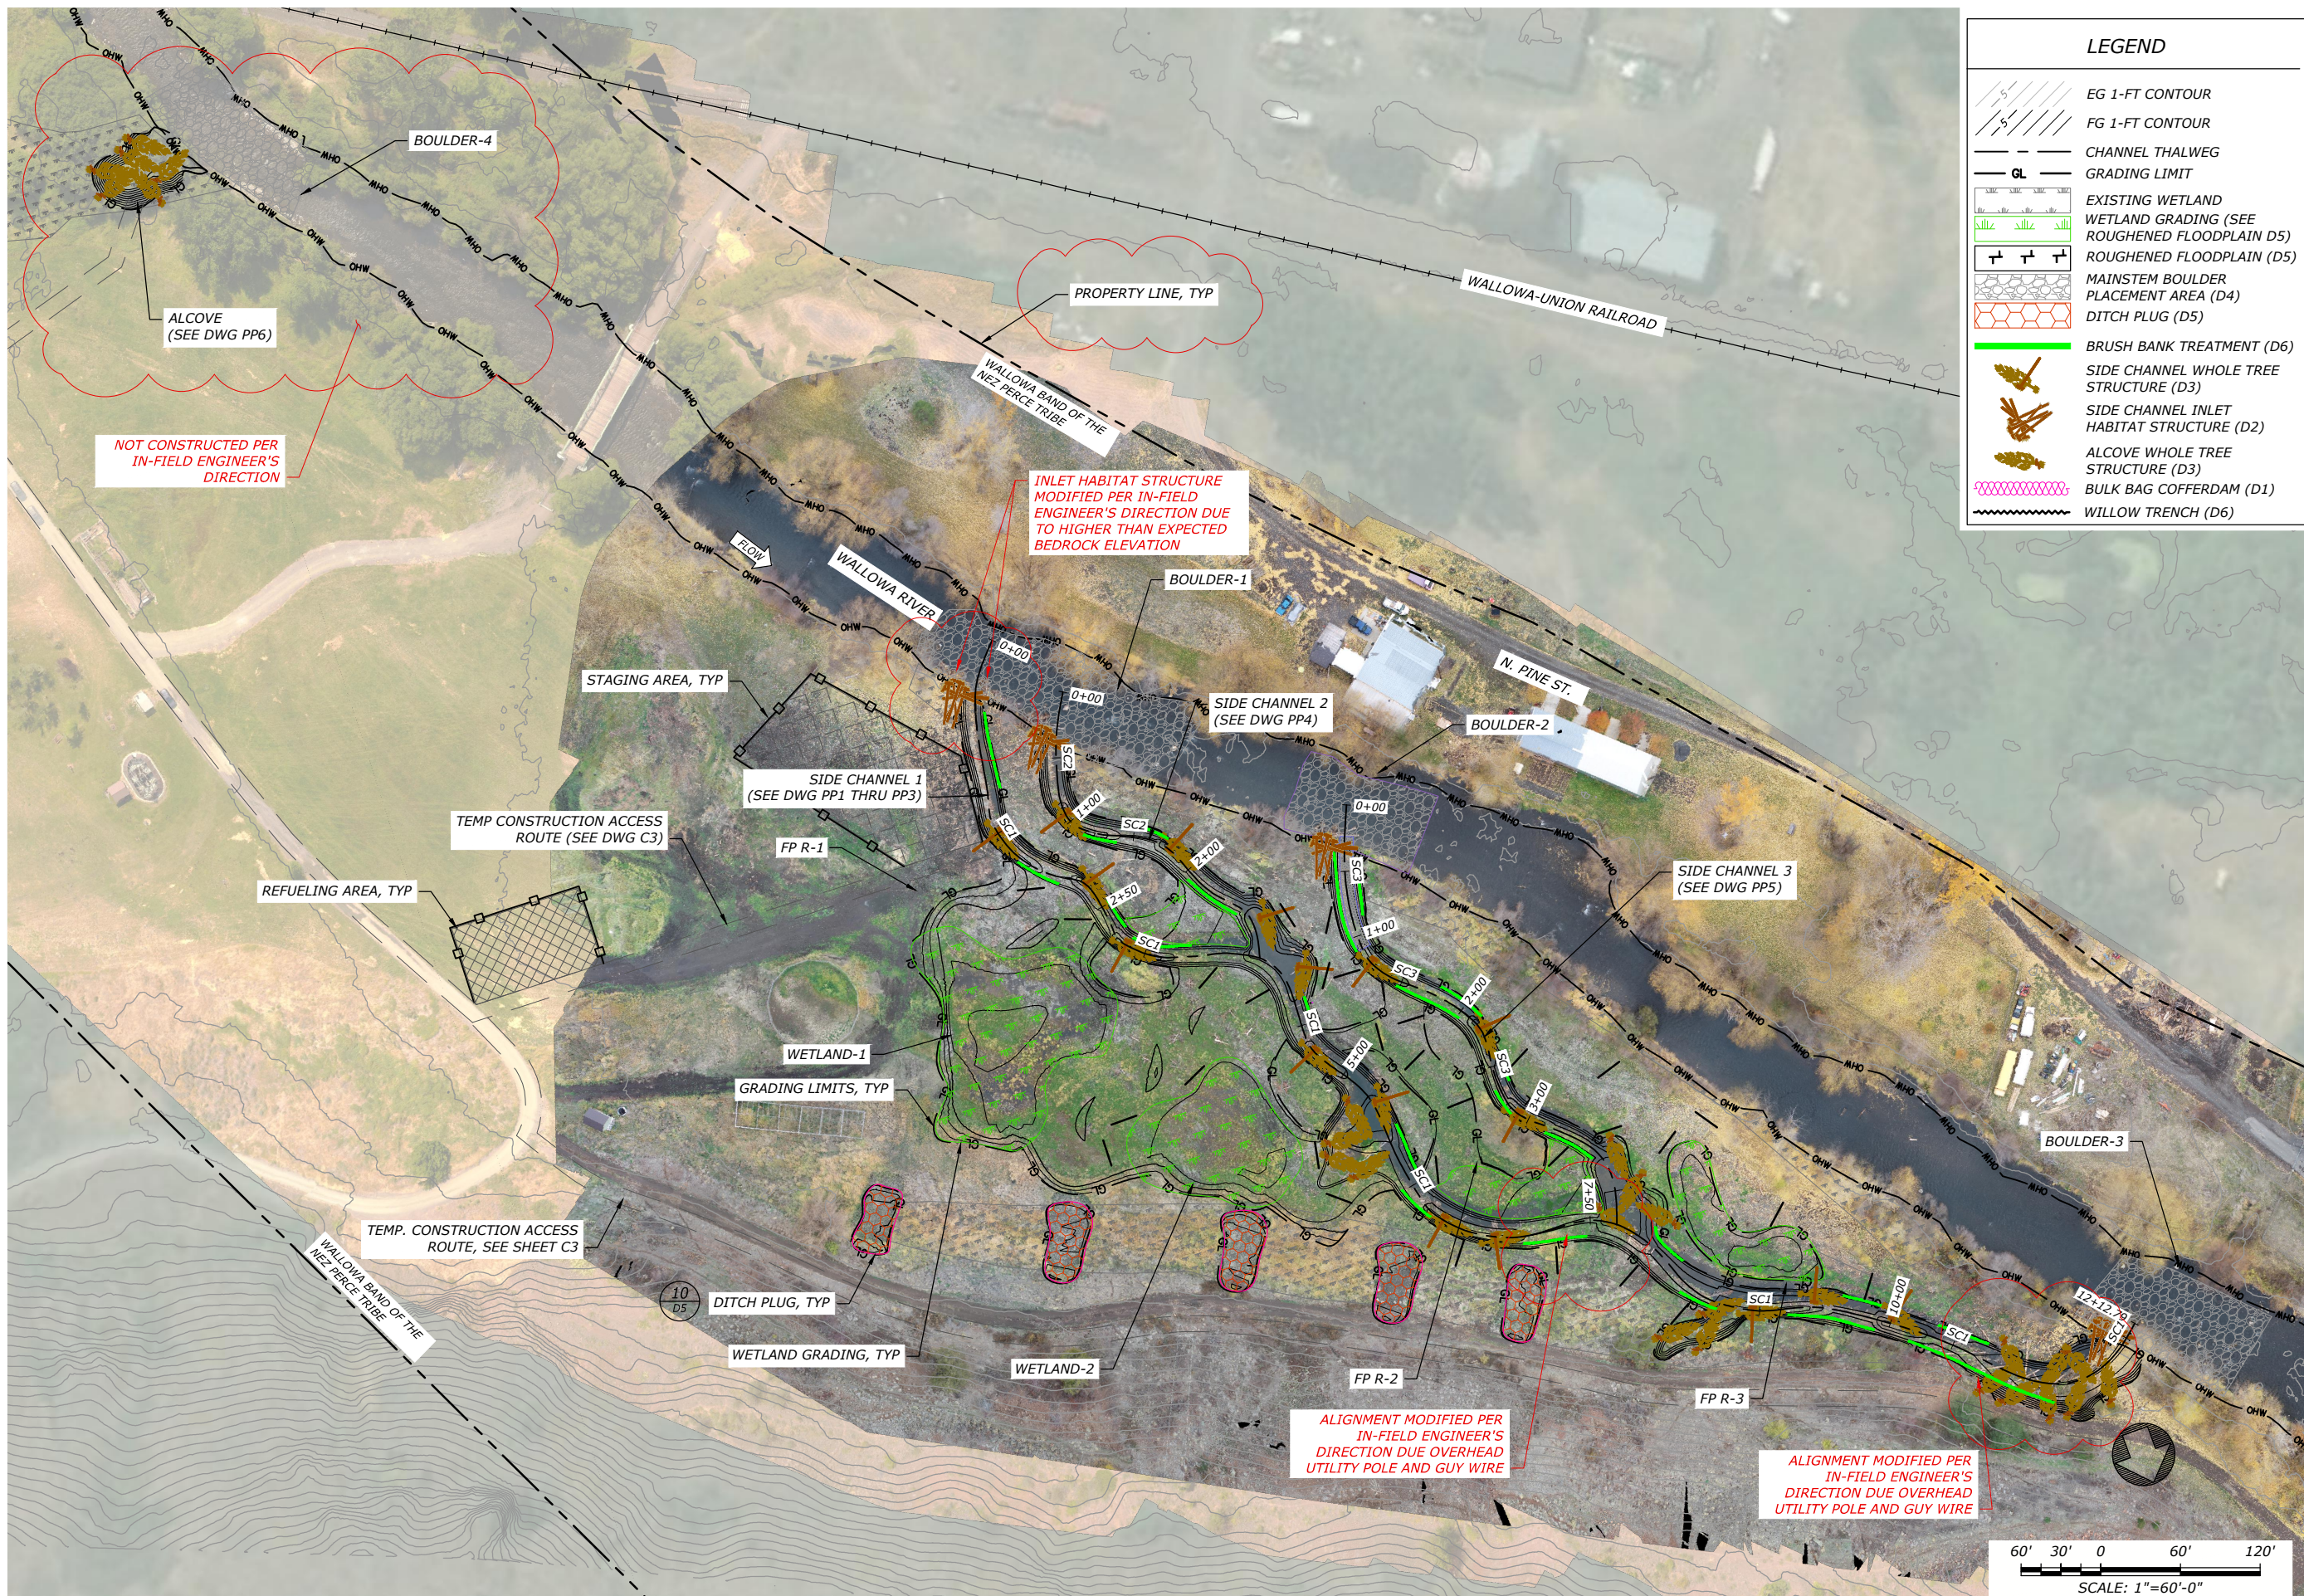
DRAWING NAME
PROPOSED CONDITIONS
 OVERVIEW

As mentioned above, the standalone alcove feature to be excavated upstream of the bridge was not implemented to avoid disturbance to existing mature cottonwood trees within the river riparian corridor. Due to existence of shallow bedrock, mainstem inlet/outlet structures were modified to account for a lack of excavation depth. Instead, these wood structures were field fit onsite by the design engineer to maximize function and minimize risk. Several pool depths were not excavated to the full extent depicted on the final designs also due to bedrock elevations. All field fit changes are documented in the attached overview plan sheet with engineer call outs in Exhibit 2.

NO.	REVISION
1	AS-BUILT DRAWING FEATURES, PROPERTY LINE & POST CONSTRUCTION AERIAL
DATE	12/13/21
