Site 1. Large Woody Material Structures at two locations.

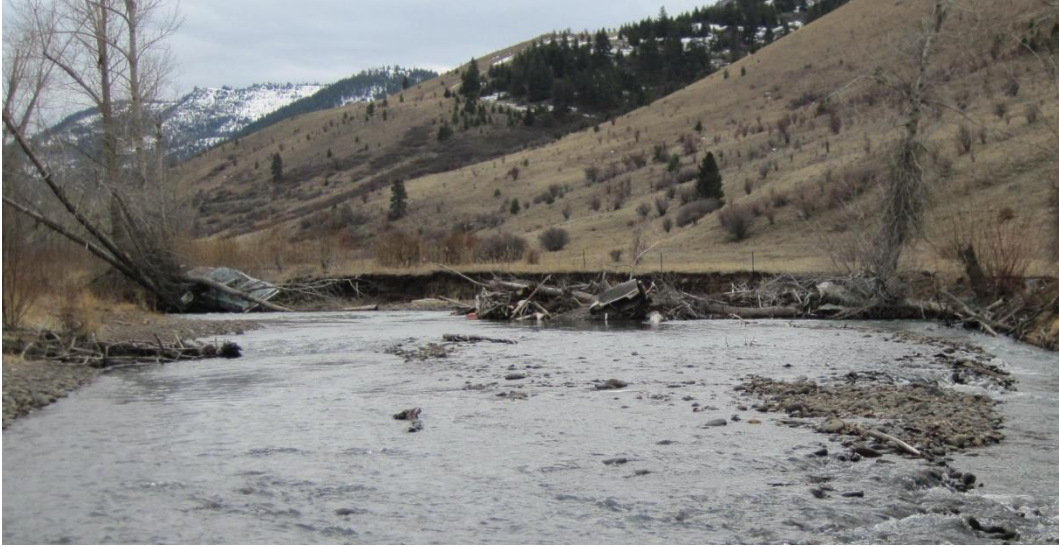
Downstream structure location looking upstream

This photo shows the existing car bodies to be removed and vertical eroded banks. Proposed actions at this location include the removal of car bodies and installation of an engineered large woody material structure to reform the bank, enhance the existing pool by concentrating scour around the proposed structure, and provide cover and habitat complexity throughout the bend.

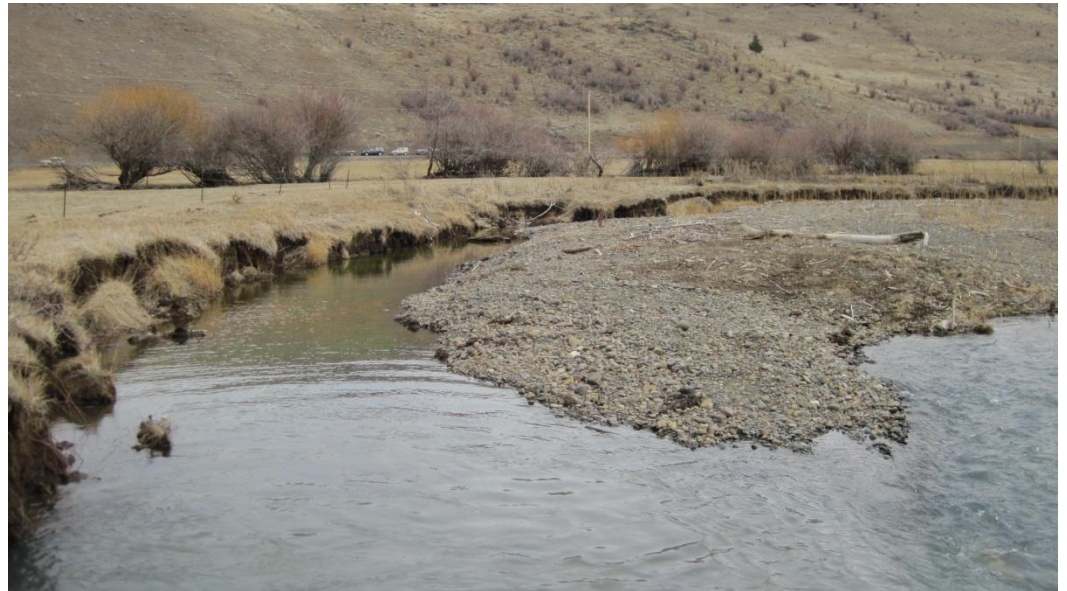
Upstream structures location looking upstream from diversion

This photo was taken from the existing diversion location which would be removed as part of the consolidation (CC-44 Phase II). Proposed actions at this site includes placement of a bleed through engineered large woody material structure at the upstream end. Four flow deflector structures would be installed downstream of the bleed through structure providing habitat complexity during high flows when the side channel is activated.

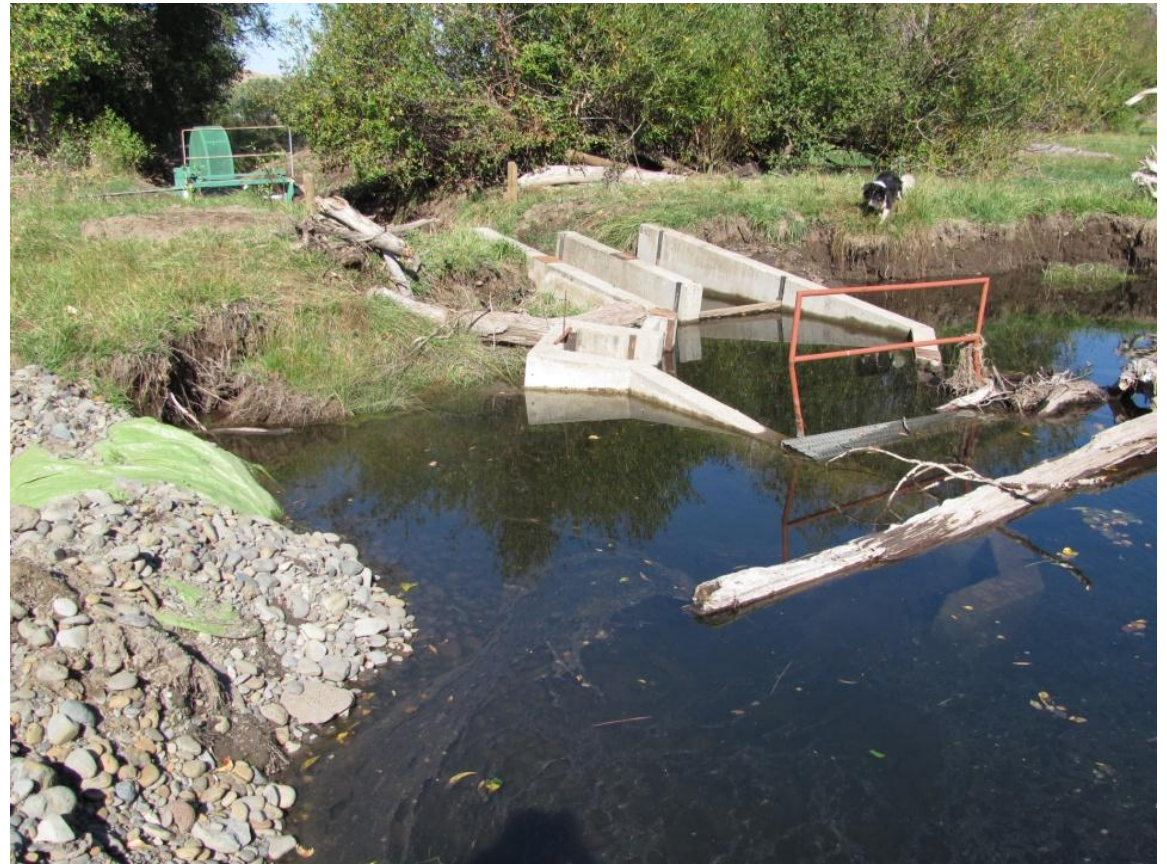
Upstream structures location looking at washed out diversion

This photo shows the original fish screen structure that was washed out at an existing diversion that would be removed as part of the consolidation (CC-44 Phase II). Concrete fish screen structure has since been removed.

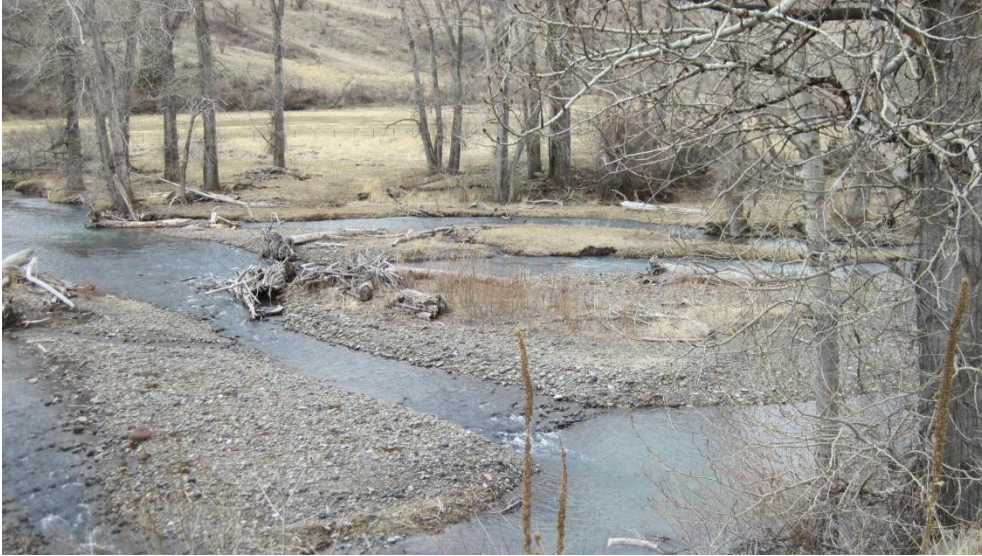
Downstream Structures Location looking upstream from Hwy 203

Proposed actions include the installation of three log jams to promote deposition along the left bar, concentrate scour and flow along the right bank to enhance the existing pool, and provide cover and habitat complexity throughout the area.

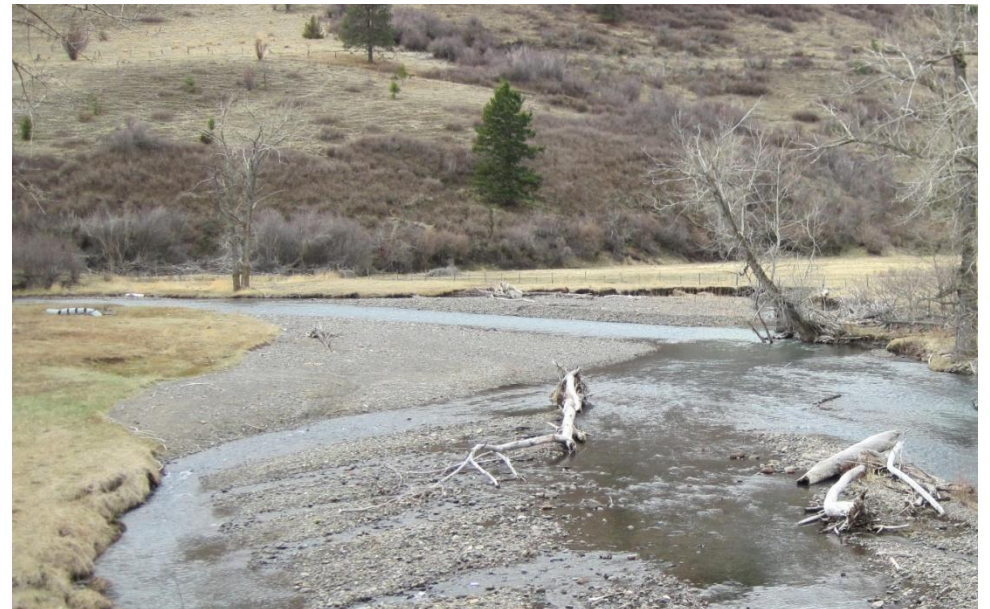
Upstream Structures Location looking upstream from Hwy 203

Proposed actions include placement of a flow through log jam at the upstream end of the meander, and 5 flow deflector jams at the downstream end, providing habitat complexity in the side channel. In addition, 4 sweeper logs will provide more complexity and aid in reducing erosion during high flow events.

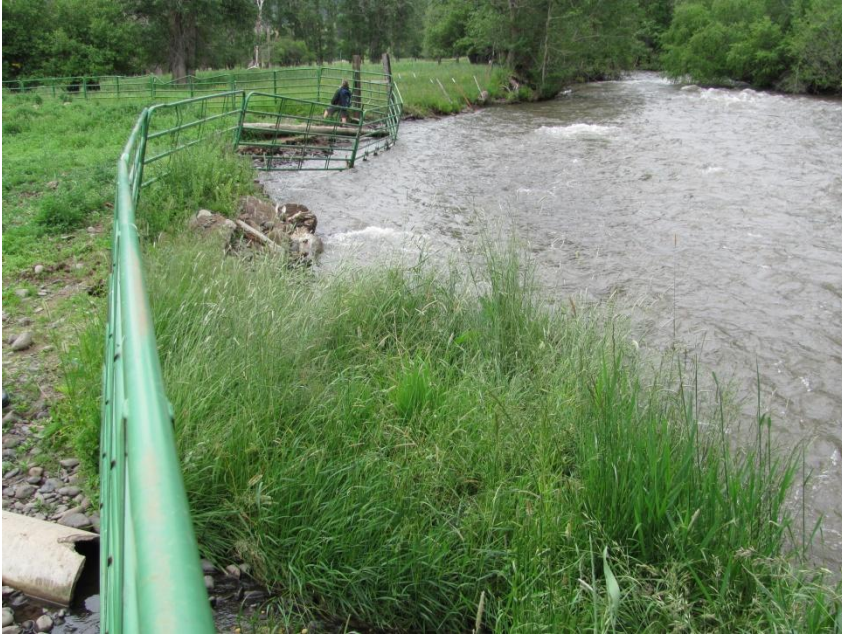
Looking upstream from existing corrals

This photo shows bank erosion in the vicinity of existing corrals. Proposed actions include installation of a wood material structure along the right bank to reduce near bank velocities, provide cover, and create habitat complexity.

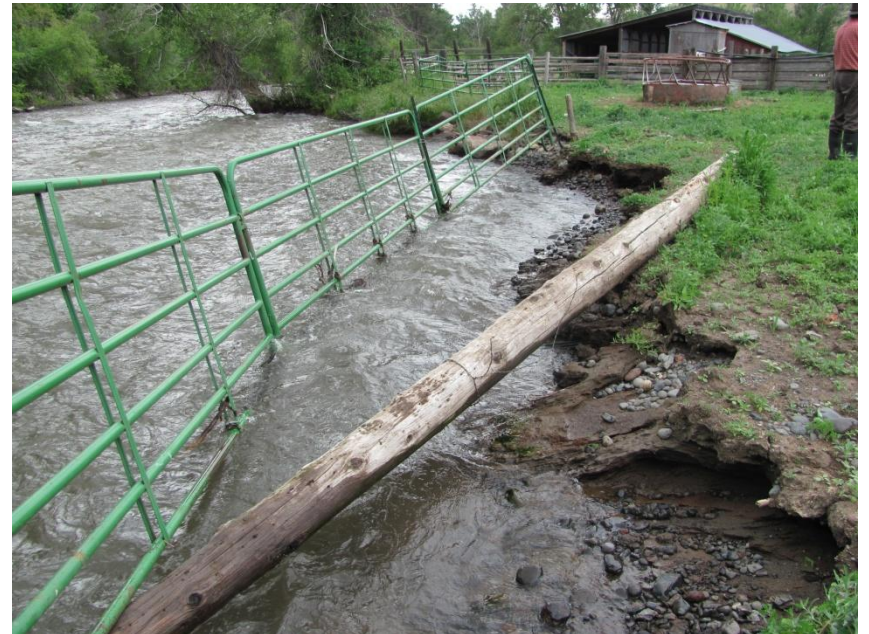
Looking downstream toward existing corrals

This photo shows bank erosion in the vicinity of existing corrals. Proposed actions include installation of a wood material structure along the right bank to reduce near bank velocities, provide cover, and create habitat complexity.

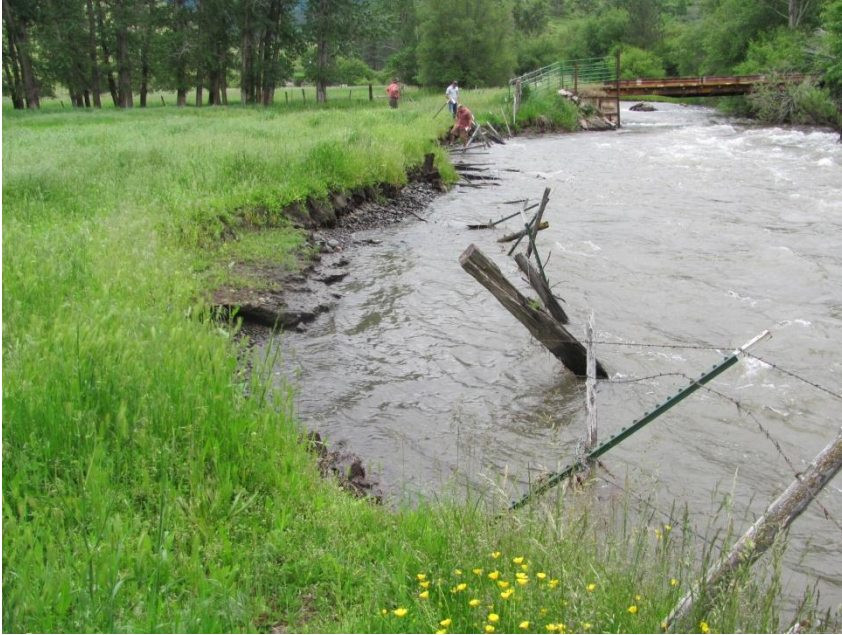
Looking Upstream Toward Existing Bridge

This photo shows bank erosion downstream of the existing bridge. This area includes a portion of right bank that has seen recent erosion immediately upstream and downstream of an existing bridge crossing.

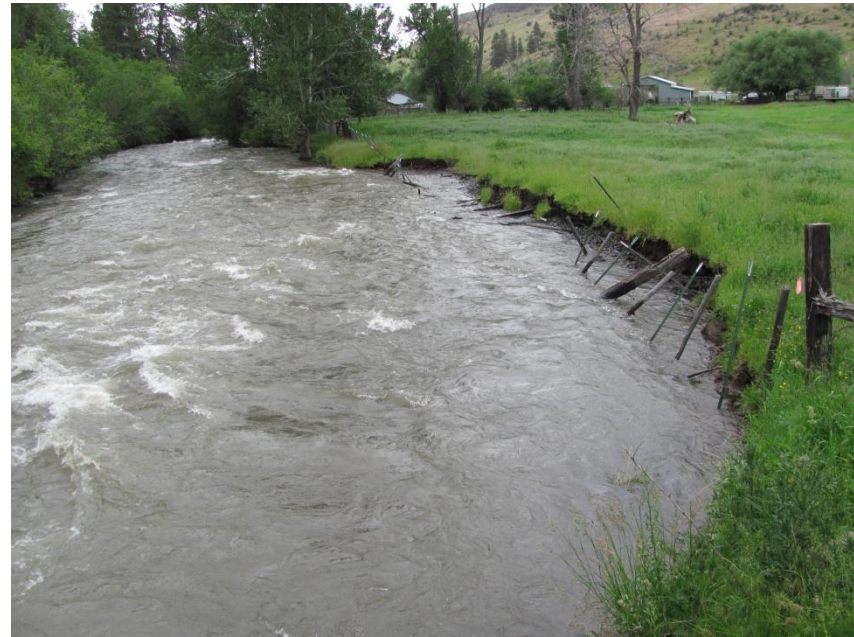
Looking Downstream From Existing Bridge

This photo shows bank erosion downstream of the existing bridge. The placement of wood along this bank will create diversity in velocity distribution across the channel section and provide an area for juvenile refuge within the main channel. The wood placement will also protect the banks from further erosion and aid in creating/maintaining a pool underneath the existing bridge.

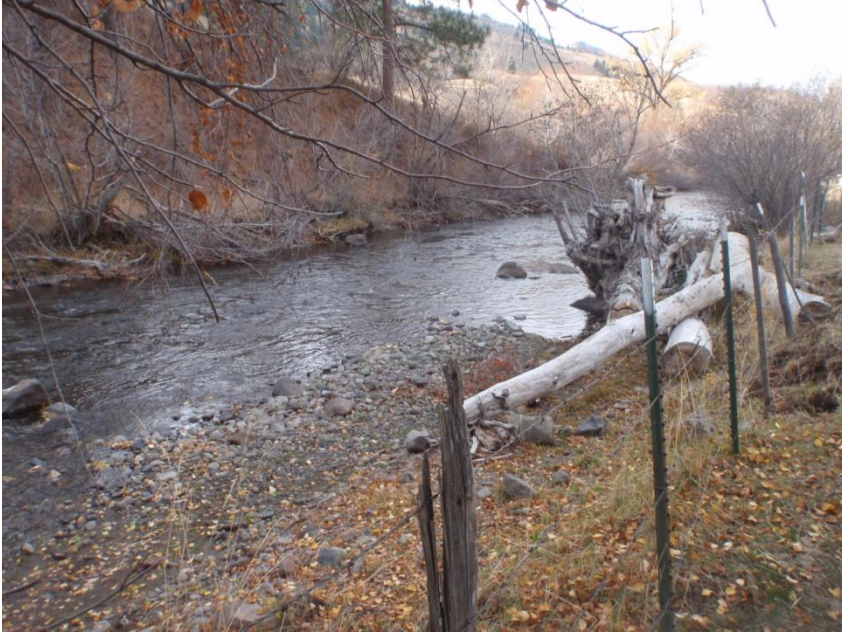
Looking Downstream From Pump Intake Site

This photo shows bank erosion in the vicinity of the existing pump intake. This area includes the immediate area around the landowner's irrigation pump intake. Large wood material placement along this bank will create diversity in velocity distribution across the channel section and provide an area for juvenile refuge within the main channel. The wood placement will also protect the banks from further erosion and aid in creating/maintaining a pool for the irrigation pump intake.

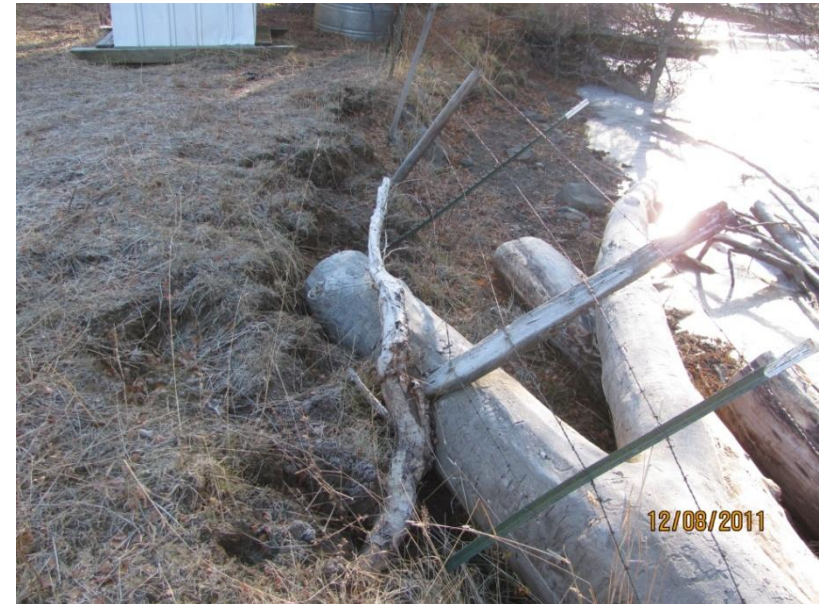
Looking Upstream at Pump Intake Site

This photo shows bank erosion on the right bank downstream of the pump intake activating fine sediment into the channel. Protecting this bank with large wood material creates diversity in velocity and provides cover for juvenile refuge while aiding in creating/maintaining a pool for the irrigation pump intake.
