# HALLOWA-WHITMAN ADUATICS PROCRAM

## **Limber Jim Restoration Project**

La Grande Ranger District 2017

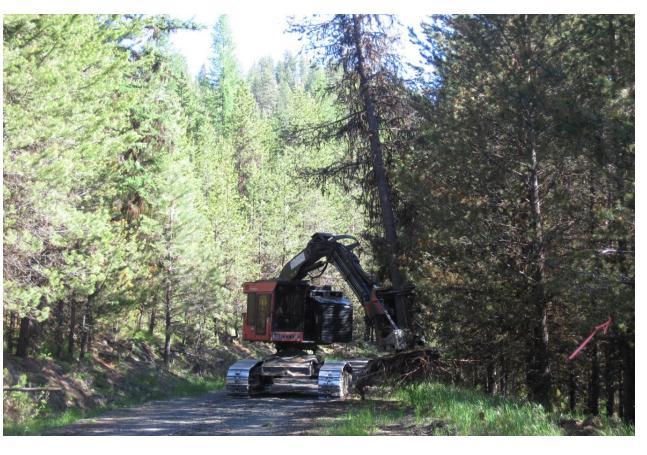
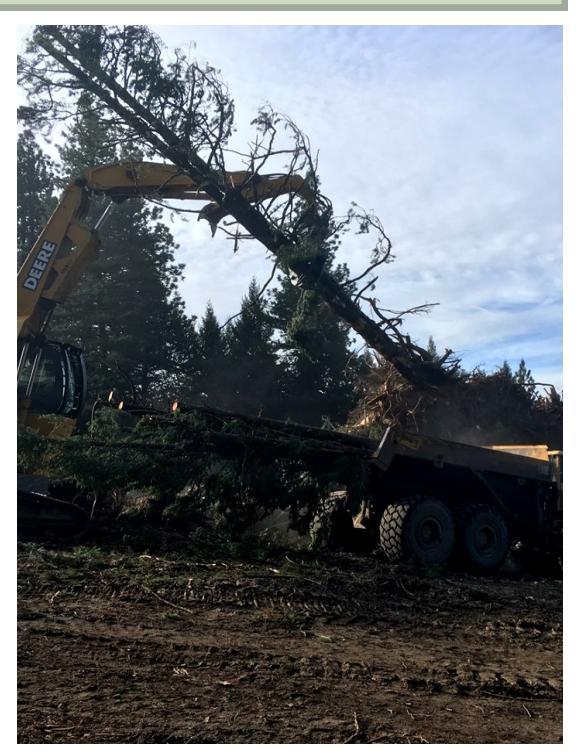
Above: Removing trees with a feller buncher. Below: Loading trees with a log loader and off road dump truck.

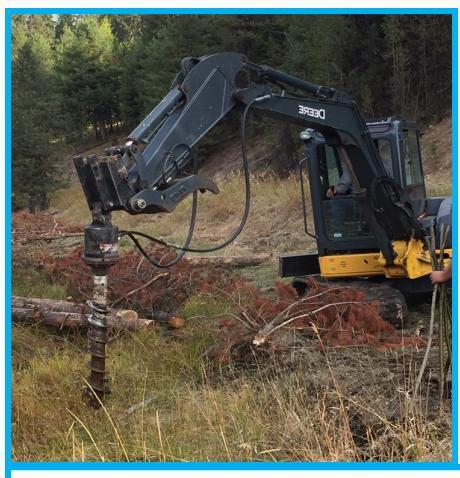
Drilled in 10,000 cuttings

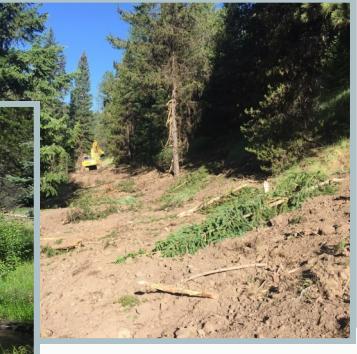
Recontoured 1 mi of road

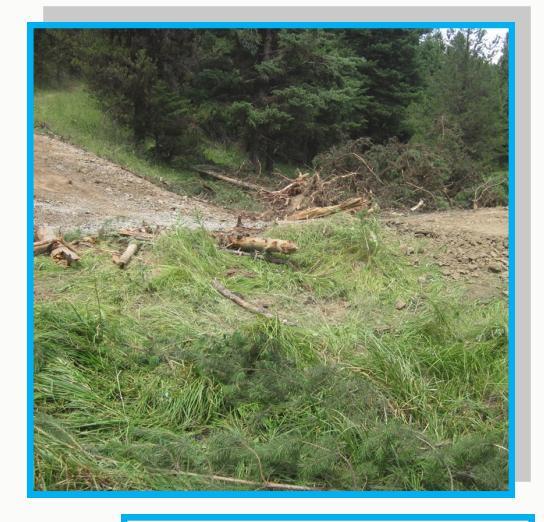
Removed culvert & constructed ford

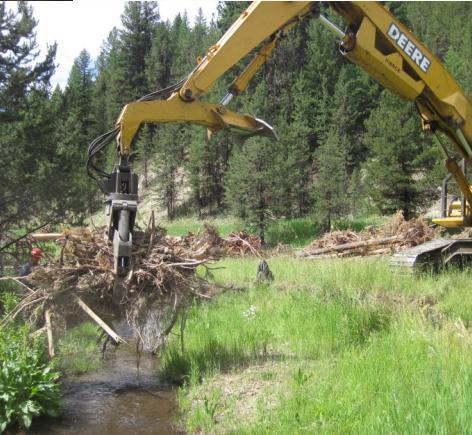
Placing racking material

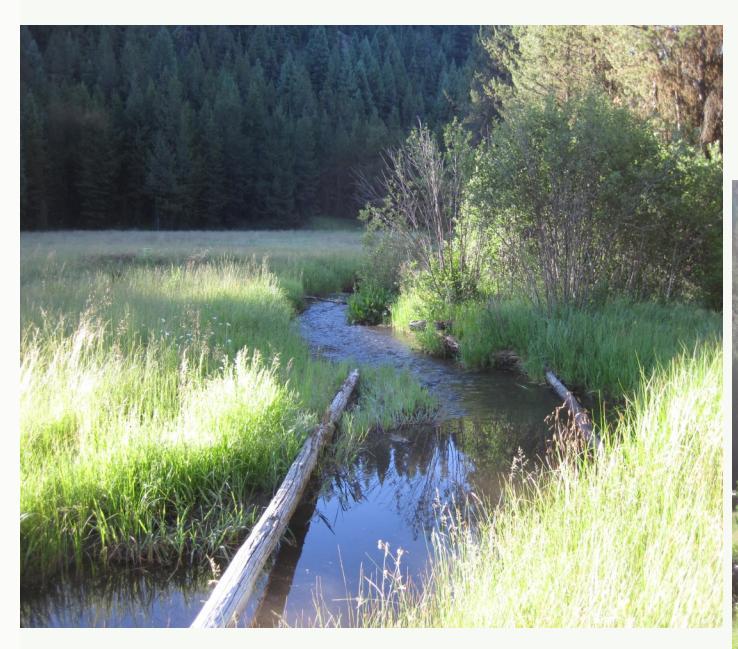
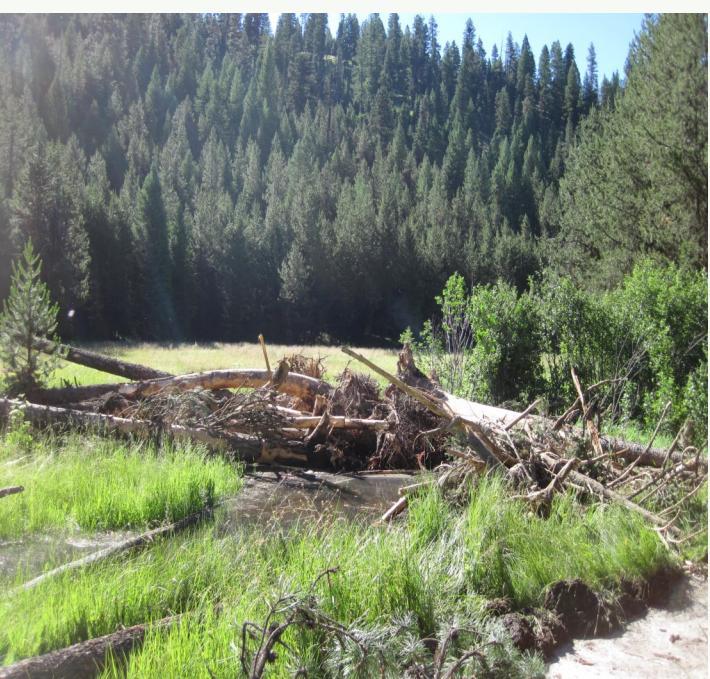
**Pre** Restoration

**Post Restoration**

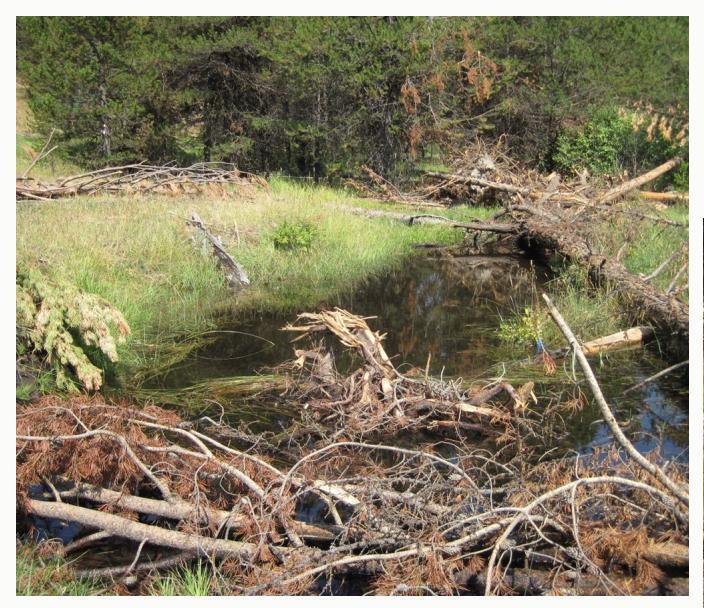
Upstream of log jam

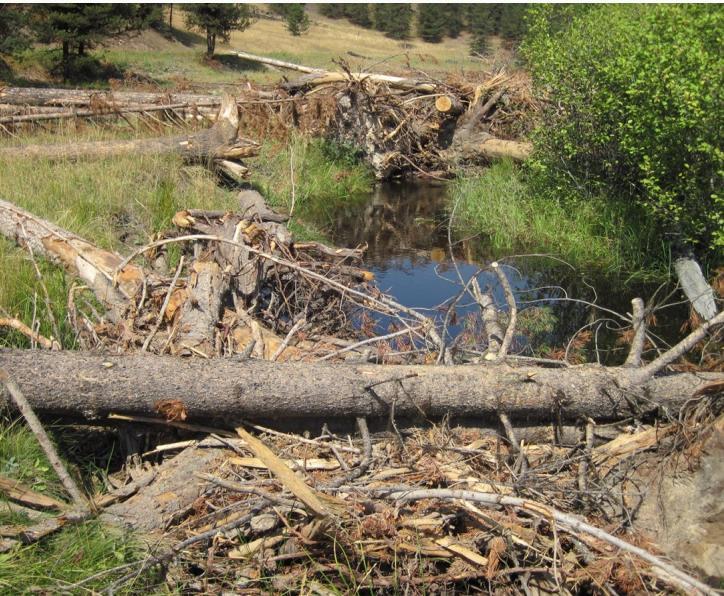
Log Jams
