Exp BIOP LIMBER JIM & CHICKEN HABITAT RESTORATION PROJECT

Contract #: 75265

Project #: 1992-026-01

Final Report

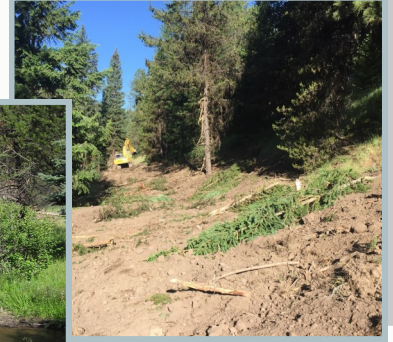
Recontoured 1 mi of road

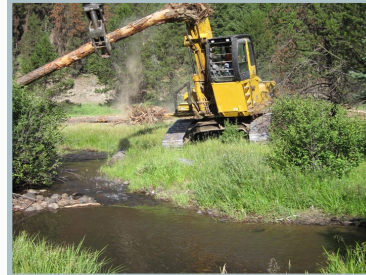
Placing wood with a log loader

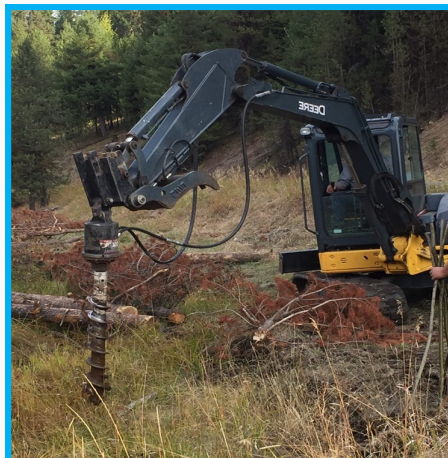
Drilled in 10,000 cuttings

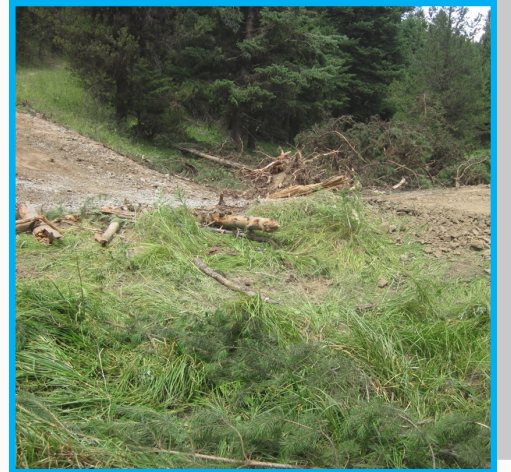
Removed culvert & constructed ford

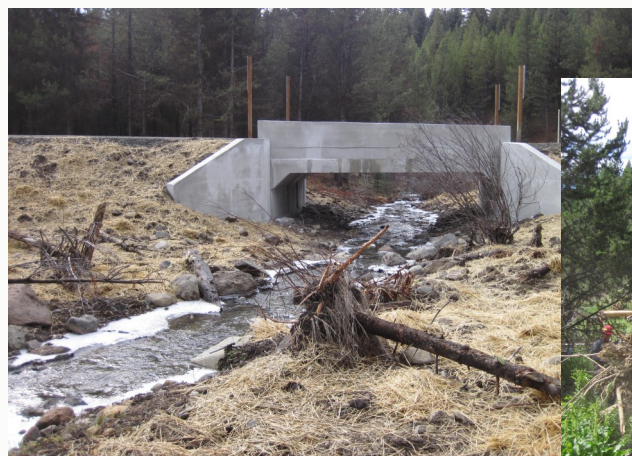
Culvert Replacement

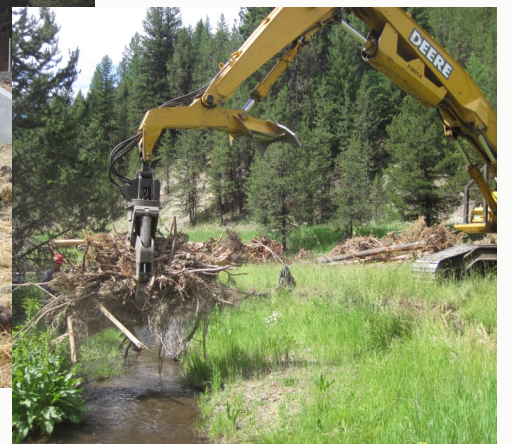
Placing racking material

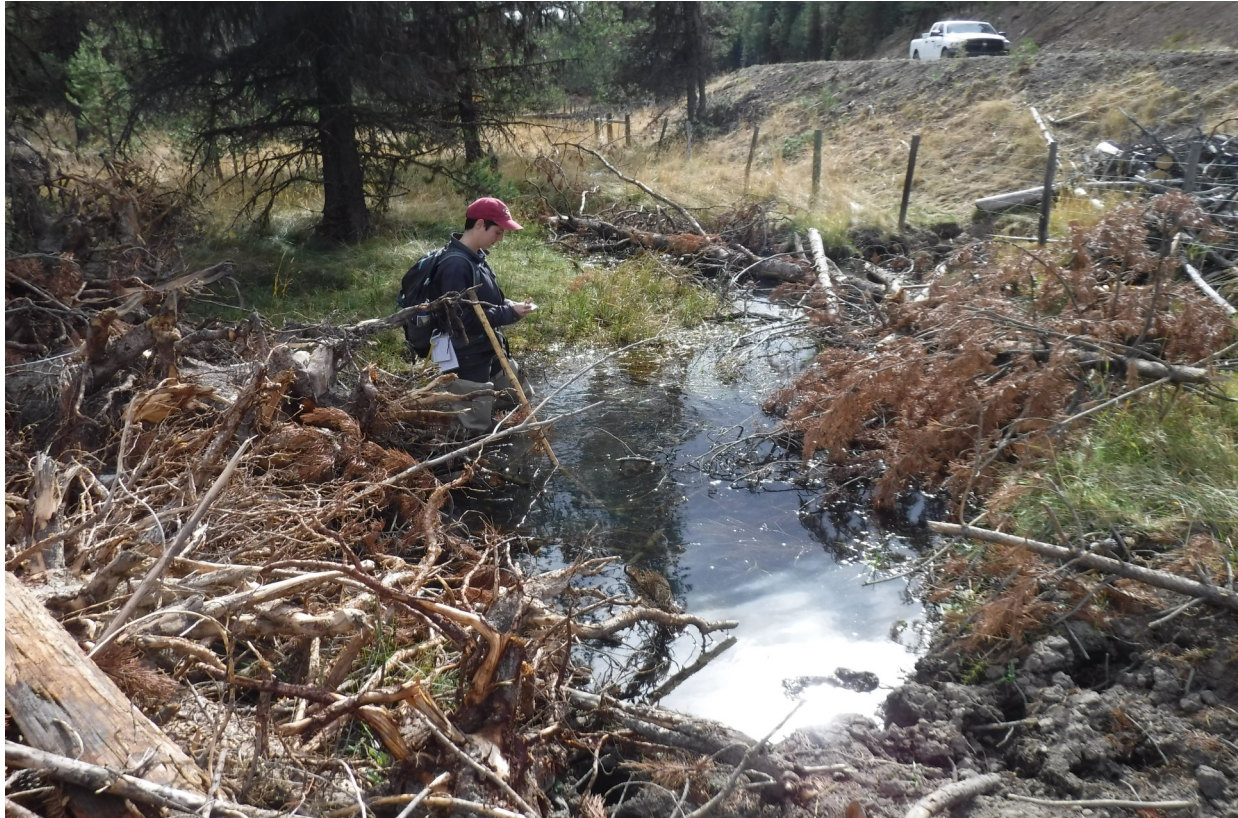
Log jam & pool on West Chicken Creek

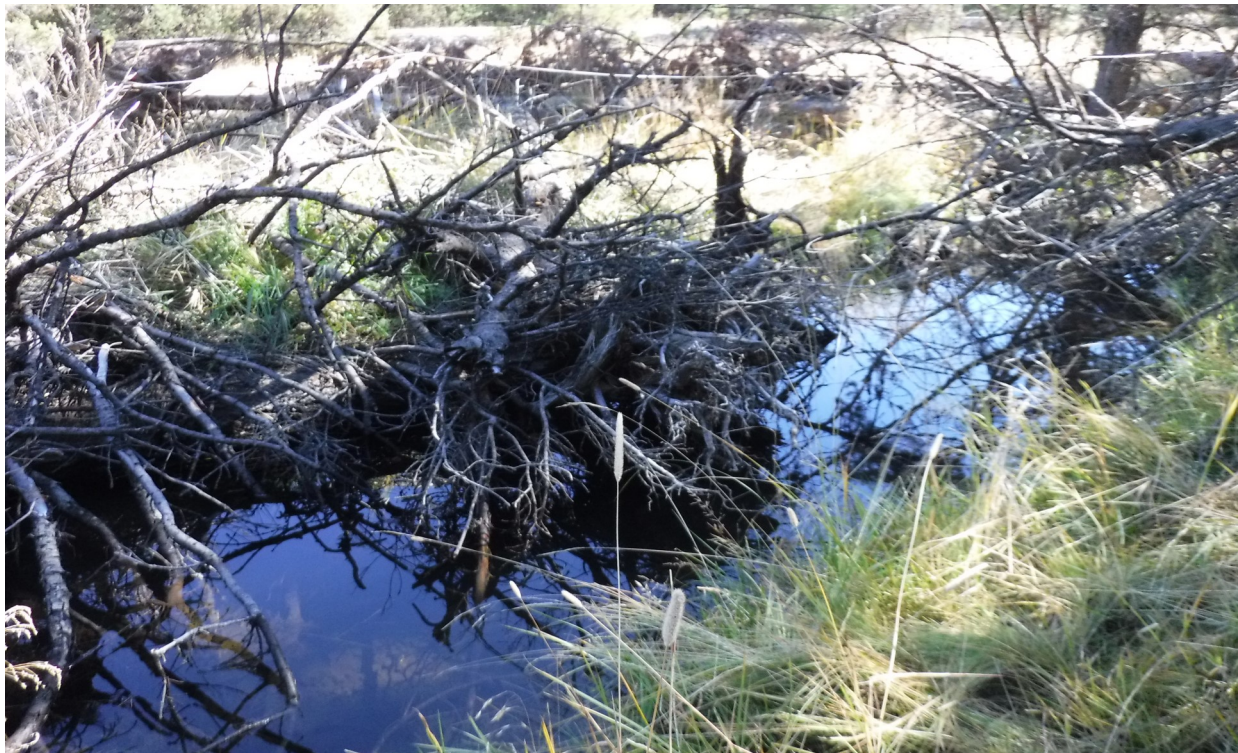
Log jam backed water into old structure on Chicken Creek

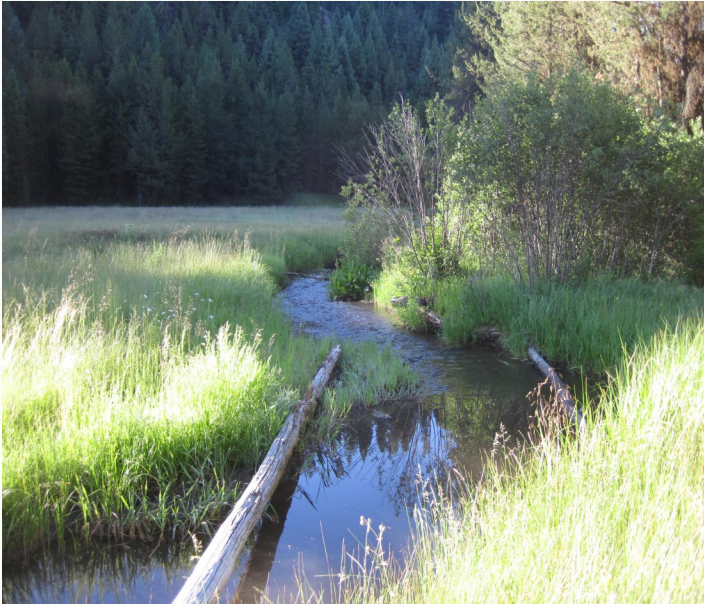
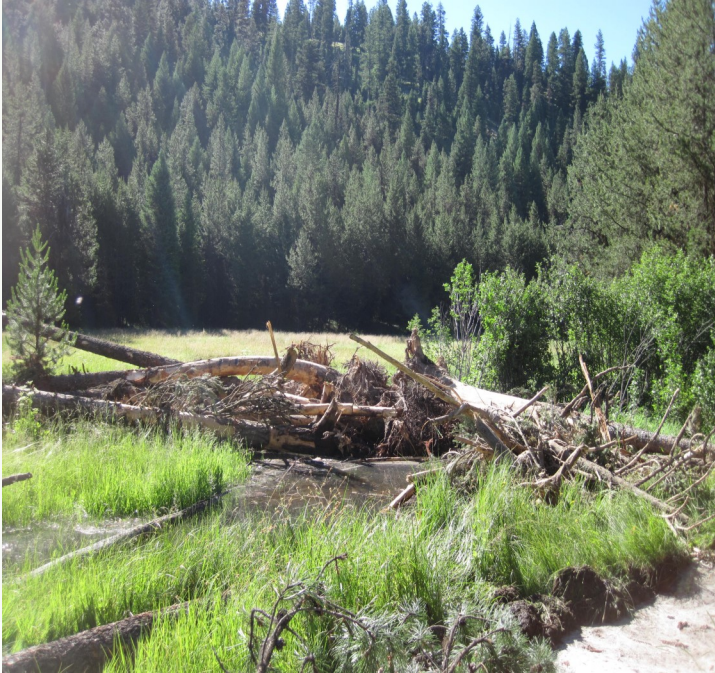
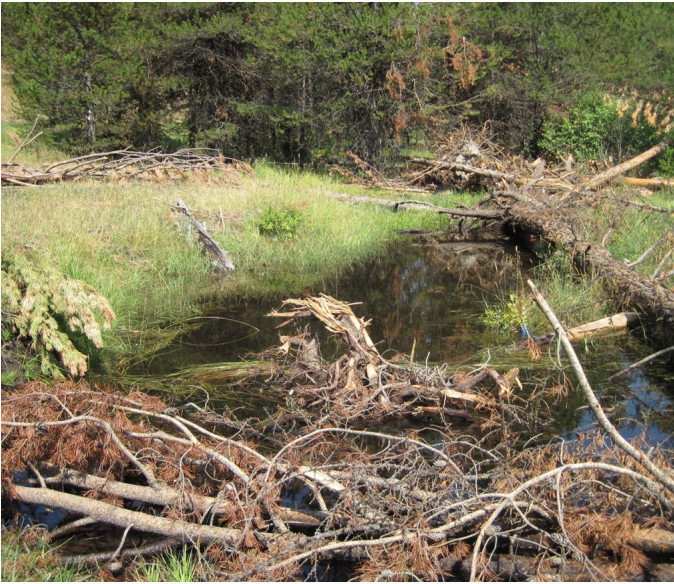
Pre Restoration

Post Restoration

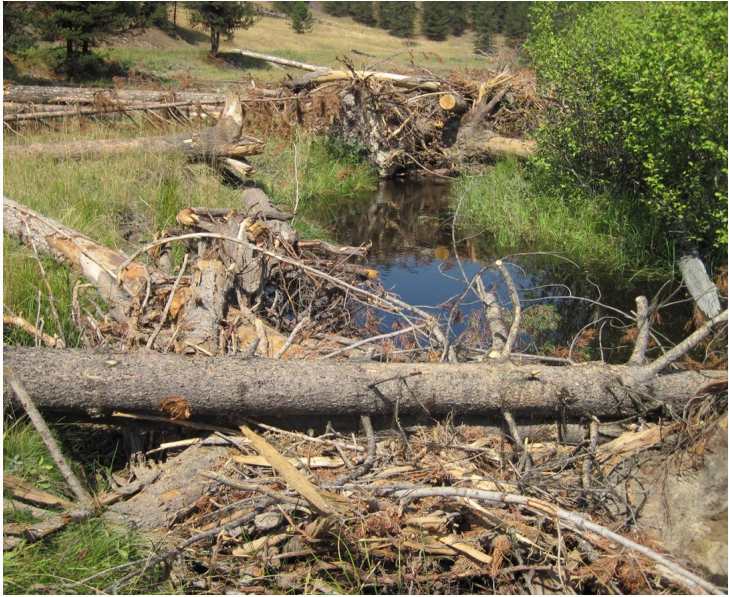
Upstream of log jam

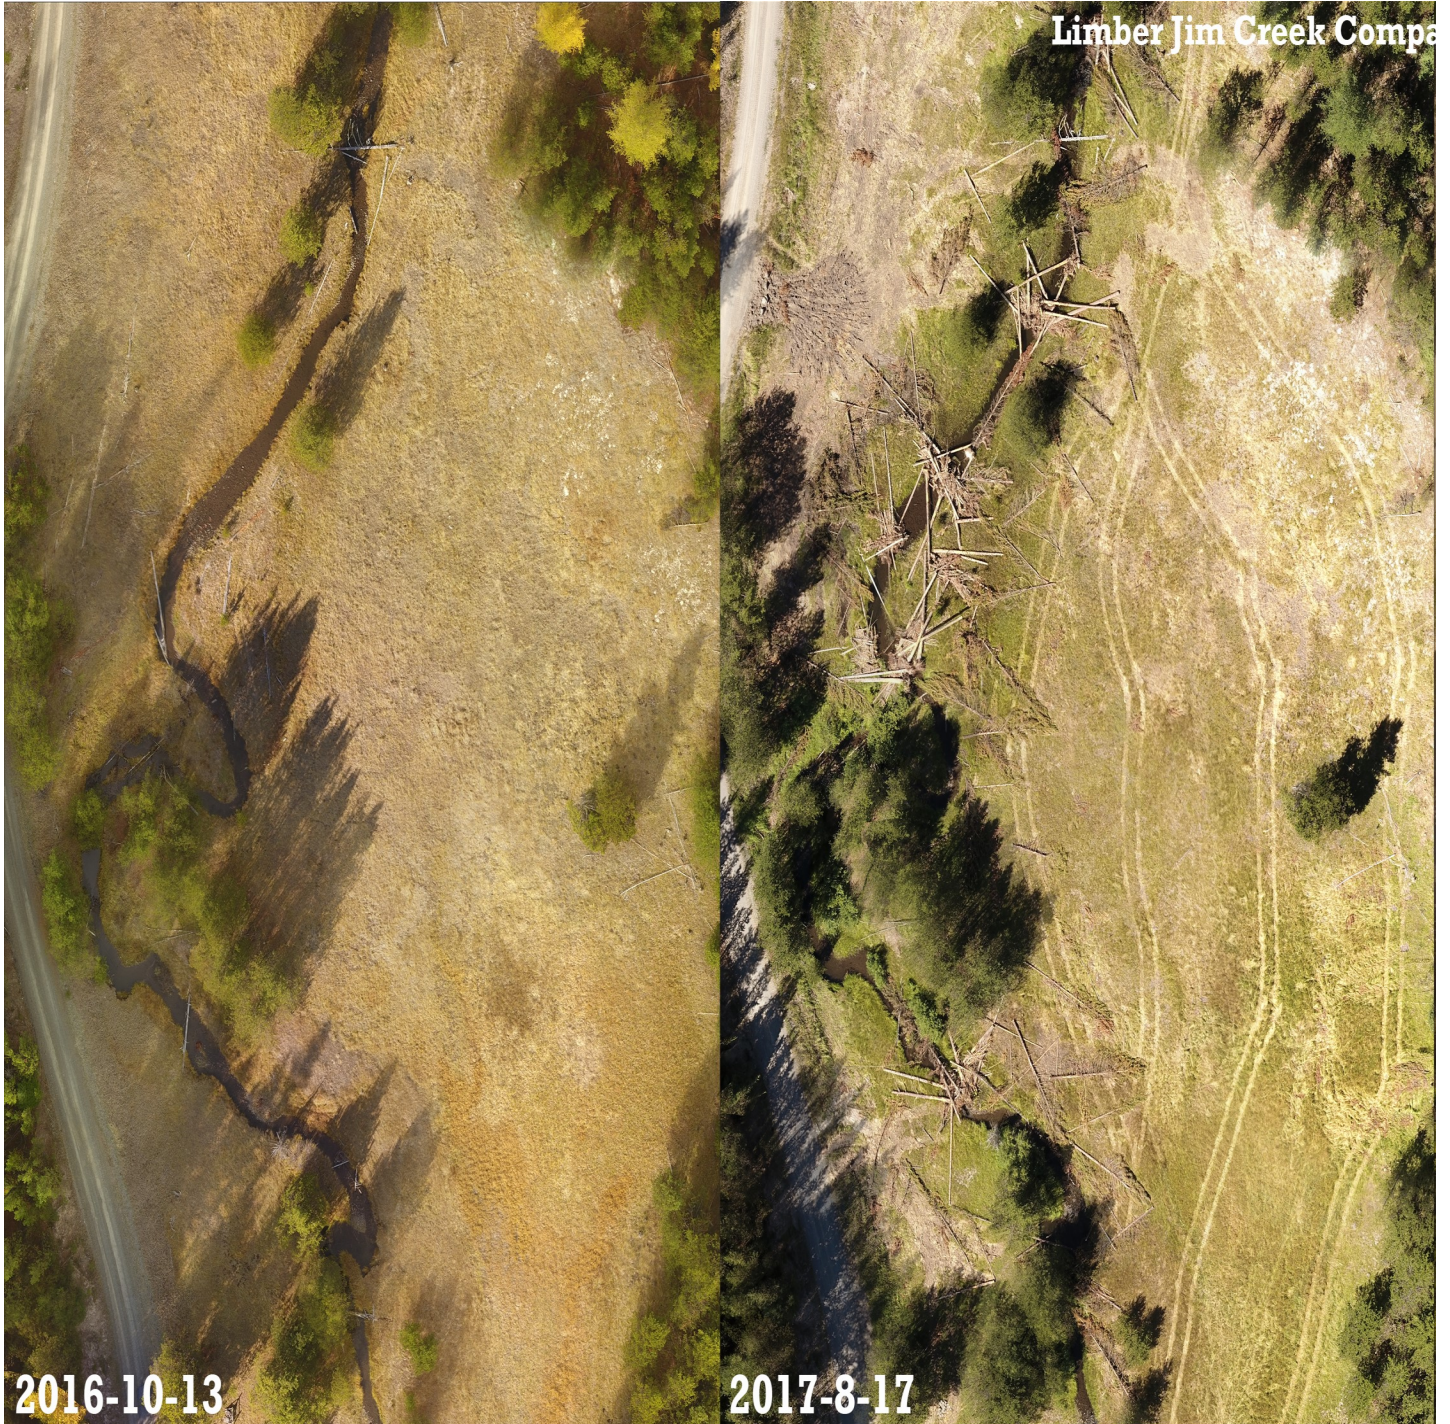
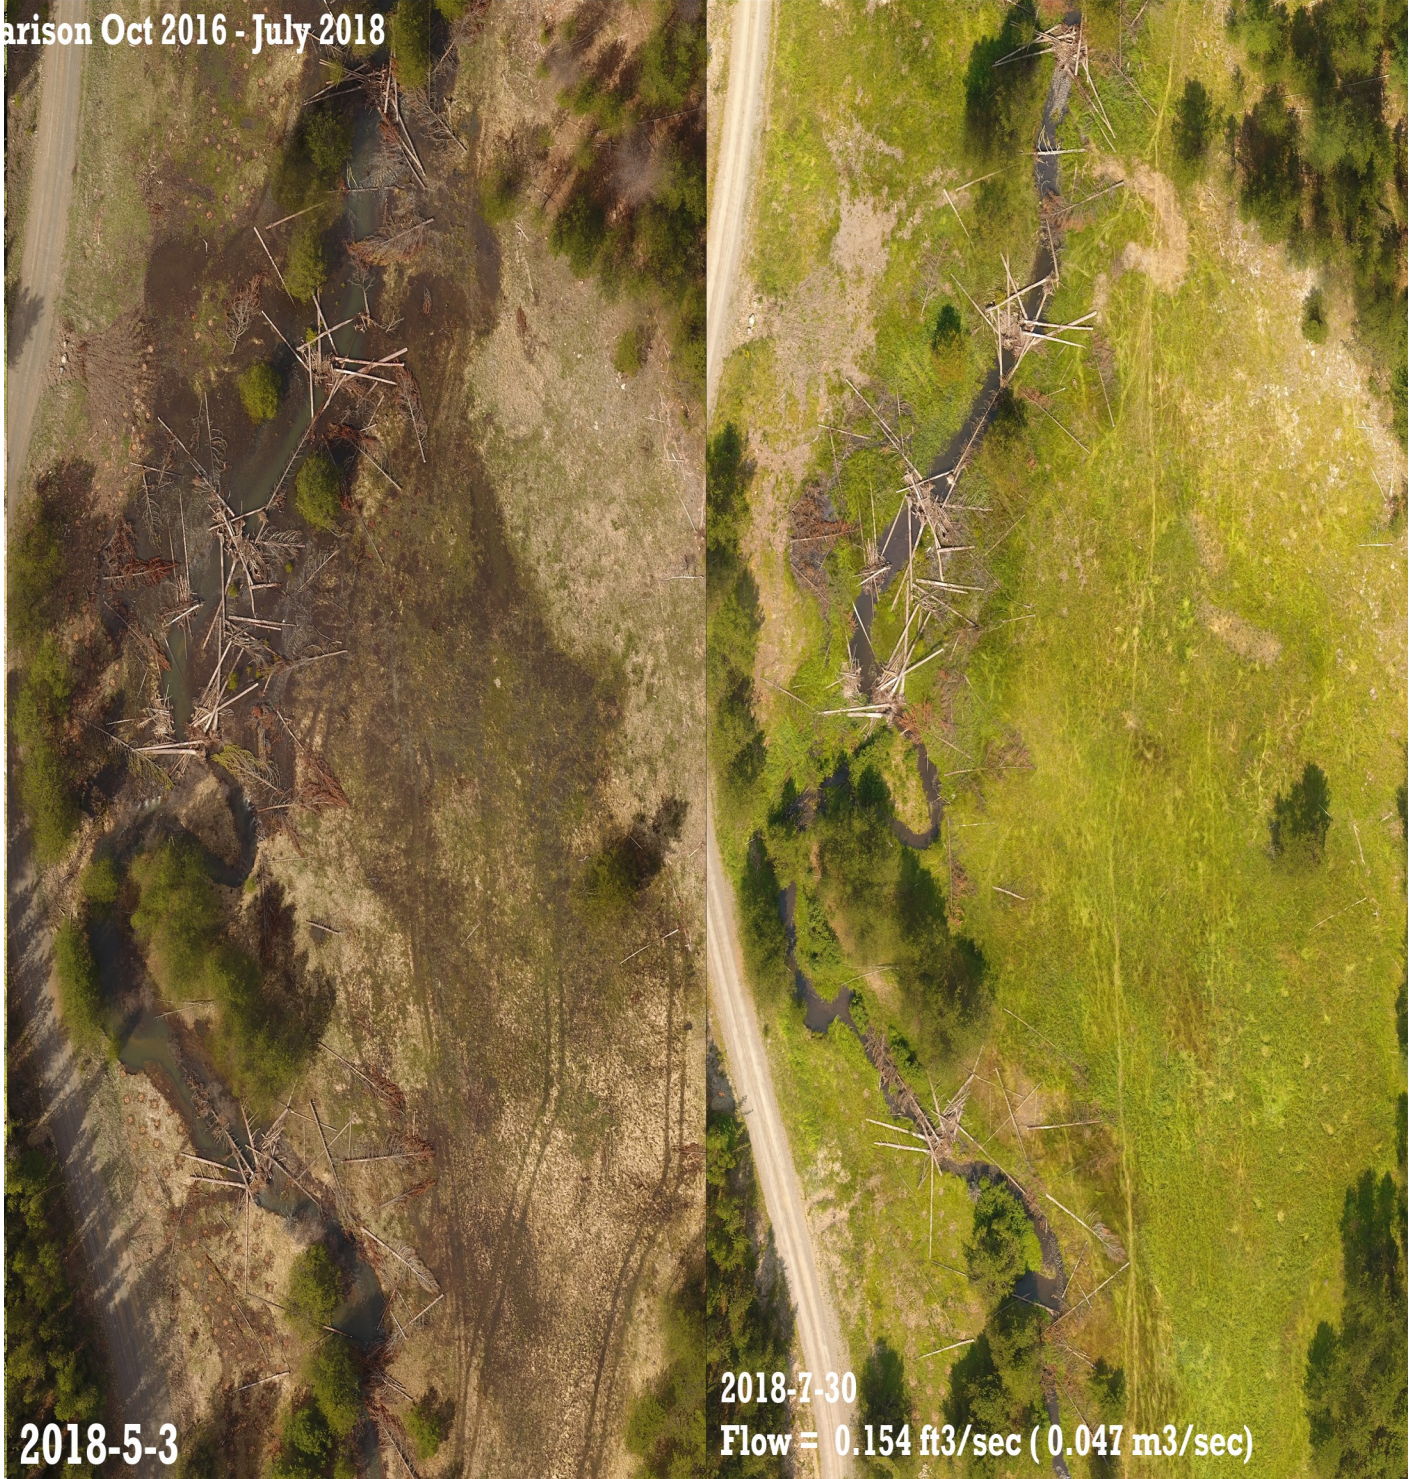
Drone photos of Limber Jim Creek (before/after photos)

Drone photos of Limber Jim Creek one season after construction showing increased floodplain inundation and greenline.
