Project Completion Report

Wallowa River

Baker Habitat Restoration Project

Project #1992-026-01

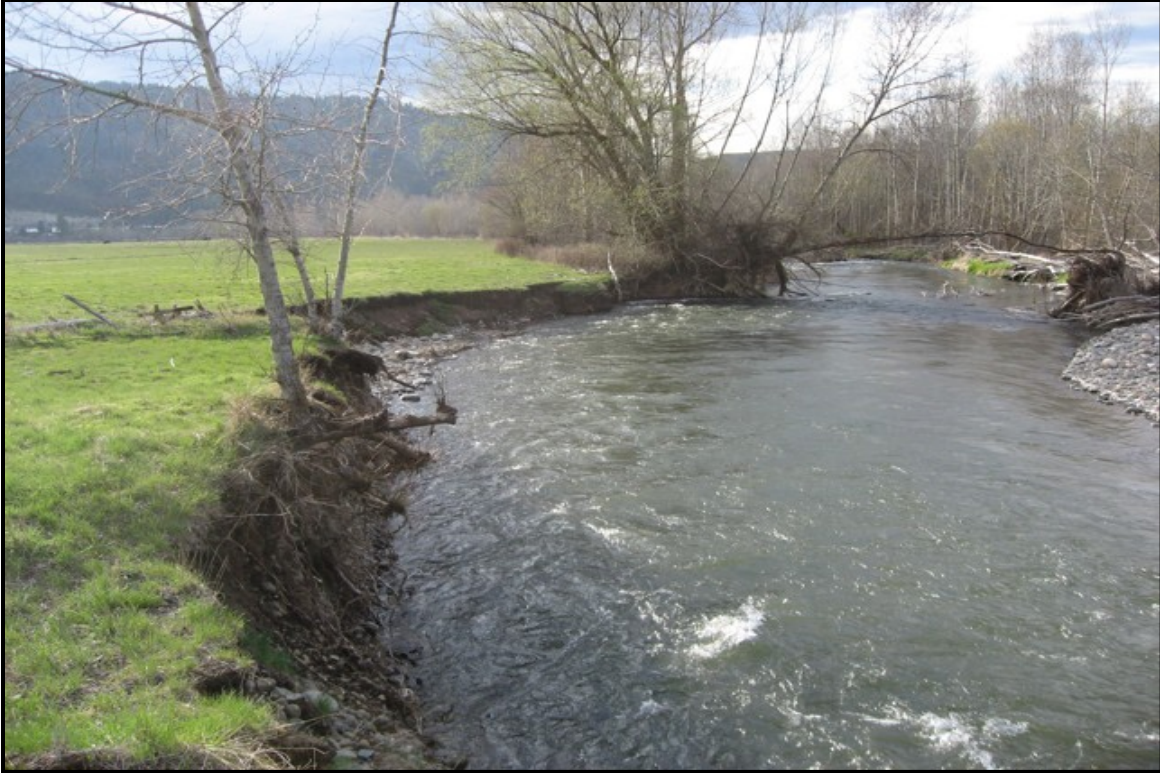
Figure 3. Looking downstream from the Baker property at the localized bank erosion, April 2007.

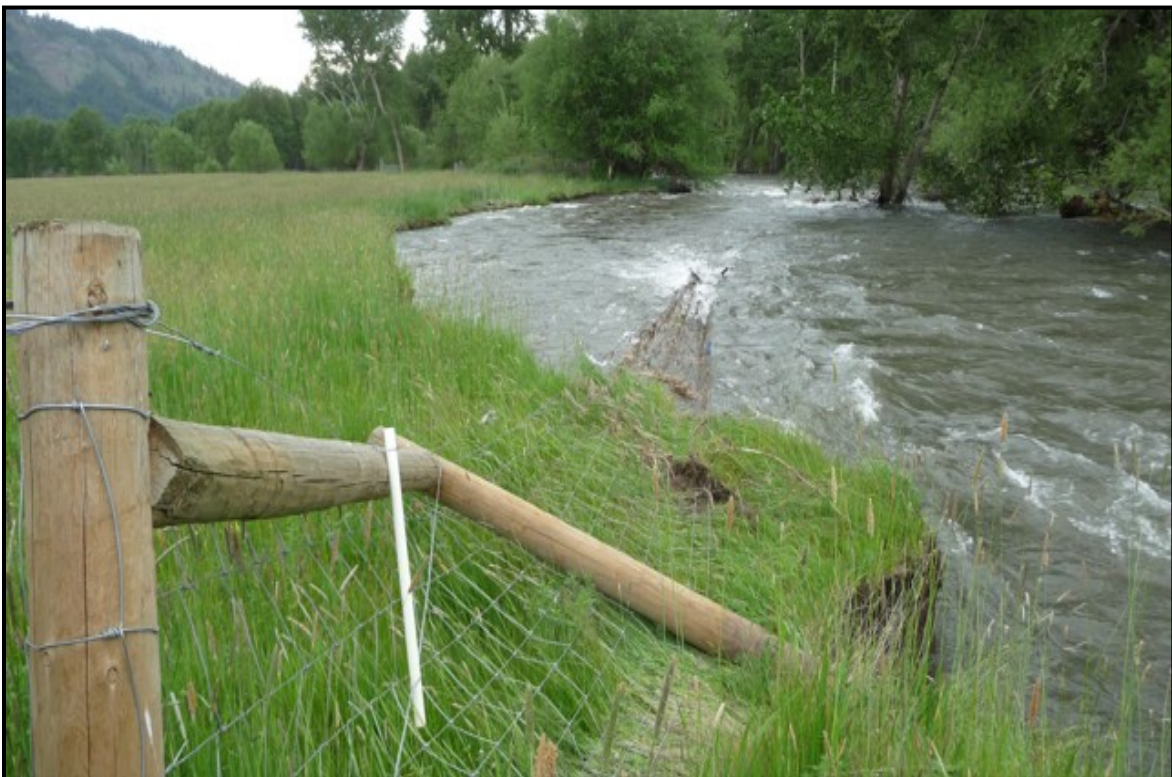
Figure 4. Looking downstream from the Baker property, June 2, 2009. The Wallowa River is shown laterally migrating through the narrow riparian buffer, carving what would become the main channel by the end of runoff.

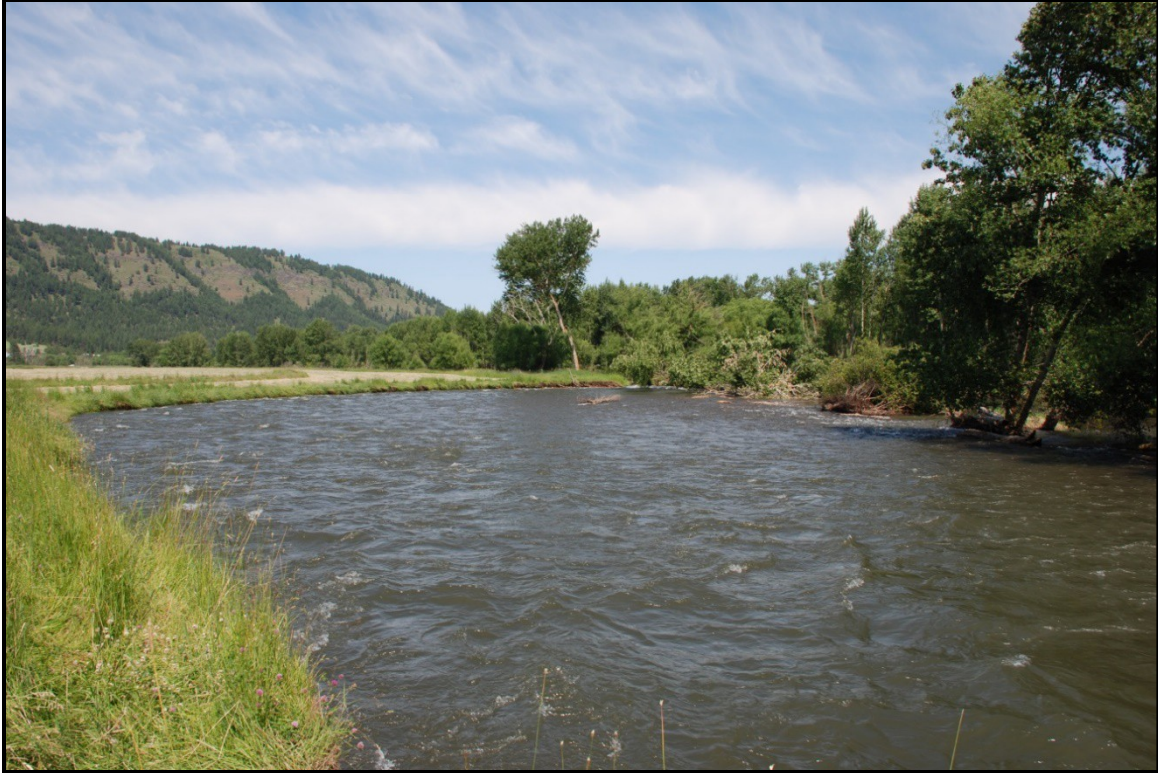
Figure 5. Looking downstream at the Wallowa River from the Baker Property, June 25, 2009. Location is close to Figure 4. As flows receded, this became the main channel.

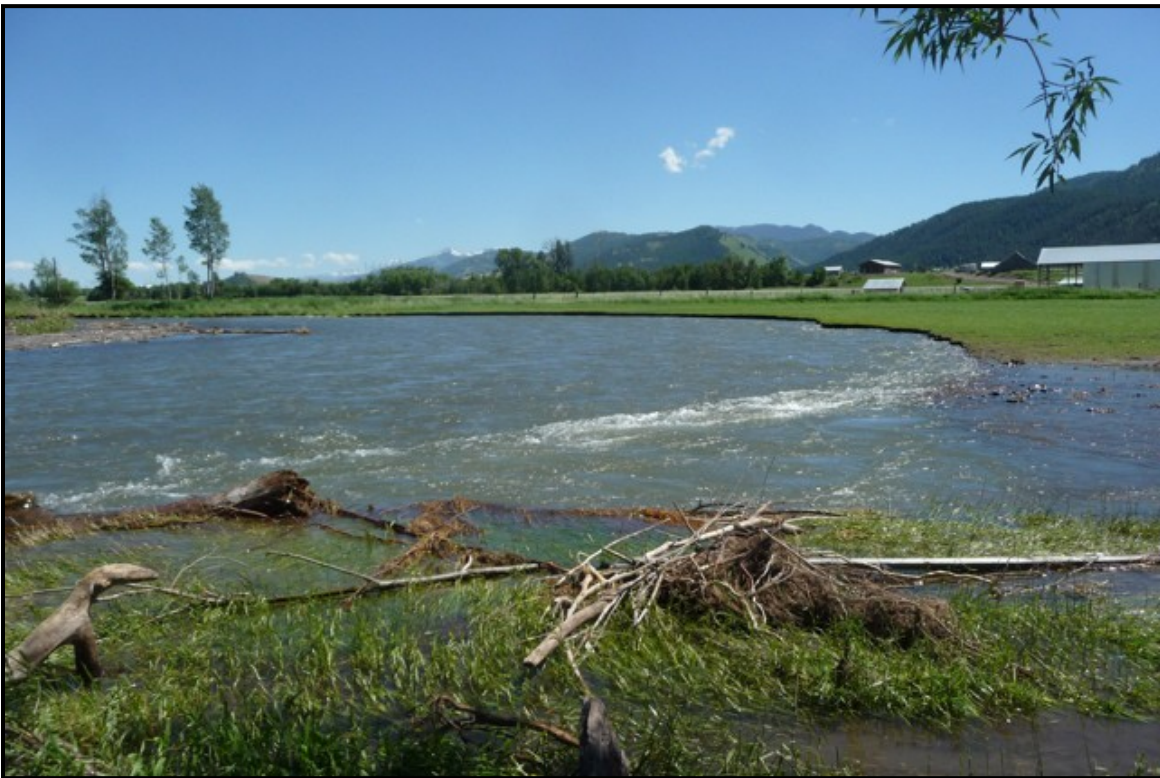
Figure 6. Looking upstream from the left bank of the Baker property (July 2010). Looking towards the locations of Figures 4 and 5. The bank is over 500 feet long.

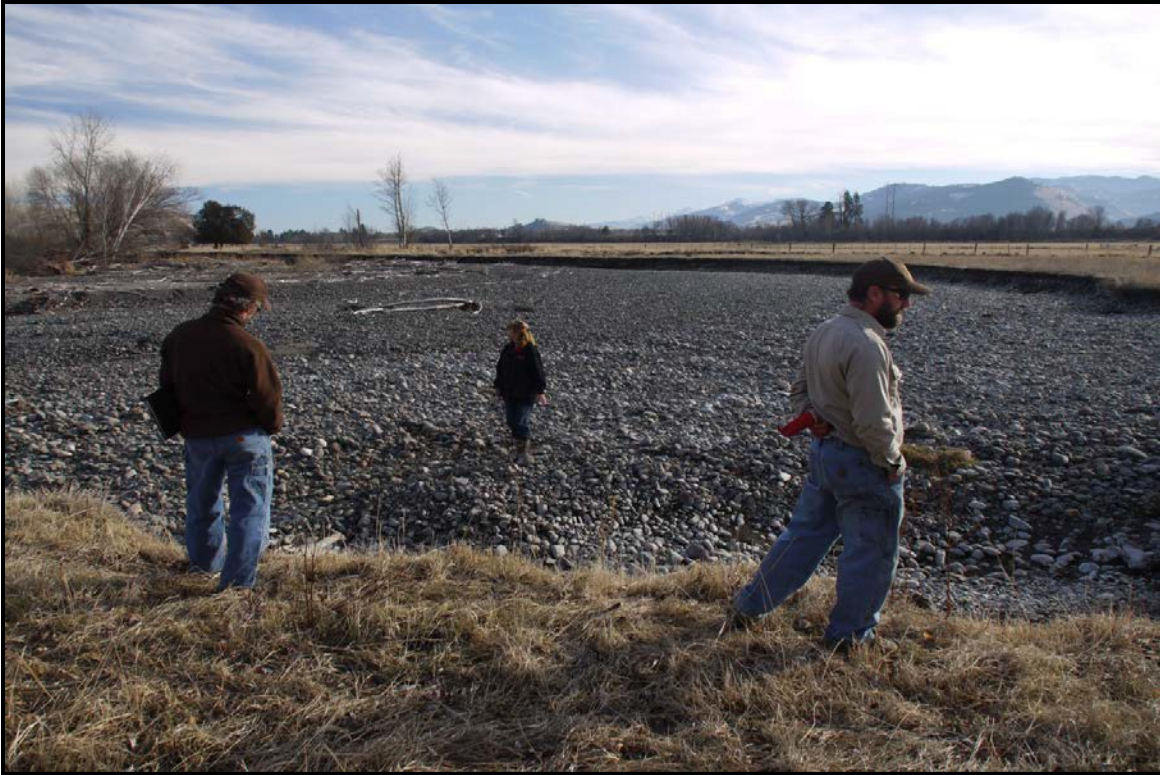
Figure 7. ODFW employees and the landowners surveying the abandoned left bank channel. This was the main channel in 2009-2012, and still activates at higher flows. Photo is taken from a location in proximity to the photo in Figure 6 (January 2012).

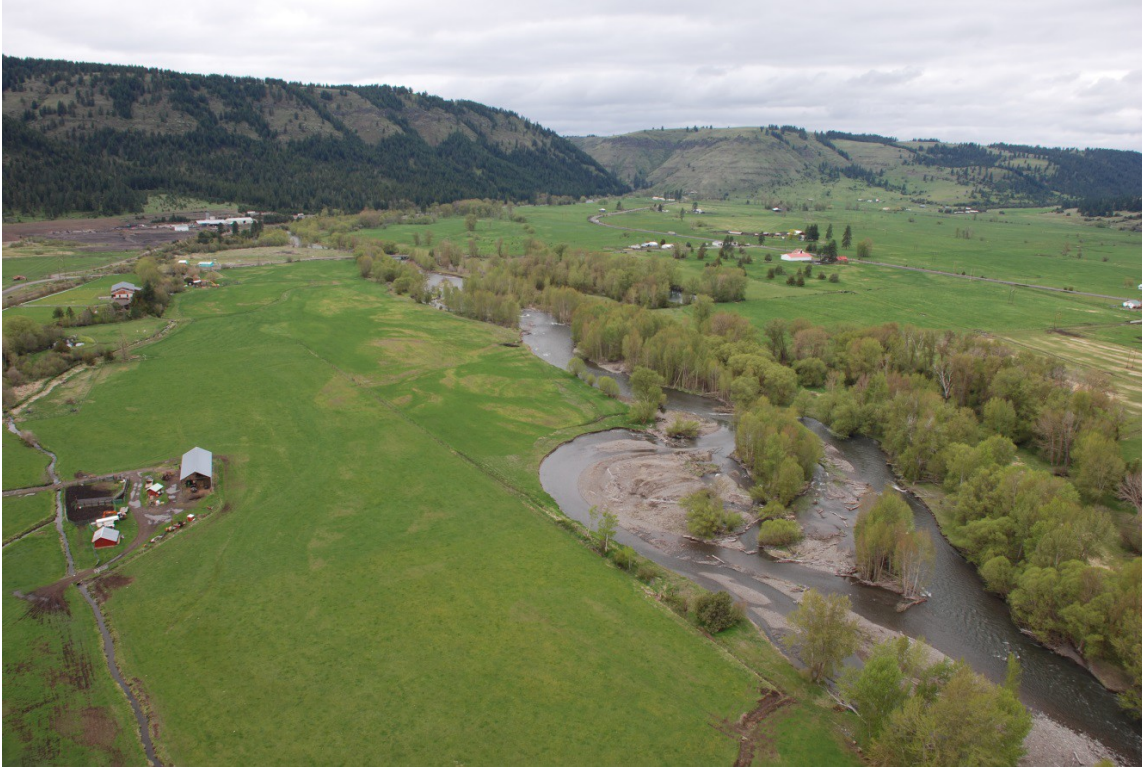
Figure 9. Aerial photo of Wallowa-Baker Project looking downstream, 2012. New channel carved on right bank and left bank channel now only activated at high flows.

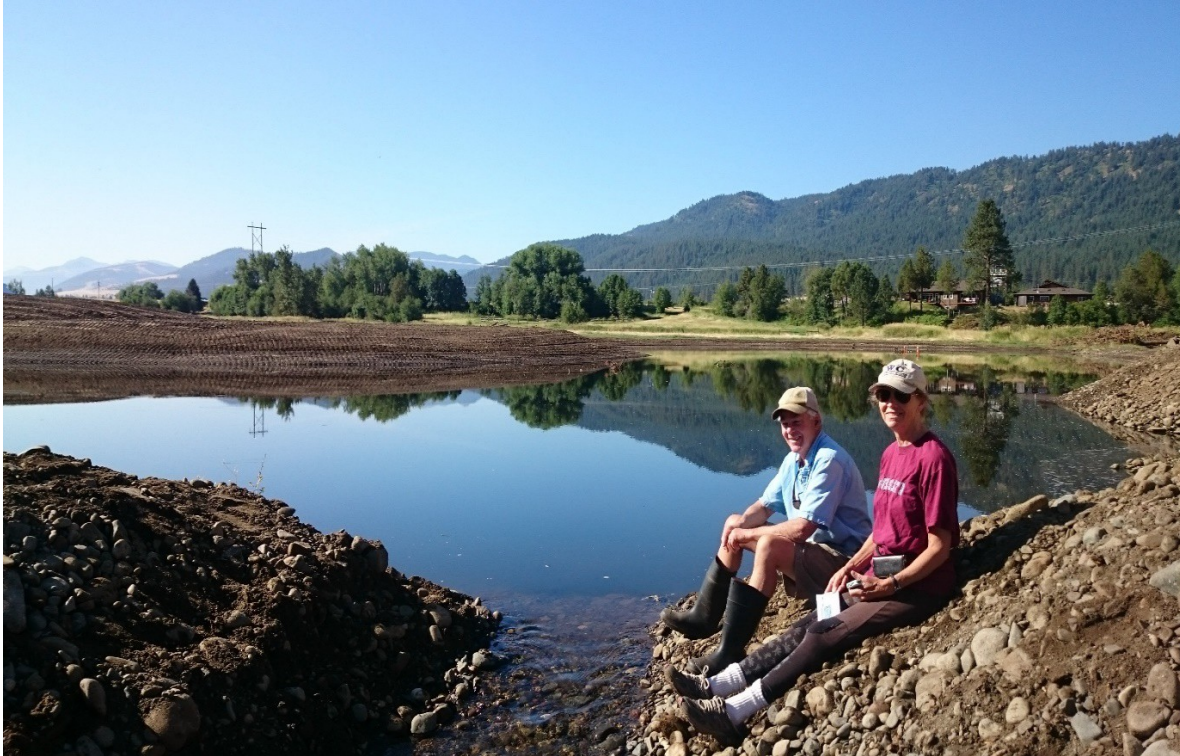
Late snow and heavy spring rains and high flows from snowmelt impacted project construction. Cutting and hauling of trees was delayed by heavy rains. Project site access was also affected with snow plowing required and a new access road constructed when maintenance of the primary access road became too onerous because of water. Side channel and wood structure construction was also affected by runoff from an adjacent landowner's field once irrigation season began (Figure 19). Additional pumps and round the clock pumping in some locations was required.

Figure 19. Landowners John and Tarrah Baker during Wallowa-Baker project construction, July 14, 2017. “Pond” formed from groundwater and irrigation run off from adjacent landowner.

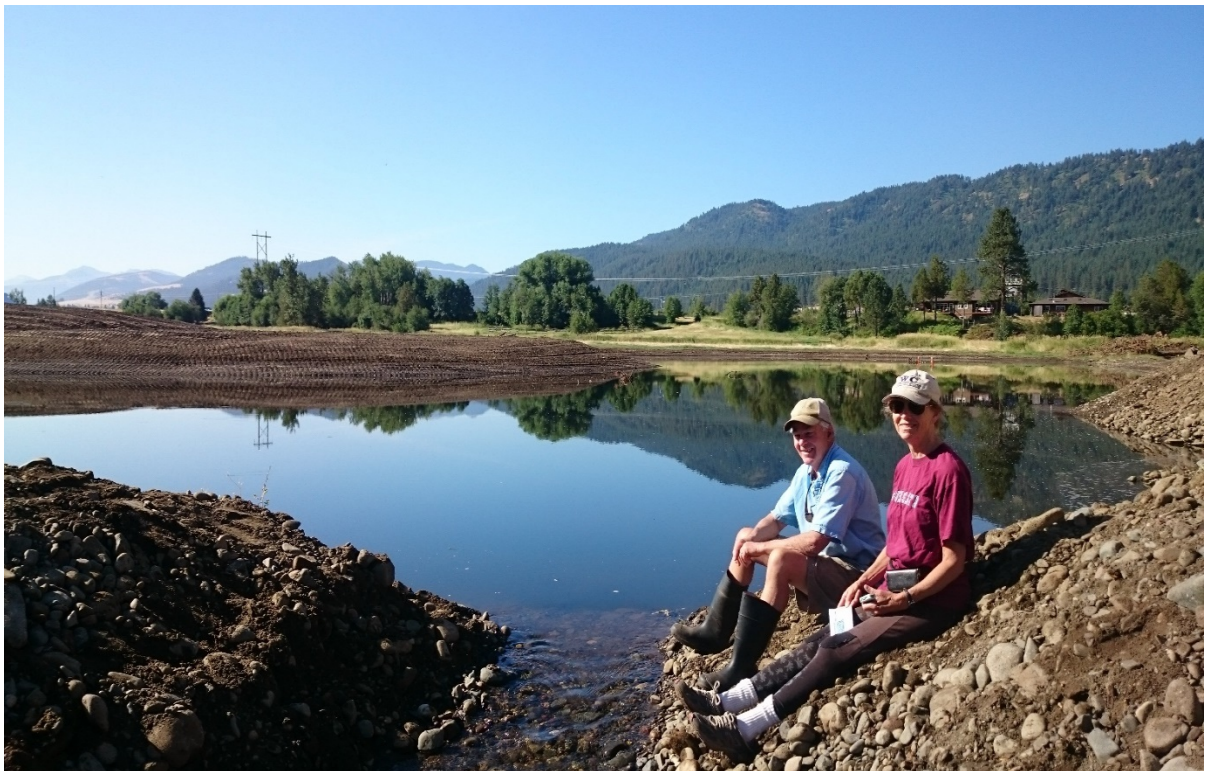
Landowners John and Tarrah Baker during Wallowa-Baker project construction, July 14, 2017. "Pond" formed from groundwater and irrigation run off from adjacent landowner.

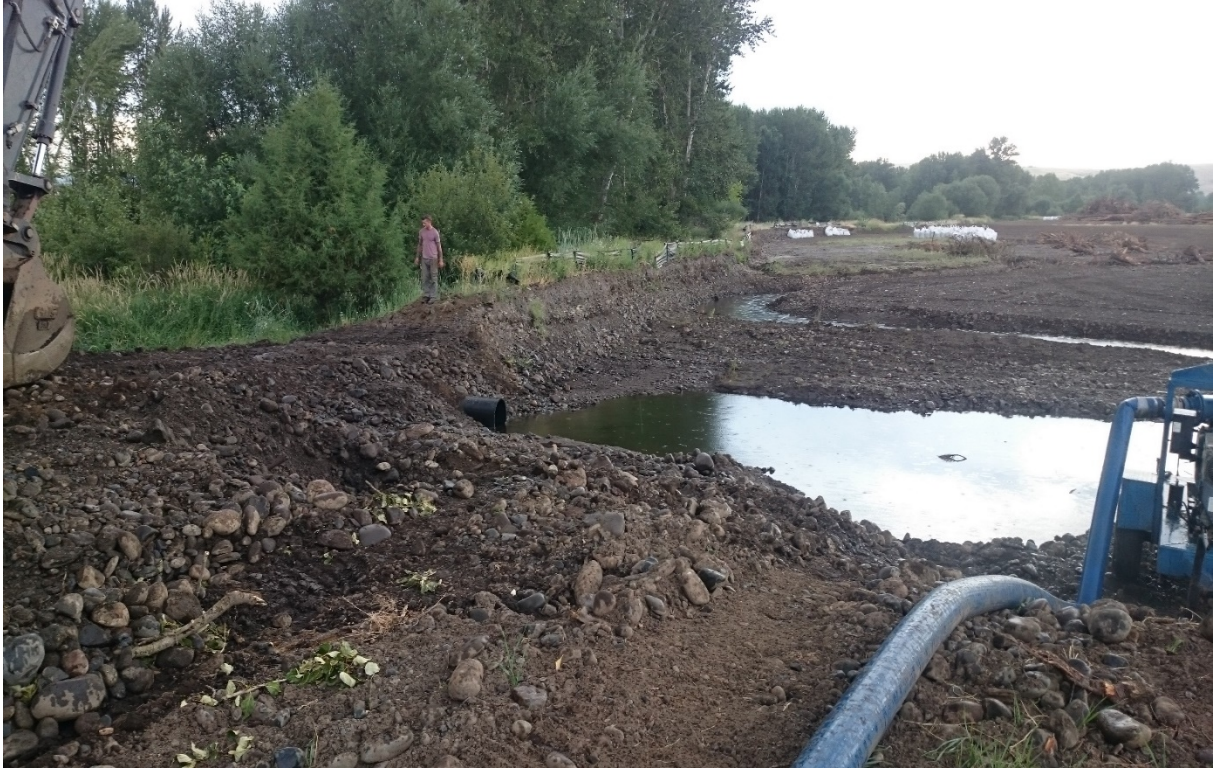
Groundwater removal from Wallowa-Baker Habitat Restoration Project Side Channel A, July 14, 2017.

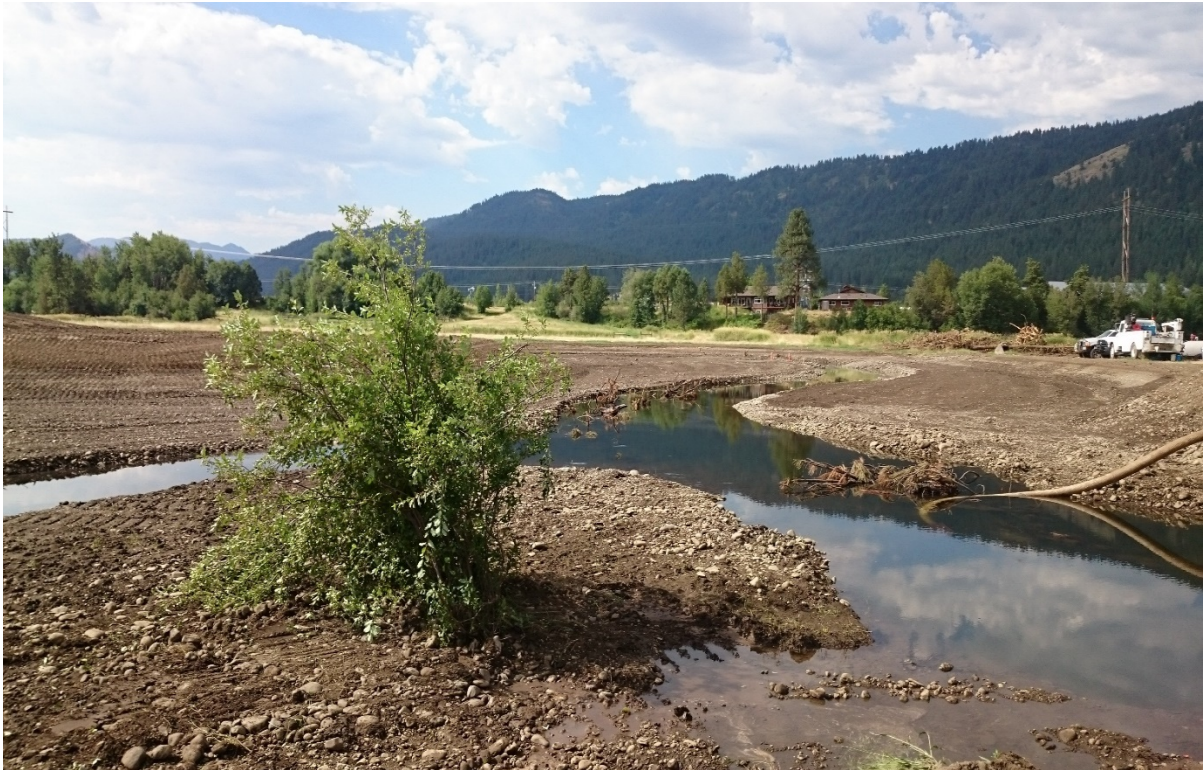
Groundwater in side channels A and C, constructed for the Wallowa-Baker project, July 18, 2017.
