Green Valley Ranch-Wallowa River Fish Passage Project

1992-026-01

Winston Morton, Nicholas Smith
Oregon Department of Fish and Wildlife
La Grande, Oregon
December, 2023

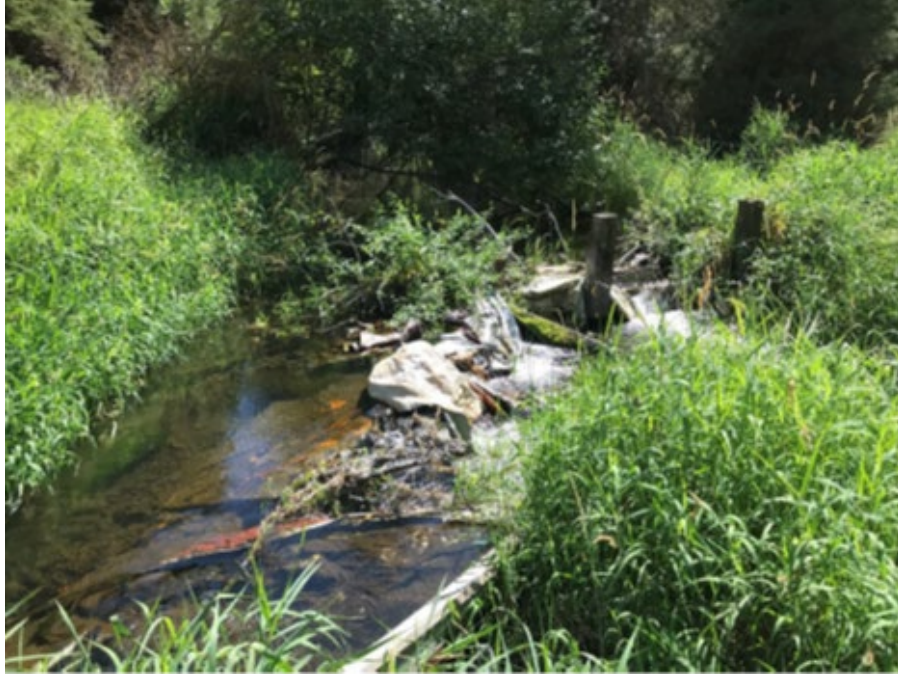
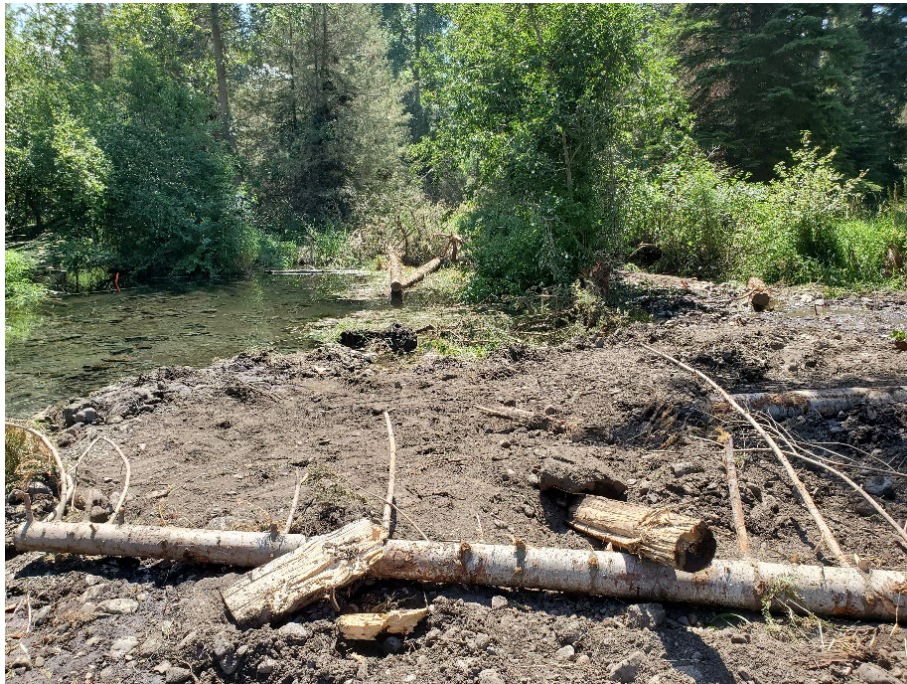
Figures 1 and 2. Top picture is the push up dam before removal, bottom picture is the push up dam removed also featuring large wood structure installation in channel and on floodplain.

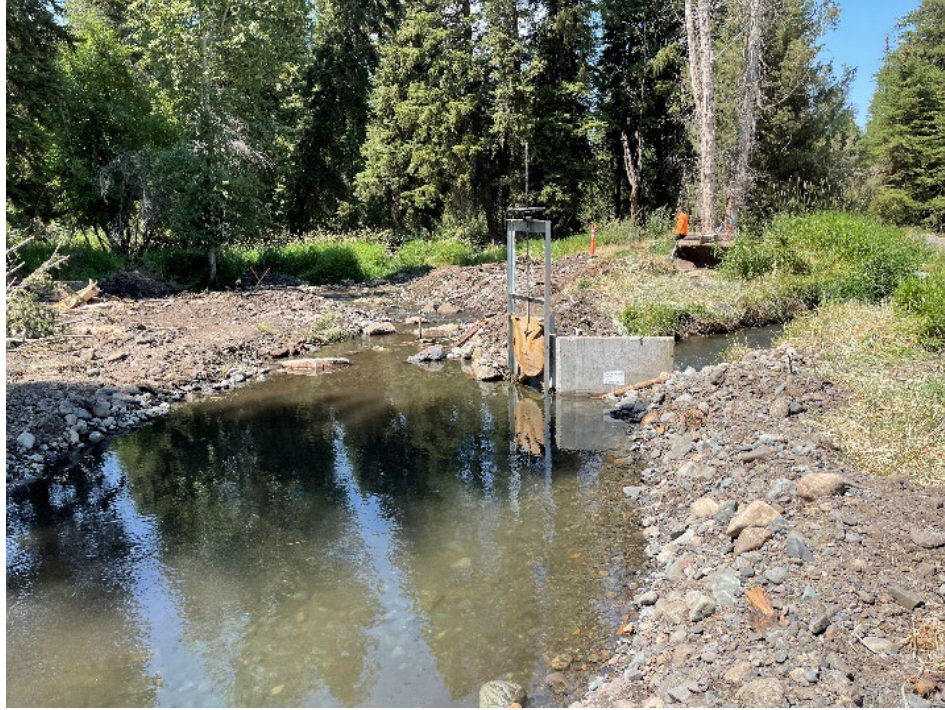
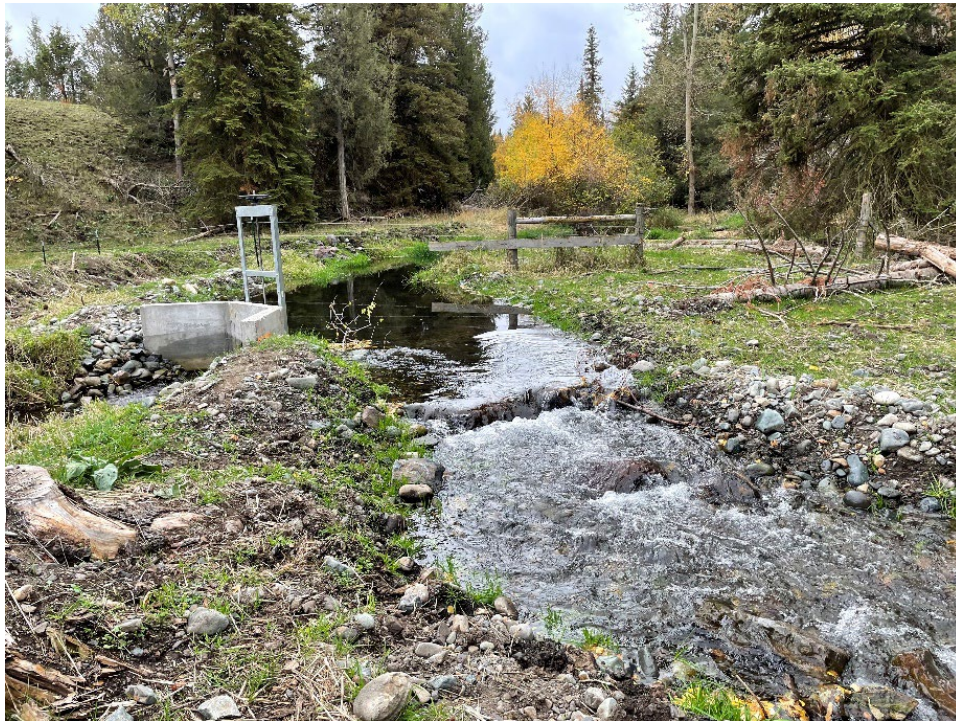
Figures 3 and 4. Top picture is looking downstream of completed roughened riffle and headgate installation. Bottom picture is looking upstream at completed roughened riffle and headgate.

The last consideration for adaptive management involves the headgate infrastructure that was installed. Everything was installed and checked off as built as designed from the engineer onsite. We noticed at a site visit this fall that the head walls on each side of the head gate seemed to have water trickling through the rocks keeping the headwall in place. We have reached out to the engineer to clarify that if the headgate is mostly closed, should this be a concern. Adaptive management may need to occur to either keep the headgate somewhat open to allow the water to be slow moving and above the area that water trickles through, or perhaps more reinforcement in these areas. The engineer is determining the best course of action at this time.

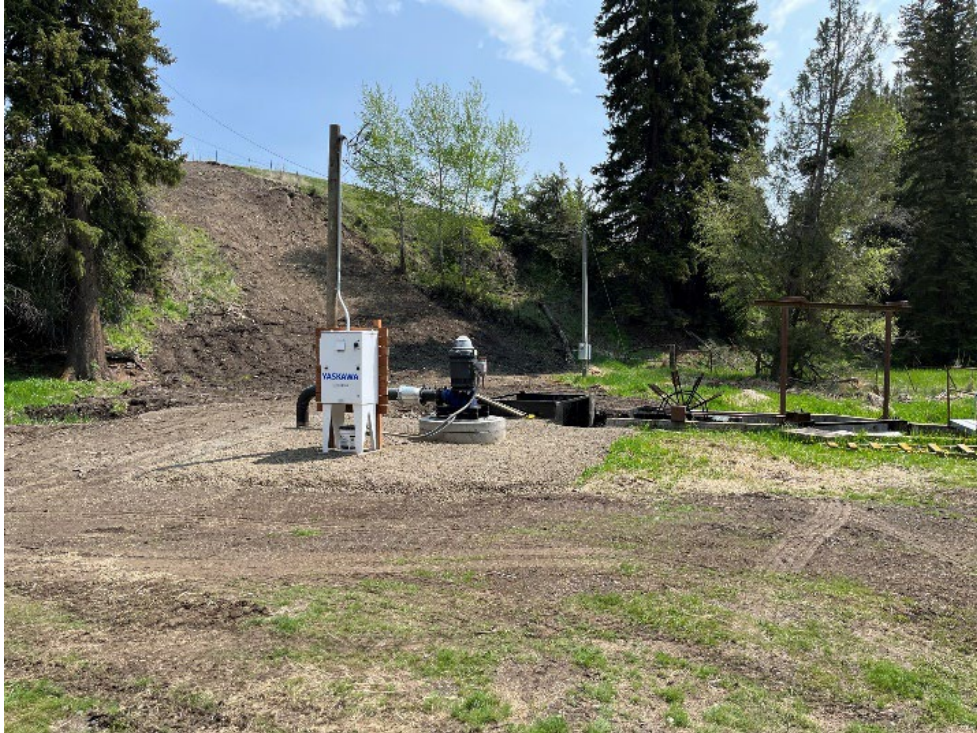
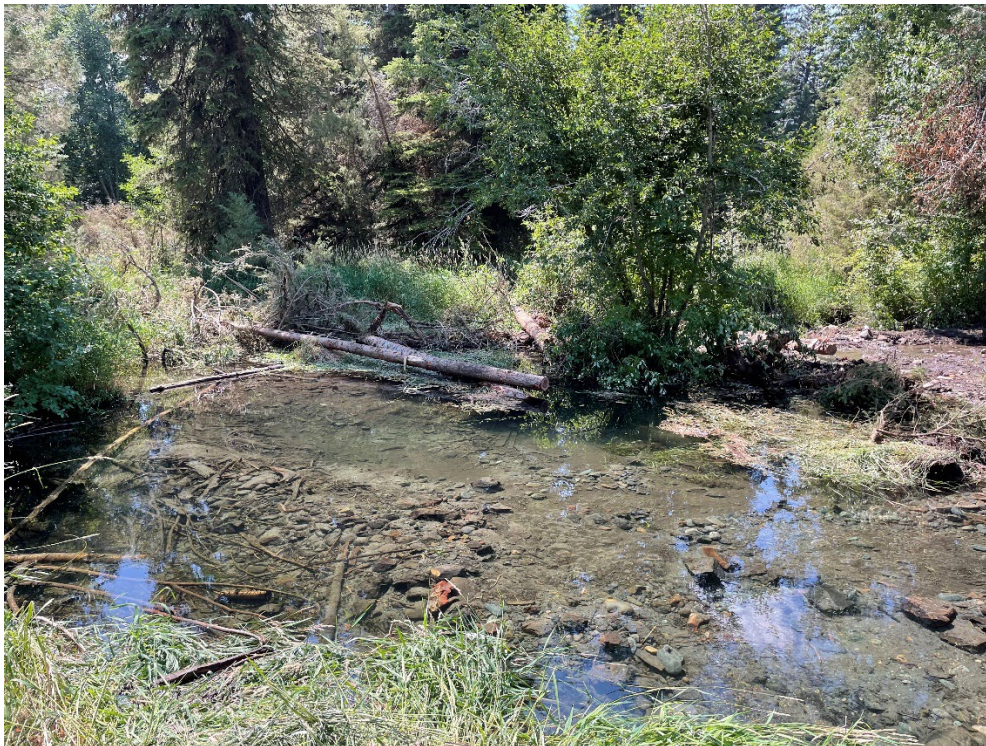
Figures 5 and 6. Top picture shows completed move and installation of turbine pump behind ODFW fish screen. Bottom picture shows completed large wood structure diverting flow to irrigation infrastructure, also shown is the high flow channel behind the structure in the pool where the debris dam use to be
