# **PROJECT COMPLETION REPORT**

## **End Creek-Rice Fish Habitat & Wetland Restoration Project**

**Oregon Watershed Enhancement Board Project No. 204-434**

**January 2007**

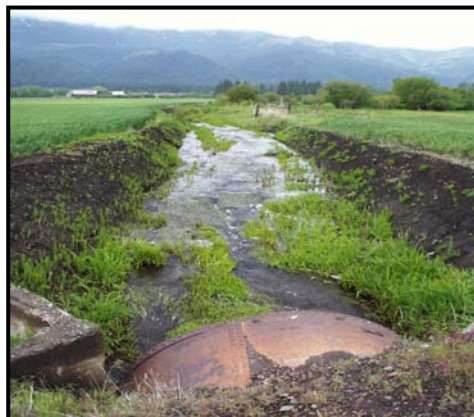
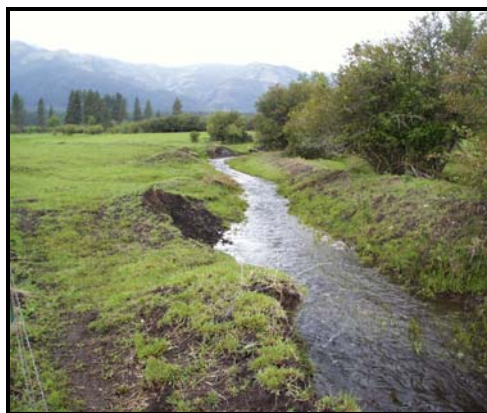
*2003 Photos illustrate lower channelized End Creek. Extensive channelization in project area created unstable stream channels, excessive erosion, elevated water temperatures, loss of riparian and wetland vegetation, and poor fish habitat.*

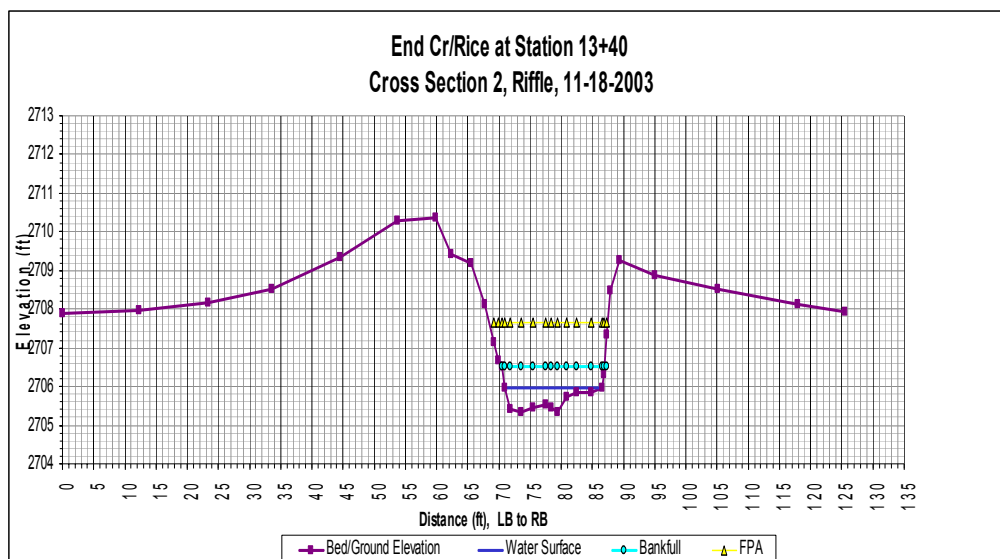
**Figure 6 Riffle Cross Section of Existing End Creek Reach**

The following figure depicts a typical riffle cross section generated from survey data collected at Station 13+40 along lower End Creek. The cross section clearly illustrates the extent of channel incision and lack of floodplain connectivity. Flood conveyance capacity of the channel is significant which contributes to unstable stream banks shown in the above photos. Note that both the bankfull discharge and floodprone area are contained entirely within the existing channel, limiting connectivity to the floodplain.

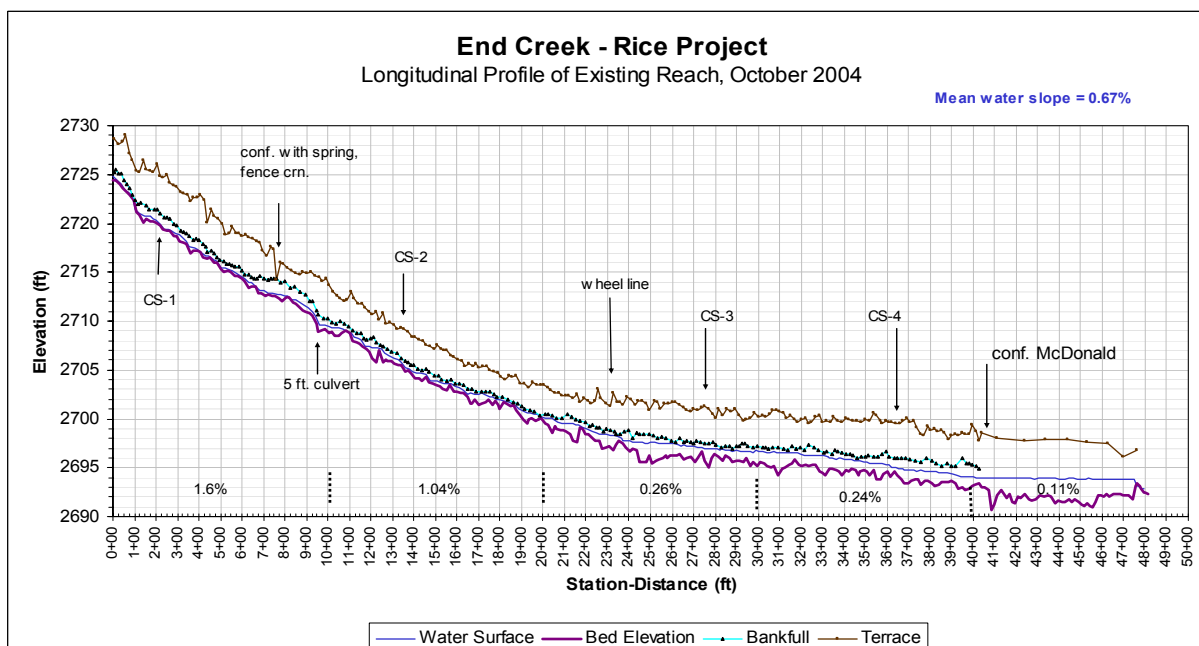
**Figure 7 Longitudinal Profile of Lower End Creek**

Figure 7 illustrates the profile of lower End Creek. Note the relation of the channel thalweg in comparison to adjacent terraces which illustrate extensive channel entrenchment, confinement, and high water slopes (mean of 0.67%). Also of note in the profile is the lack of large pool habitat. In the current condition, End Creek is severely unstable and lacks stable morphology necessary to develop high quality fish habitat.

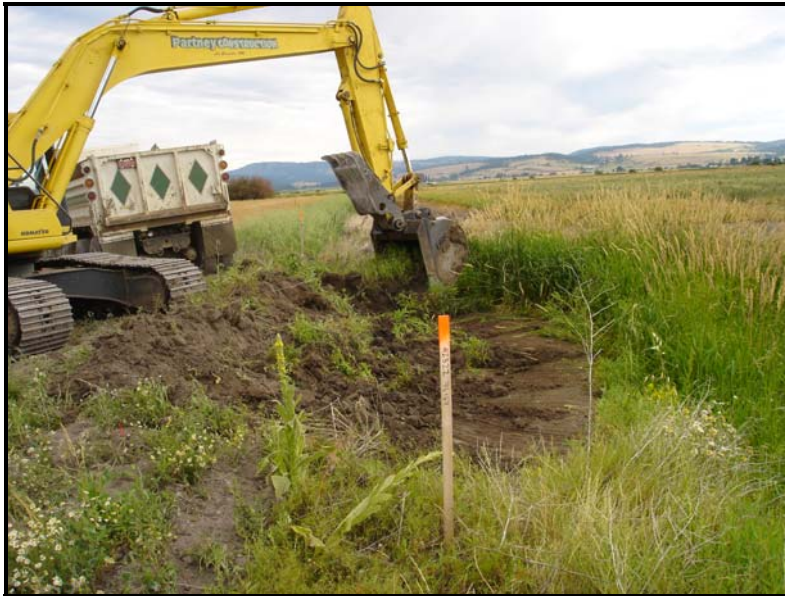
***Initiation of End Creek restoration channel construction***

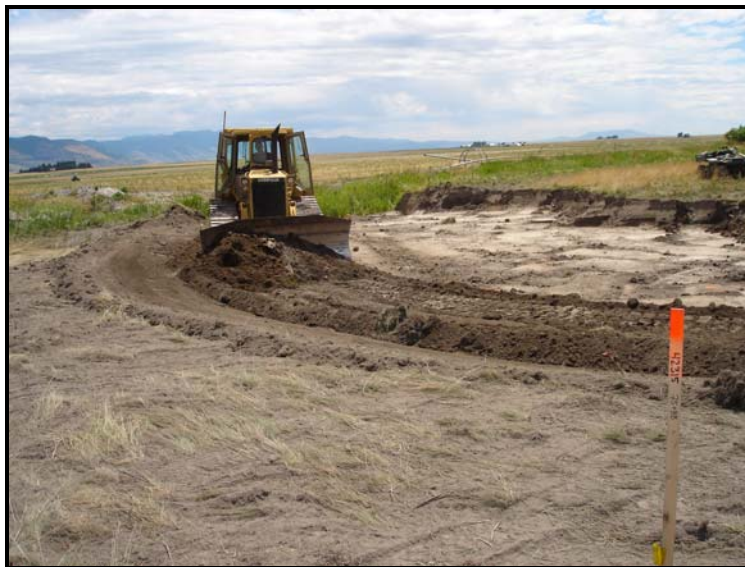
***D5 Dozer grading material from floodplain in preparation for bankfull channel excavation by track-hoe***

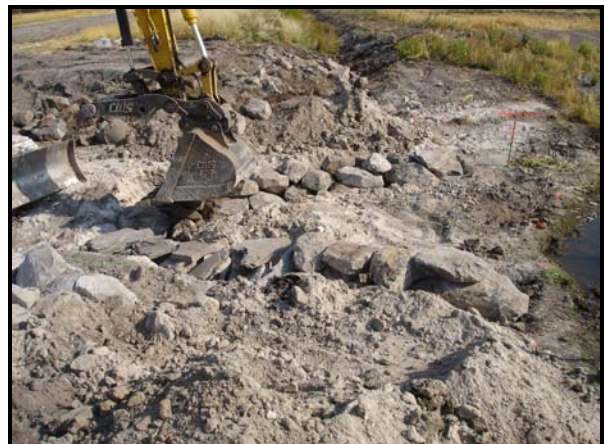
Photos below illustrate structure layout in the constructed restoration channel and an installed structure prior to backfill. Note that the elevation (invert) of the structure is the same as the bottom (thalweg) of the channel.

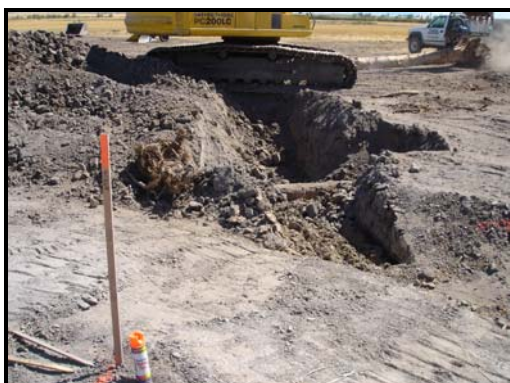
**Rootwad revetment installation.** Photo illustrates installed footer log and keyway for rootwad and tree bole installation.

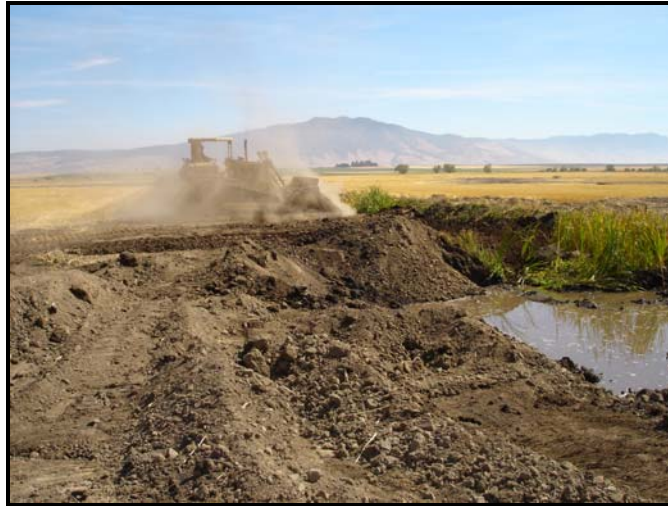
*Reclamation of channelized End Creek following activation of restoration channel.*

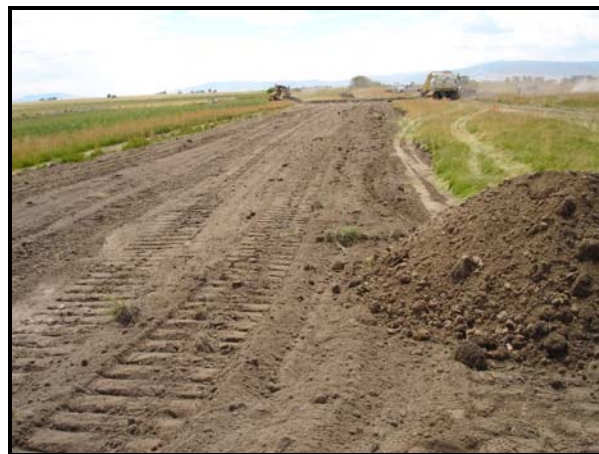
*Earthen terrace constructed along eastern project boundary to minimize potential for flooding on adjacent private land*

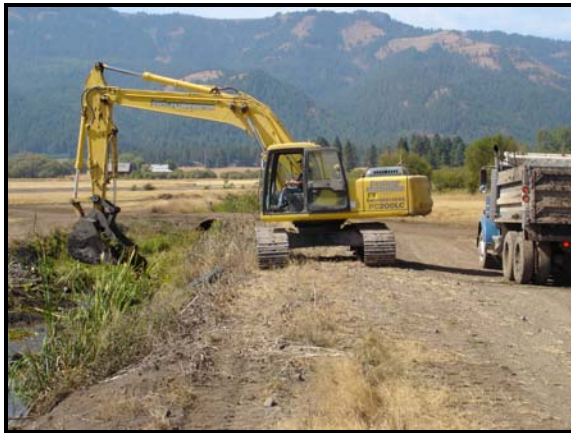
*Excavator prepares excavate and load sedge matt from the channelized End Creek alignment prior to reclamation (backfilling).*

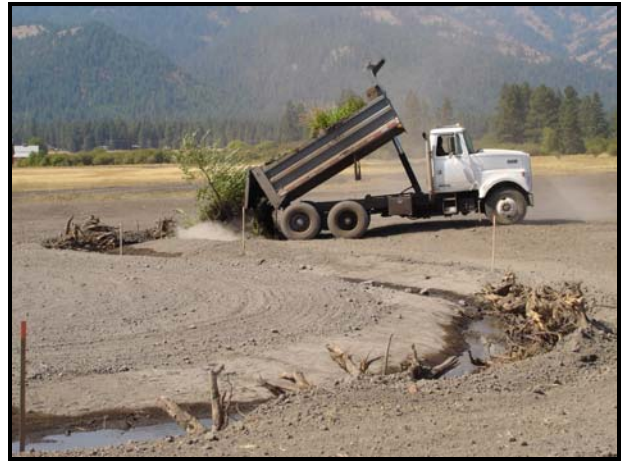
*Dump truck hauling and stockpiling plant materials at selected locations along End Creek restoration channel.*

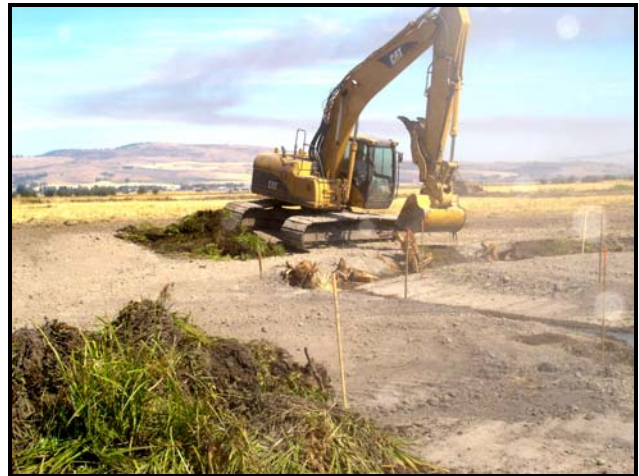
*Excavator installing sedge/rush matts along outside stream meander on rootwad revetment*

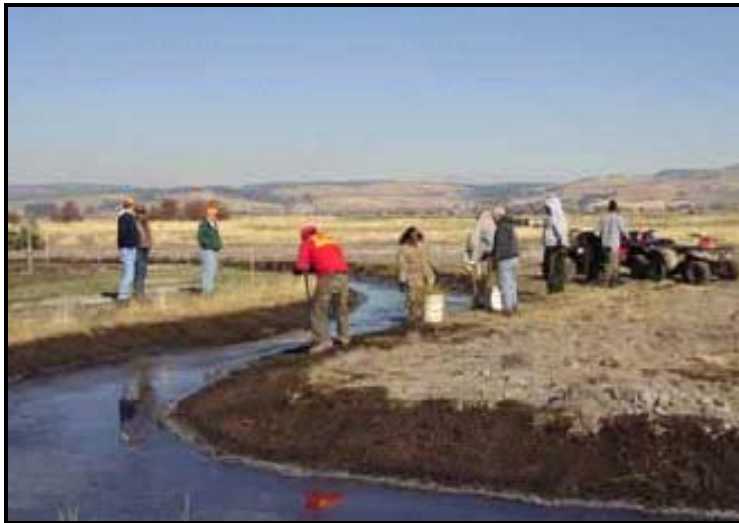
**CTUIR habitat crew installing sedge/rush plugs along South Fork Willow Creek**

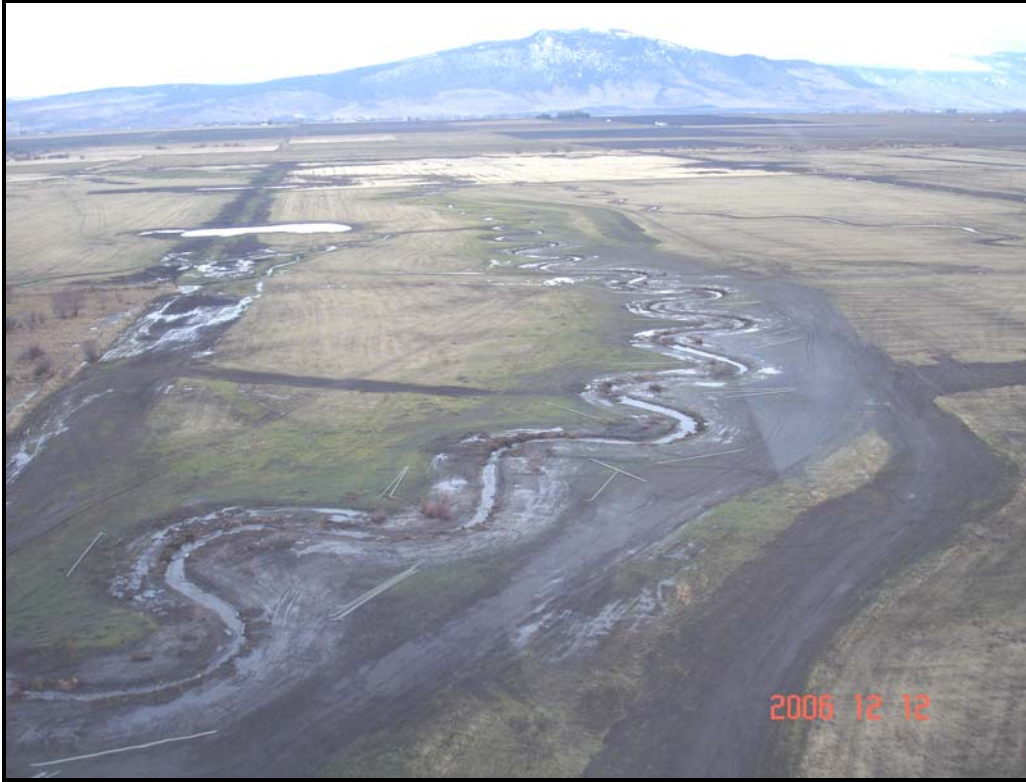
*Upstream reach of End Creek (Rice) Restoration Channel, viewing east (downstream) towards South Fork Willow Creek confluence. Note reclaimed channelized reach in left corner of photo and floodplain ponds incorporated into reclamation plan*
