THE CATHERINE CREEK TRIBUTARY
ASSESSMENT
GRANDE RONDE RIVER BASIN
Tributary Habitat Program, Oregon

U.S. Department of the Interior
Bureau of Reclamation
Pacific Northwest Region
Boise, Idaho

February 2012

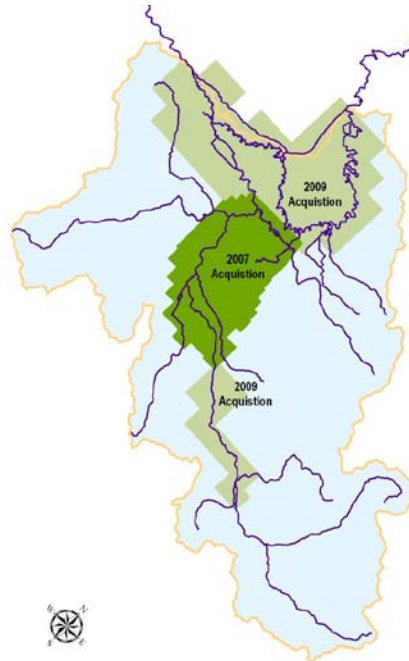
Figure 3. Catherine Creek floodplain and river corridor aerial photo and LiDAR data set collection areas including year of acquisition.

1. **Aerial Photography (historic and current)** – High-resolution (1-foot ground resolution) true-color orthophotographs were obtained through airborne data acquisition in 2007. The 2007 imagery covered the middle of the Catherine Creek river corridor and floodplain (Figure 3). Additional orthophotography for upper Catherine Creek, lower Catherine Creek, and the Grande Ronde River was acquired in 2009. This imagery provides a record of current land use and location of the present-day stream channel.

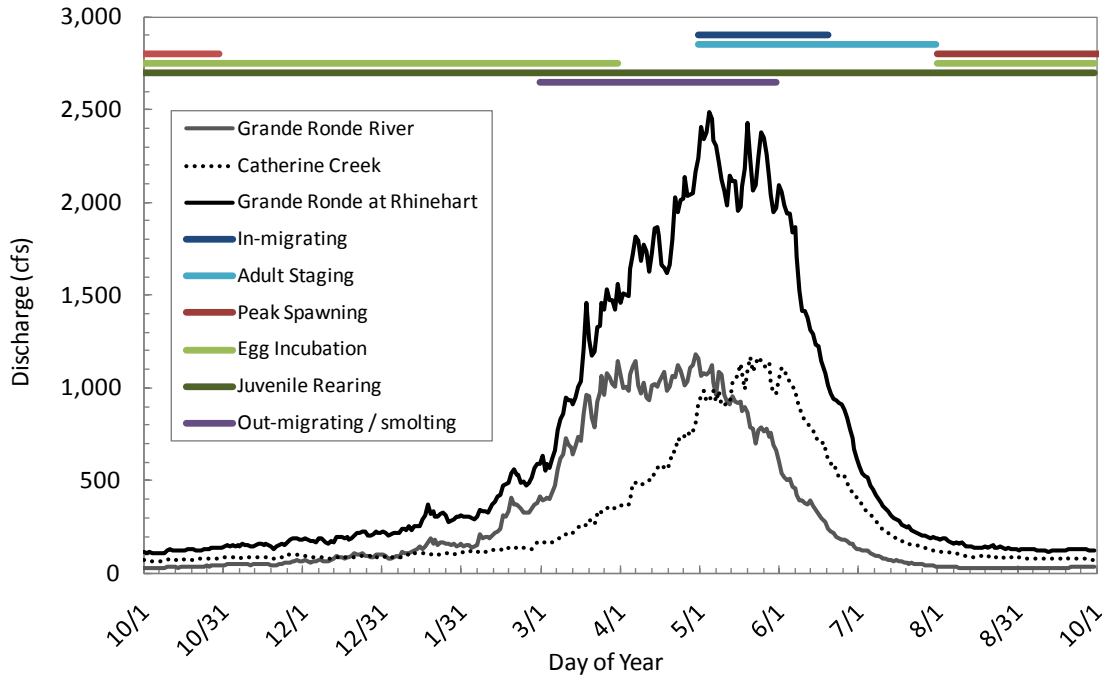
Figure 7. Average annual hydrograph for Catherine Creek near Union, Oregon (RM 46.7) and combined annual hydrographs for Grande Ronde River near Perry, Oregon and Grande Ronde River at La Grande, Oregon stream gages displaying present-day spring Chinook salmon life stages. The shaded area represents the approximate irrigation season during an average year.

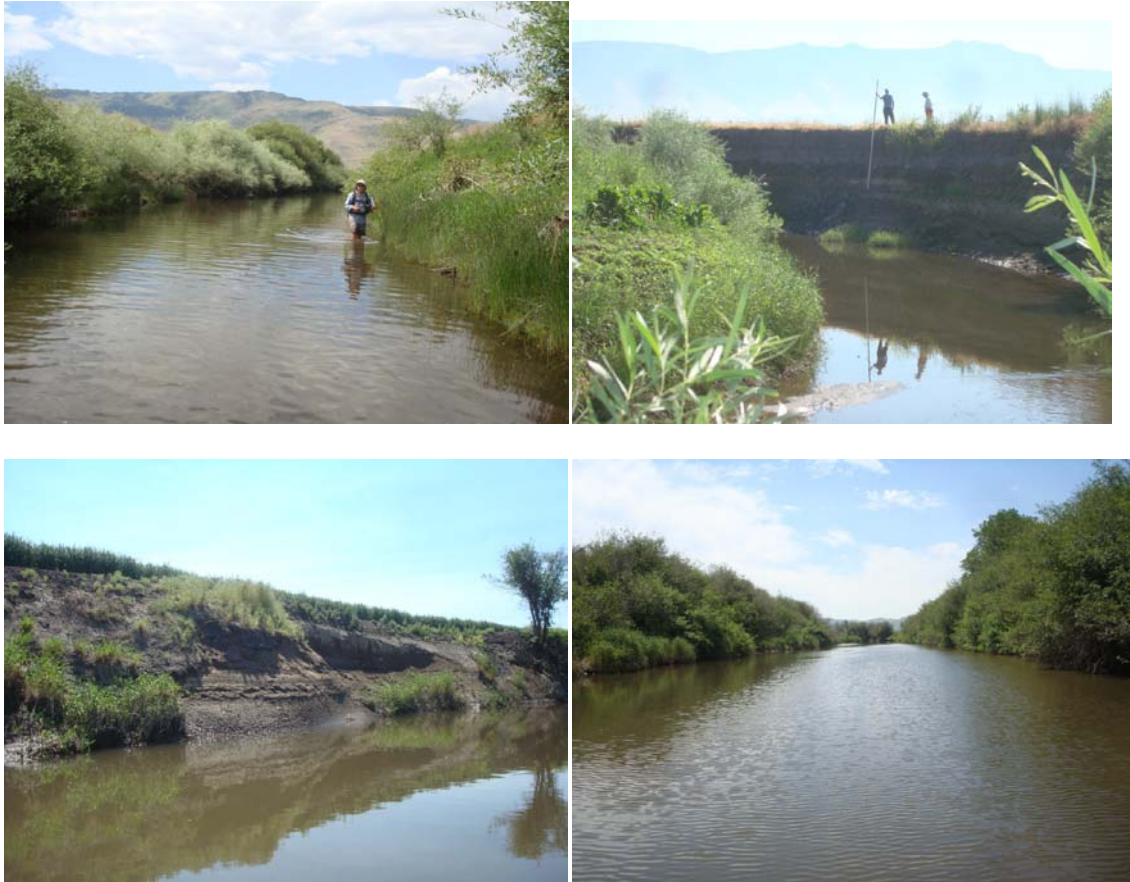
Figure 18. Typical streambank conditions and vegetation in the valley floor segment – Catherine Creek, Grande Ronde Subbasin (Reclamation photograph by D. Stelma – July 2010).

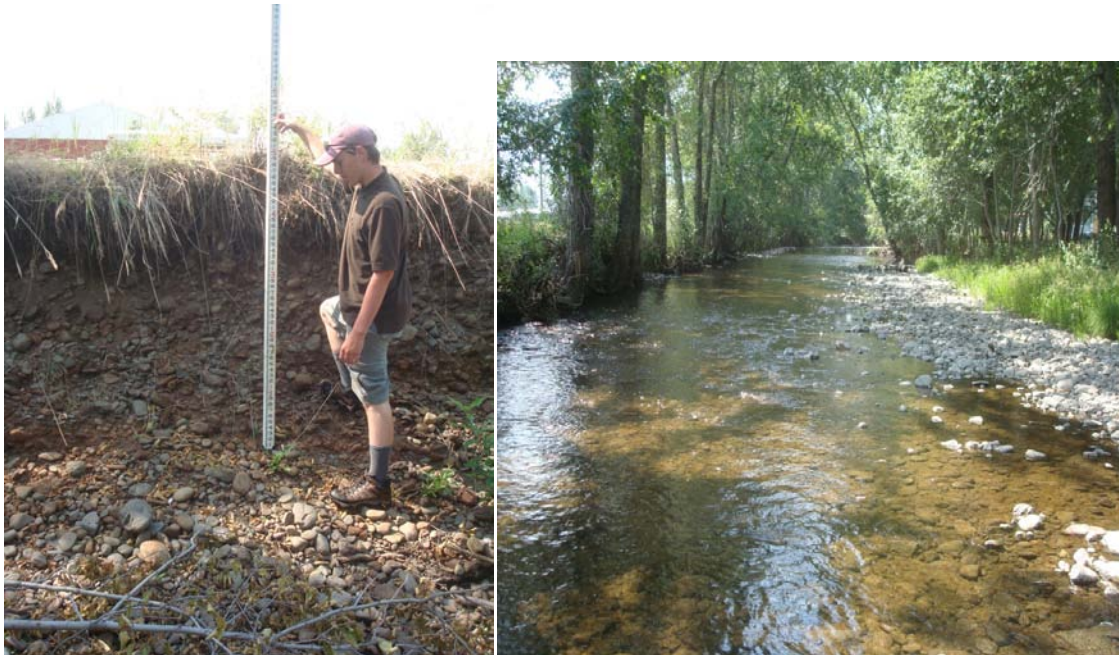
Figure 20. Typical bank conditions, vegetation, and substrate in reach 3 – Catherine Creek, Grande Ronde Subbasin. Subbasin (Reclamation photograph by D. Stelma – August 2010).

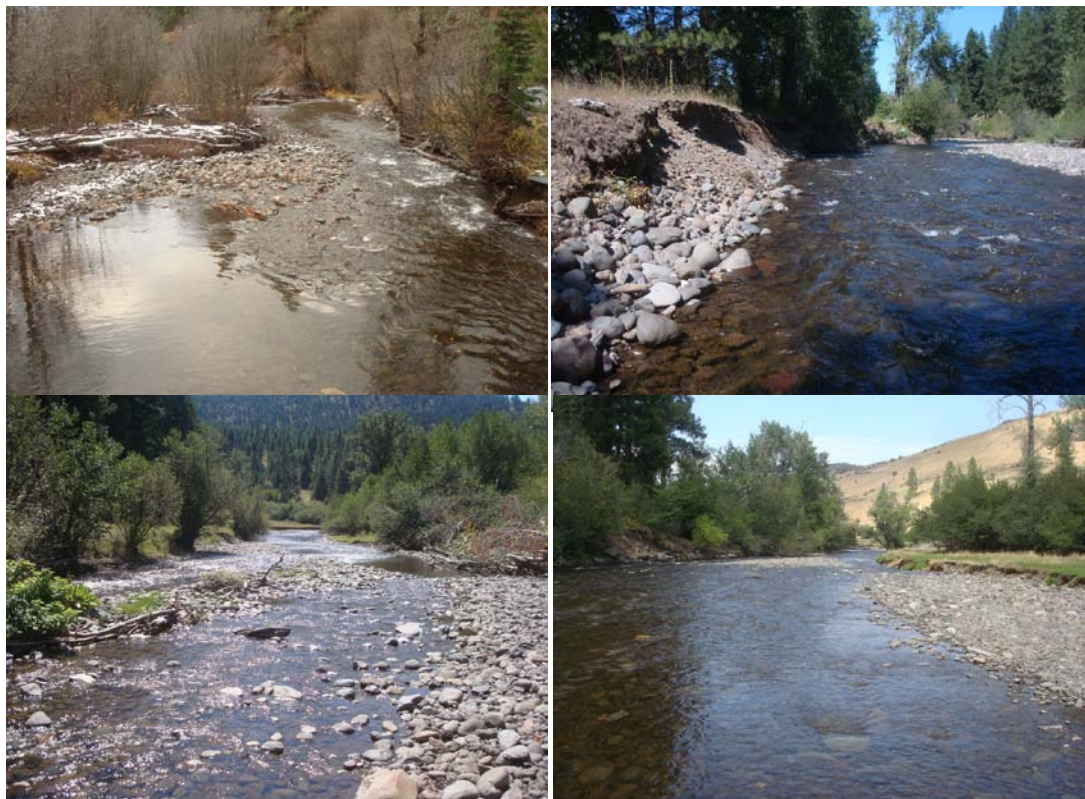
Figure 21. Typical bank conditions, vegetation, and substrate in the upper valley reach – Catherine Creek, Grande Ronde Subbasin. (Reclamation photographs by D. Stelma – August and November, 2010).

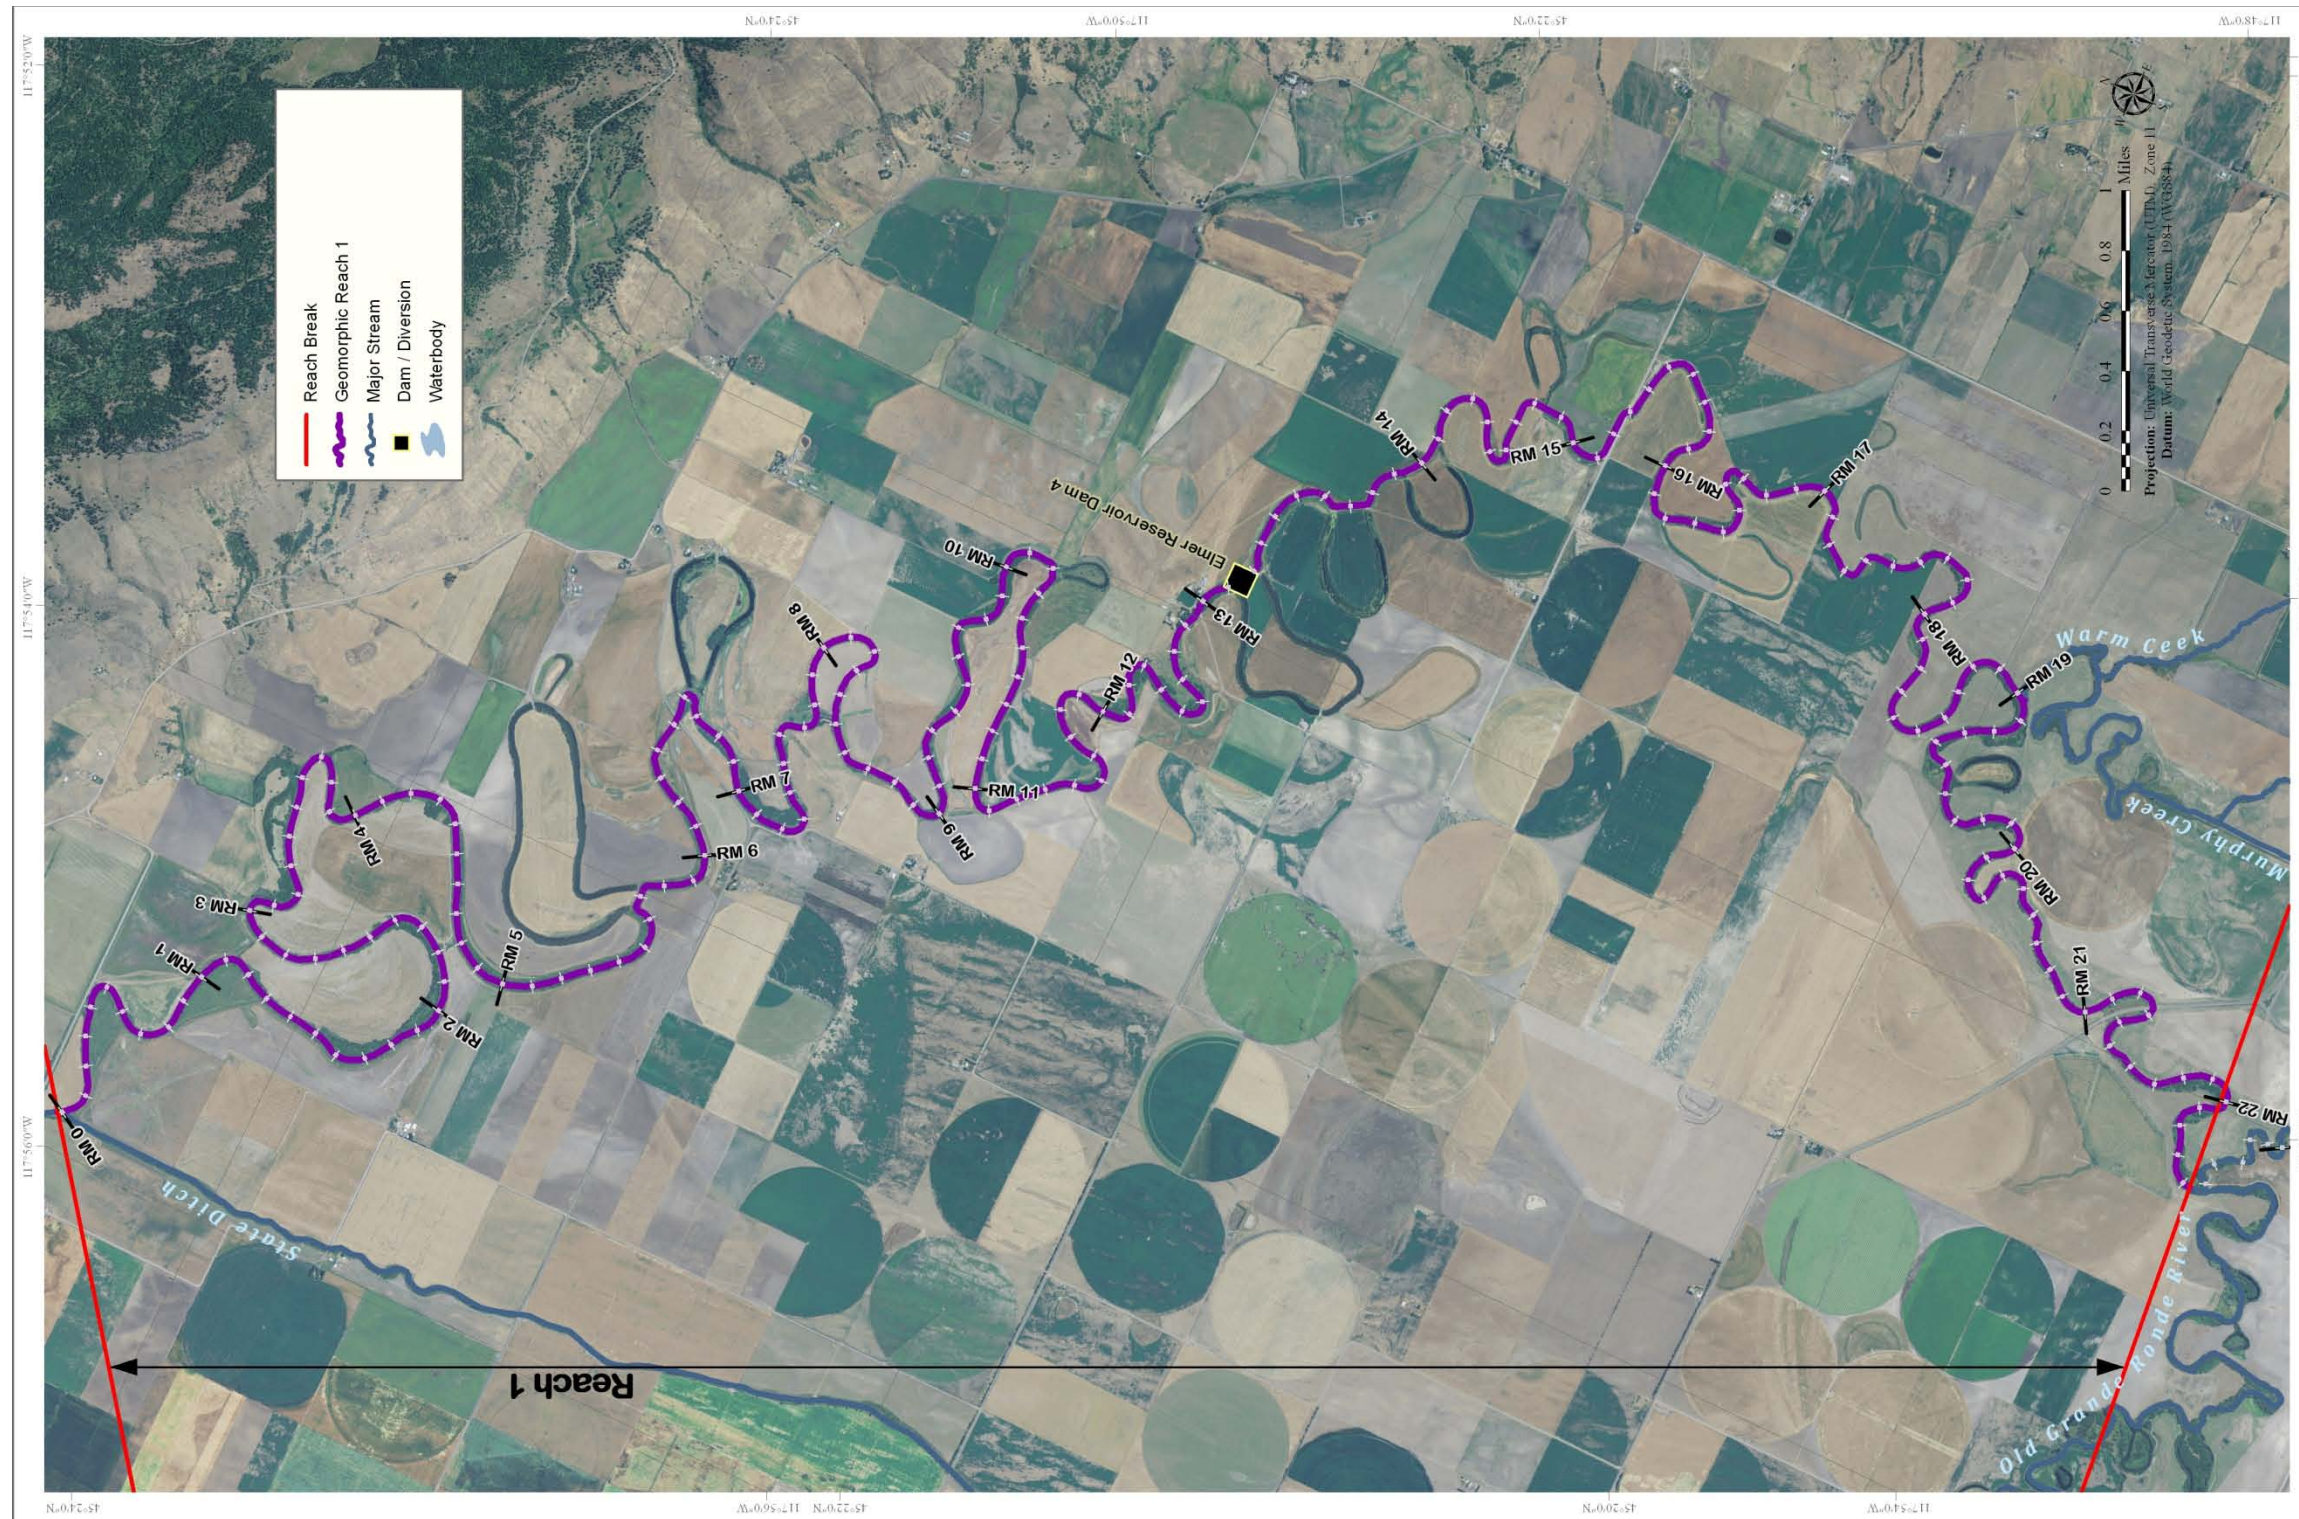
Figure 22. Reach 1, bounded by the historic Grande Ronde River confluence upstream and the current confluence downstream. The active channel is shown and many lakes can be seen throughout the reach.

Reach 1 is located in the lower Grande Ronde Valley and flows into the Grande Ronde River at the confluence with State Ditch (Figure 22). This reach was historically the Grande Ronde River but the construction of State Ditch, which began in 1869, resulted in the eventual capture of the entire Grande Ronde River flow (Flow Technologies 1997; Gildemeister 1998). The Grande Ronde River now flows through the State Ditch and only Catherine Creek flows through the former Grande Ronde River channel in this reach. Reach 1 is characterized by fine and highly productive soils. This reach is atypical of most inner Columbia River Basin mountain stream reaches, as its gradient is nearly flat at 0.04 percent slope. The gradient is geologically controlled downstream by Rhinehart Gap. It is a single-thread meandering reach located within a broad valley. Disconnected

Reach 1 (Figure 22) extends from the current confluence with the Grande Ronde River upstream to the historic confluence with the Grande Ronde River. Prior to construction of State Ditch, this 22.5-mile-long reach contained both Catherine Creek and the Grande Ronde River but it now only contains the discharge from Catherine Creek. Historic accounts, which indicate that this part of Catherine Creek would have been classified as a wetland complex throughout much of the floodplain, are supported by geomorphology, hydrology, valley controls, substrate, and evidence of a highly sinuous channel (Figure 23). Historic data is minimal, but the few historic descriptions that do exist indicate a wet environment with abundant beaver, seasonal and extended flooding, and an array of wetlands and their associated habitats throughout the valley, which would have likely been complex and diverse salmonid habitat.

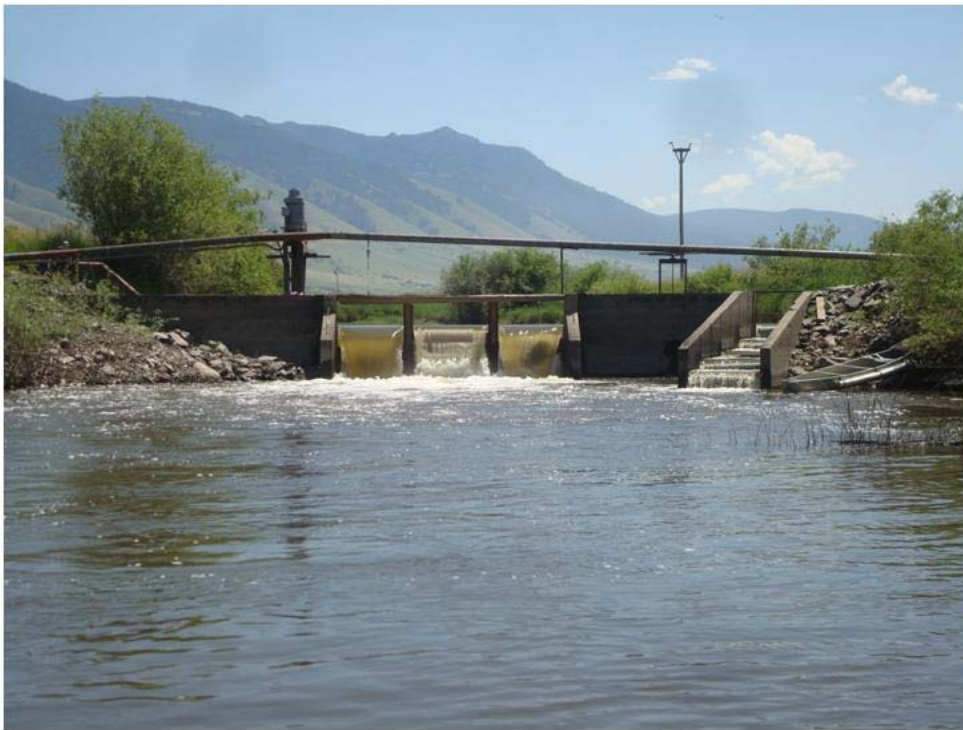
Figure 25. View looking upstream at Elmer Dam located at RM 13.1 used for irrigation water storage and diversion – Catherine Creek, Grande Ronde Subbasin. (Reclamation photograph by D. Stelma – July 9, 2010).

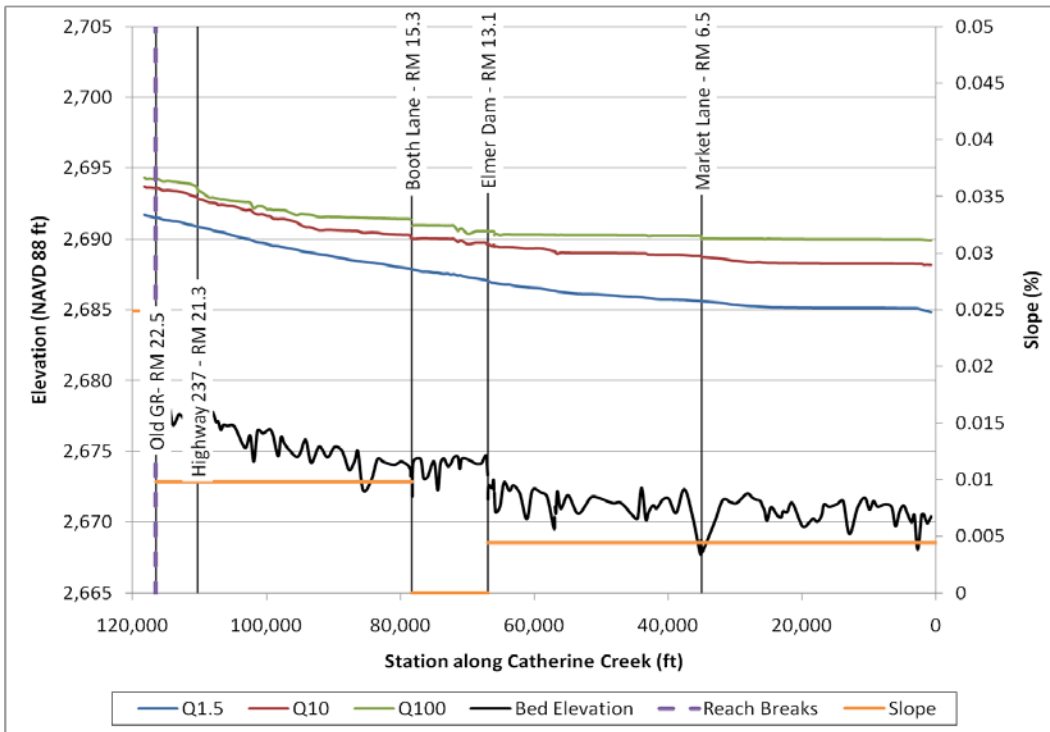
Figure 26. Computed water surface elevations along on Catherine Creek (Appendix D).

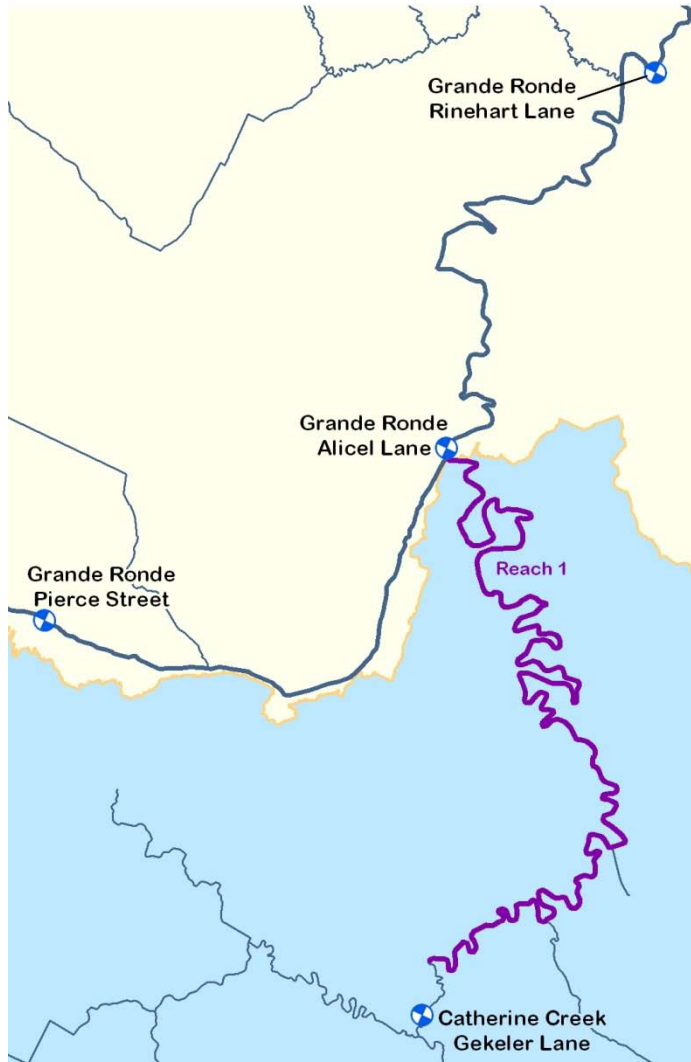
Figure 30. Stream gages located in or near reach 1.

2010 near this reach along the Grande Ronde River at Rhinehart Road Bridge, Alicel Road Bridge, and Pierce Road Bridge and along Catherine Creek at Gekeler Road (RM 24.7) (Figure 30). Each gage measures stage and temperature on an hourly basis. Initial data analysis was beyond the scope of this assessment, but will be used to further refine understanding of hydrology, groundwater influences, and hydraulics and will be included in any future assessment of this area.

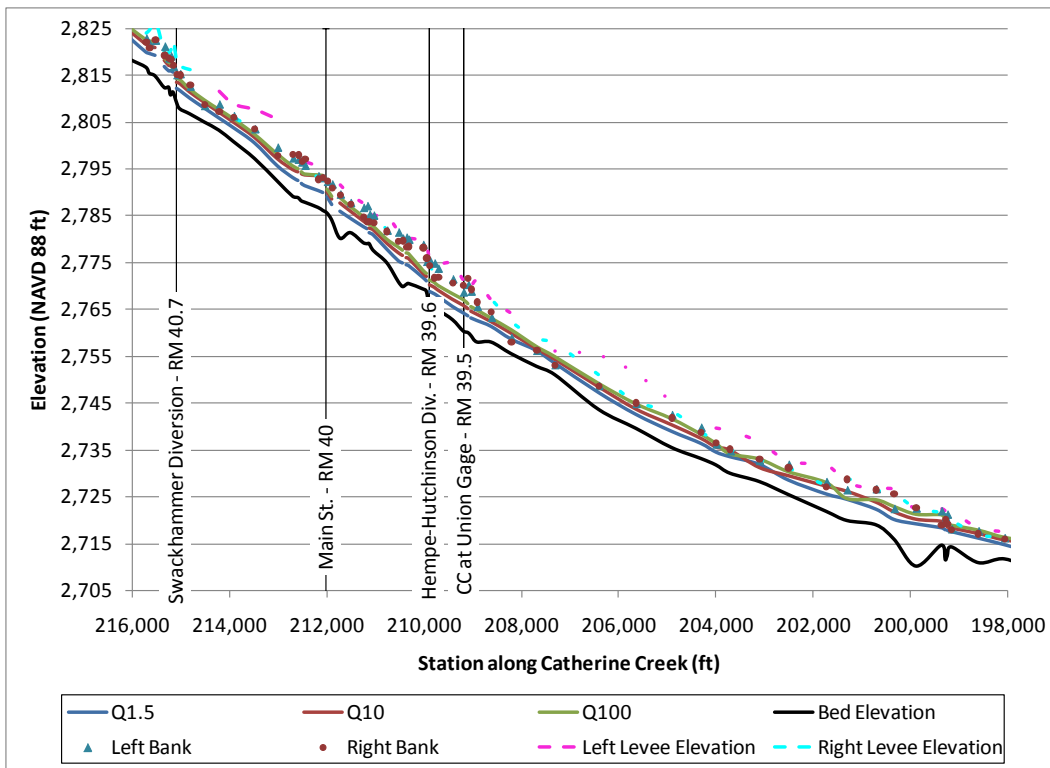
Figure 43. Reach 3 water surface profiles and levee elevations (Appendix D).

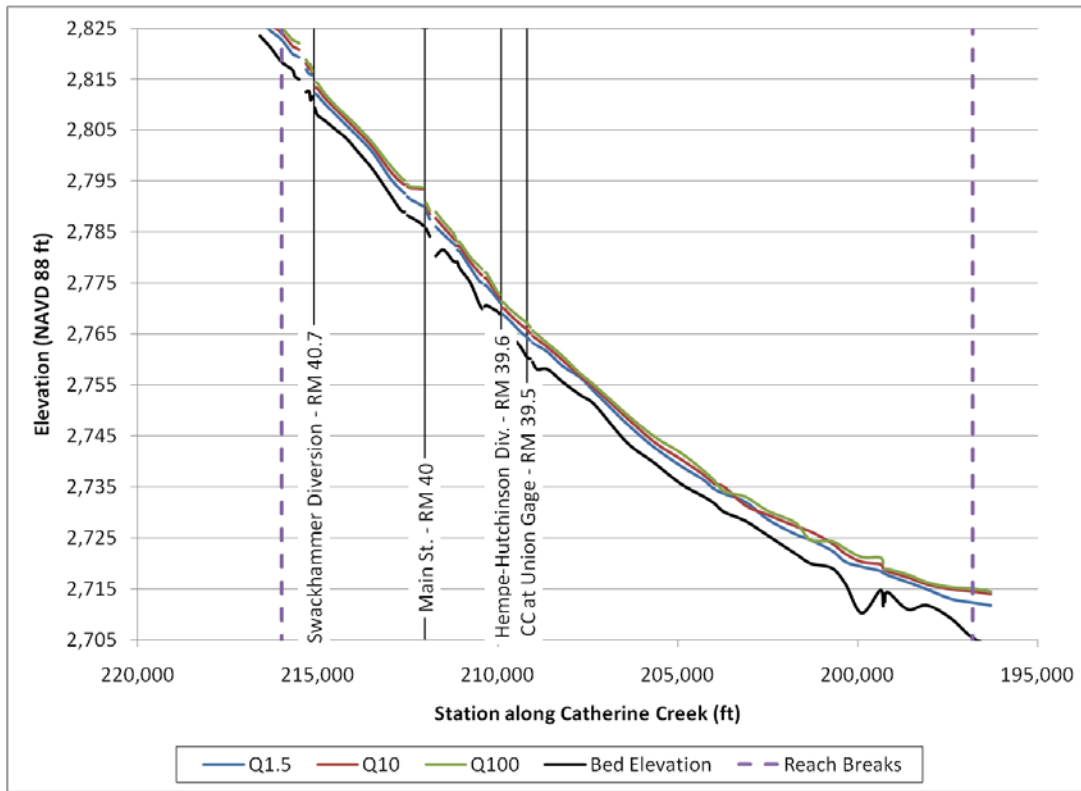
Figure 44. Computed water surface elevation for reach 3 of Catherine Creek (Appendix D).

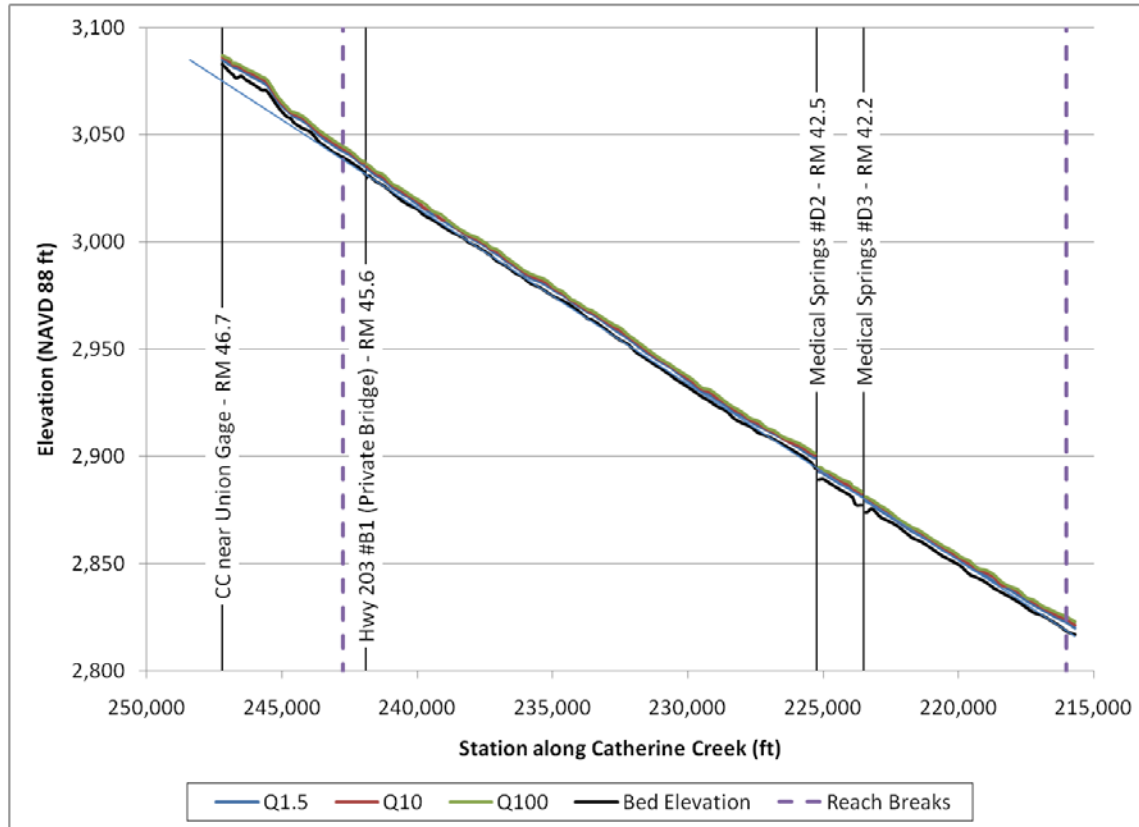
Figure 53. Computed water surface elevations along reach 4 (Appendix D). Medical Springs #2 is more commonly known as the Catherine Creek Adult Collection Facility (CCACF) and Medical Springs #3 is more commonly known as State Diversion.

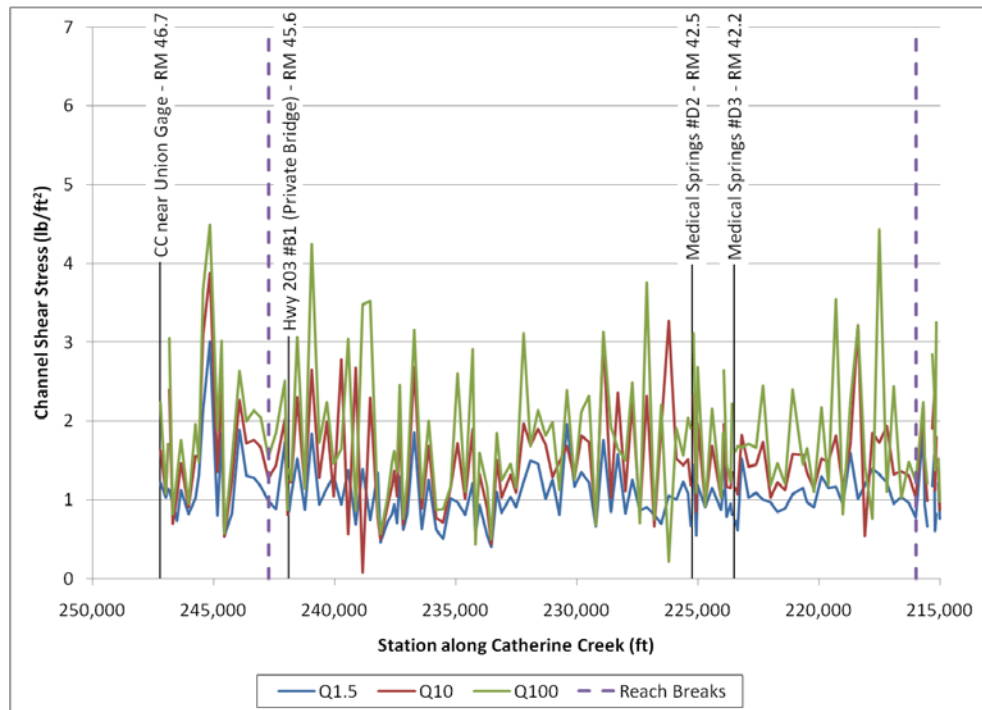
Figure 55. Channel shear stress in reach 4 on Catherine Creek (Appendix D). Medical Springs #2 is more commonly known as the CCACF and Medical Springs #3 is more commonly known as State Diversion.
