APPENDIX A – HYDROLOGY

HYDROLOGY REPORT
CATHERINE CREEK TRIBUTARY ASSESSMENT –
GRANDE RONDE RIVER BASIN
Tributary Habitat Program, Oregon

U.S. Department of the Interior
Bureau of Reclamation
Pacific Northwest Region
Geology and Fluvial Analysis Group
Boise, Idaho

February 2012

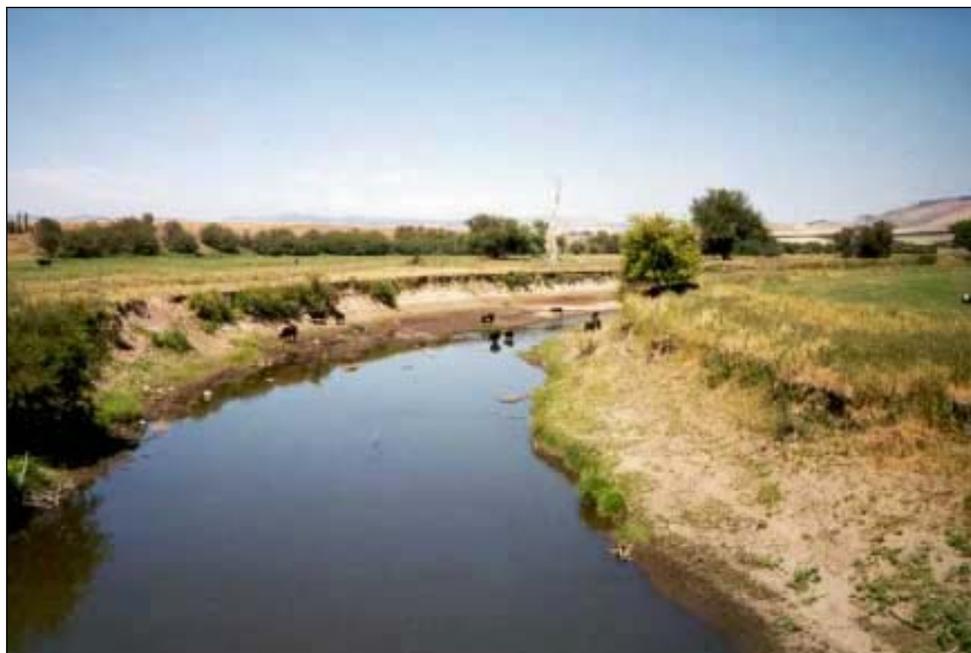
Figure 24. Grande Ronde River downstream of the Catherine Creek confluence, August 1999. (ODEQ 2000)

Riparian vegetation is especially sparse and provides little shade cover in lower Catherine Creek (Favrot et al. 2010). Low shade levels result from a combination of lack of streambank vegetation and/or wide stream channels (ODEQ 2000). Often, low shade levels result from lack of tall streambank vegetation. In many areas that do have tall streambank vegetation but low shade levels, channel widths are too great to effectively shade. Temperature monitoring of stream reaches on Catherine Creek within riparian fencing projects demonstrated that the improved vegetation vigor and density reduced thermal loading of the stream, which suggested a correlation of stream temperature to riparian vegetation's ability to shade the stream (Miles nd).

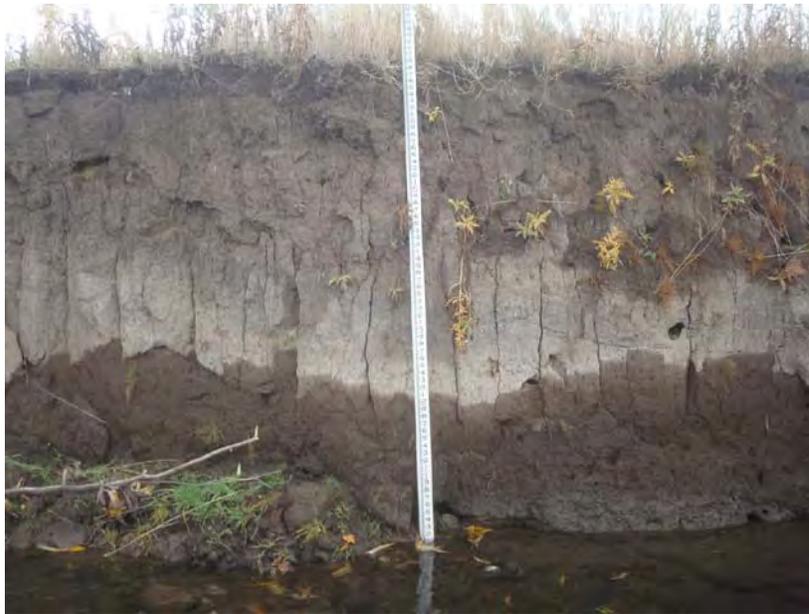
Figure 4. View of loess (L) exposure on the outside bank of a meander bend along Catherine Creek at river mile (RM) 37.25. Catherine Creek Tributary Assessment-Grande Ronde River Basin-Tributary Habitat Program, Oregon – Bureau of Reclamation – November 10, 2010.

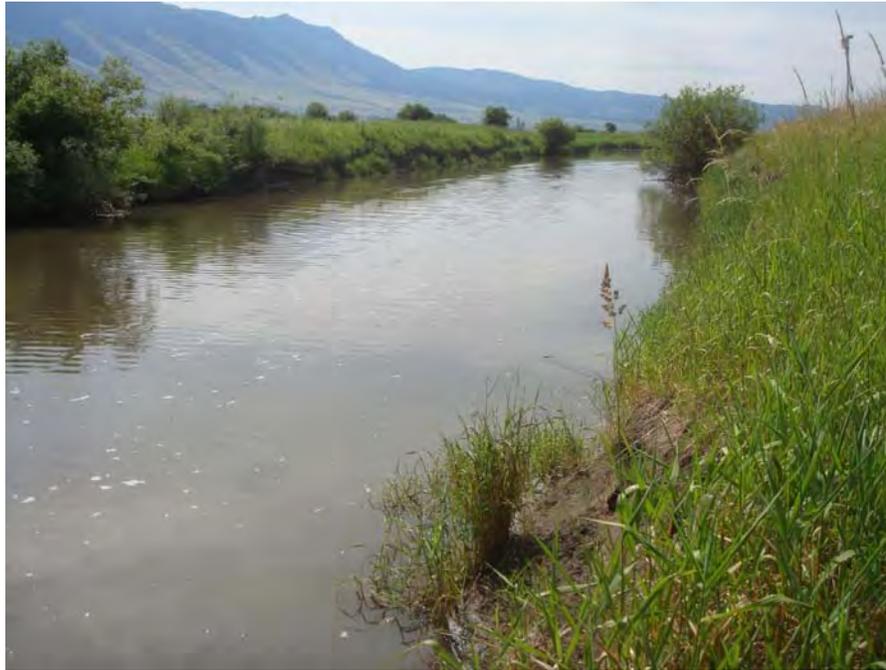
Figure 5. View looking upstream at typical section of Catherine Creek, upstream of Elmer Dam at RM 13.60. Catherine Creek Tributary Assessment-Grande Ronde River Basin-Tributary Habitat Program, Oregon – Bureau of Reclamation – July 10, 2010.

The active alluvium (Qa) in the artificial backwater sections of Catherine Creek (behind Elmer and Davis dams) is submerged (Figure 5) and difficult to observe. However, based on samples from the lower banks, the overall soft texture of the submerged bed, and low gradient of the reach, it is likely the active alluvium consists primarily of fines, including silt, elastic silt, fine sand and clay, derived from sorted upland sediments, and reworked and redeposited valley plain fluviolacustrine and loess sediments (Qa1) eroded from the banks.

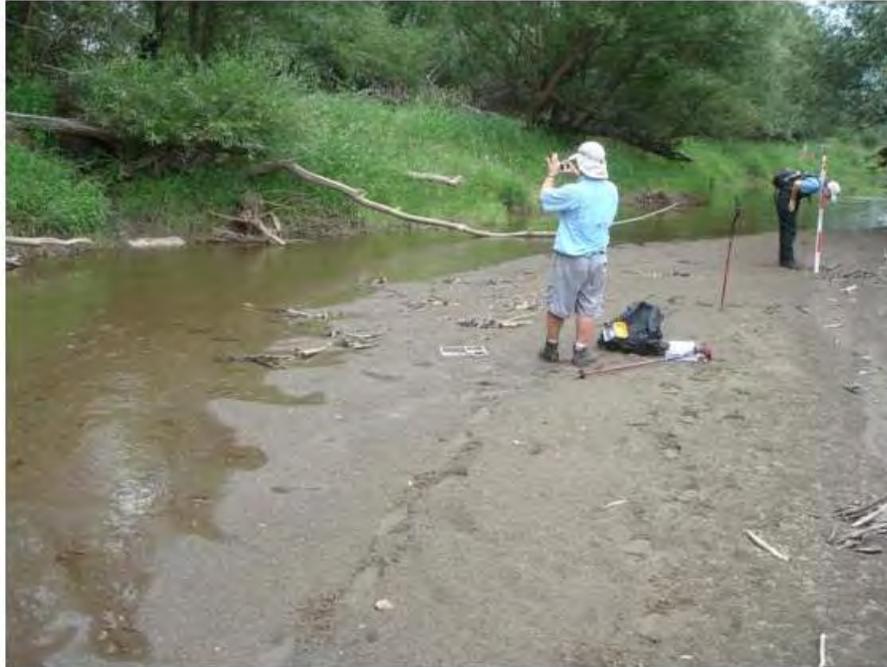
Figure 6. View looking downstream at active alluvium (Qa) deposits in a sand bar along Catherine Creek at RM 30.89. Catherine Creek Tributary Assessment-Grande Ronde River Basin-Tributary Habitat Program, Oregon – Bureau of Reclamation- July 28, 2010.

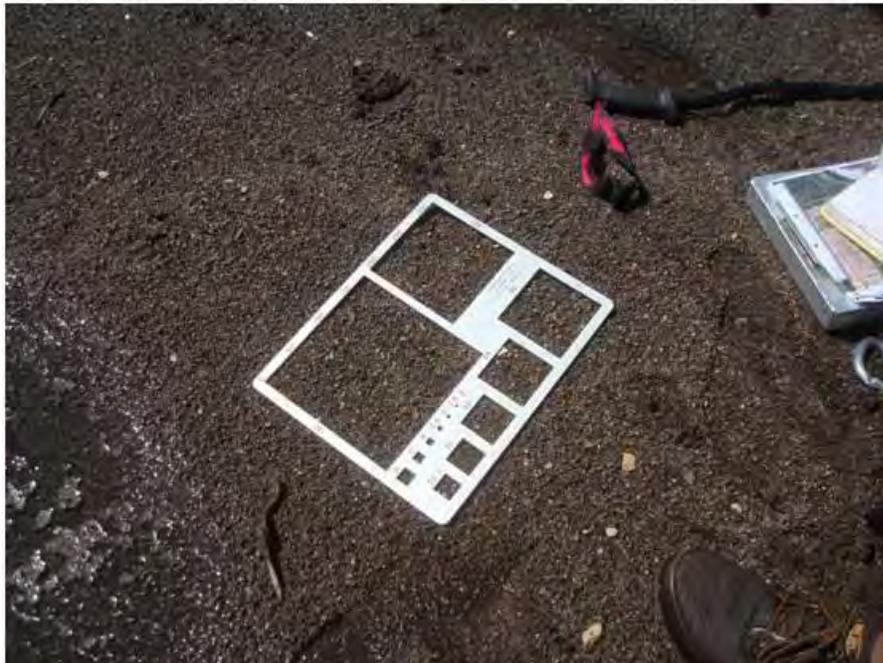
Figure 7. Close up view of active alluvium (Qa) deposit consisting of medium sand (2 mm) sized fragments, Catherine Creek at RM 31.40. Catherine Creek Tributary Assessment-Grande Ronde River Basin-Tributary Habitat Program, Oregon – Bureau of Reclamation - July 28, 2010.

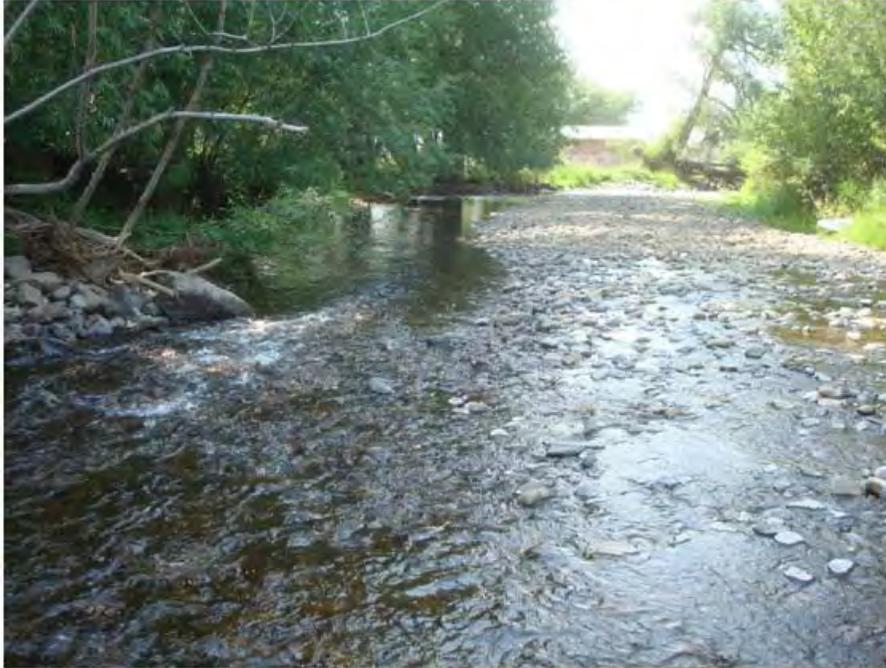
Figure 8. View looking downstream at active alluvium (Qa) deposit forming riffles along the bed of Catherine Creek at RM 39.10. Catherine Creek Tributary Assessment-Grande Ronde River Basin-Tributary Habitat Program, Oregon – Bureau of Reclamation – August 2, 2010.

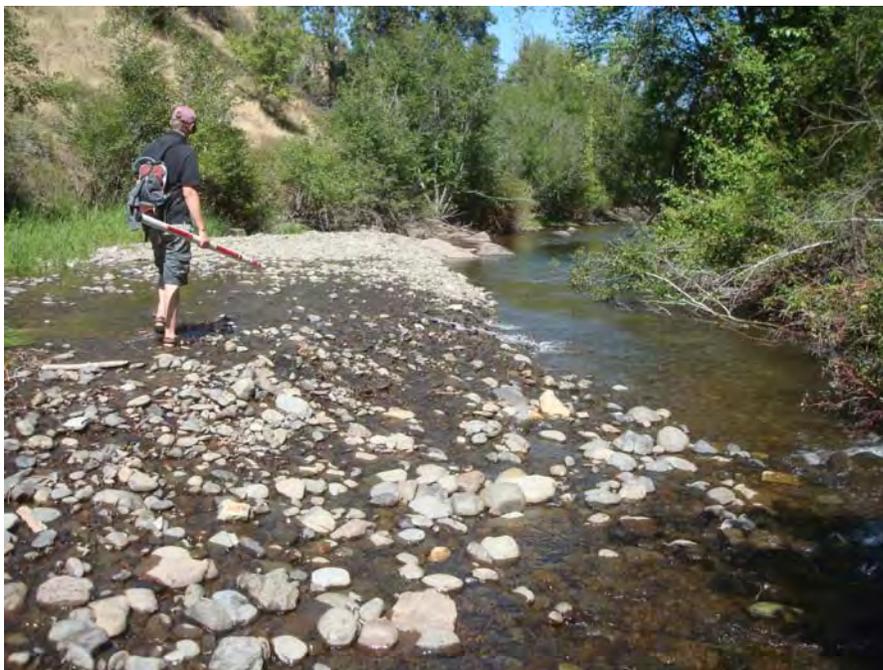
Figure 9. View looking downstream at active alluvium (Qa) deposit forming a gravel and cobble bar along the bed of Catherine Creek at RM 41.65. Catherine Creek Tributary Assessment-Grande Ronde River Basin-Tributary Habitat Program, Oregon – Bureau of Reclamation – August 16, 2010.

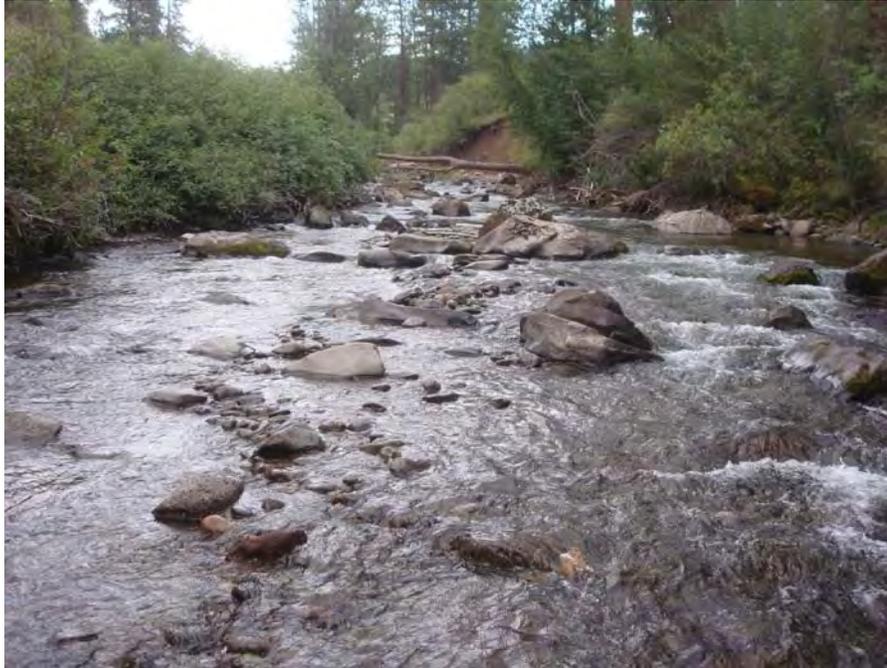
Figure 10. View looking upstream at active alluvium (Qa) deposits along the bed of Catherine Creek at RM 46.20. Catherine Creek Tributary Assessment-Grande Ronde River Basin-Tributary Habitat Program, Oregon – Bureau of Reclamation – August 18, 2010.

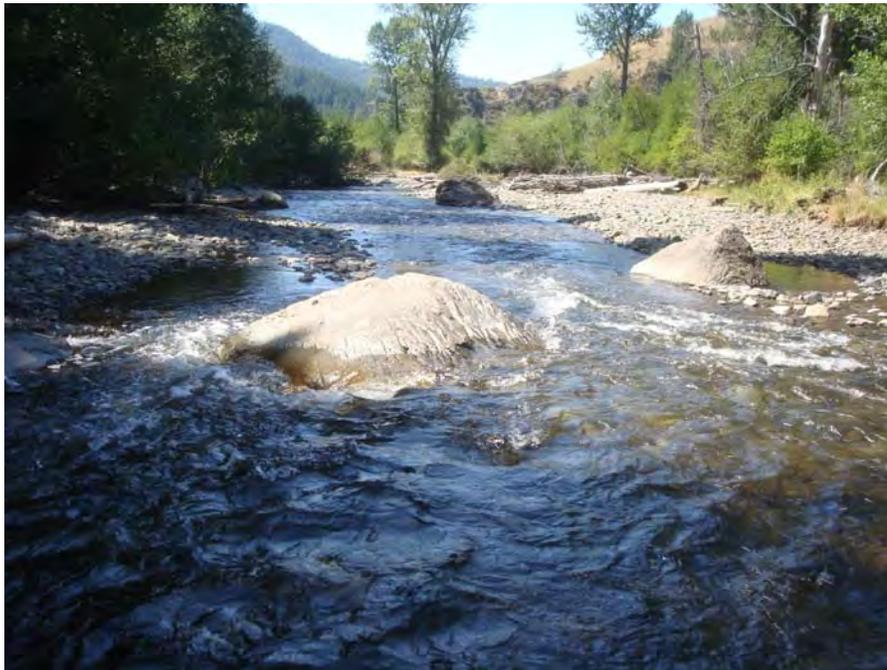
Figure 11. View looking downstream at active alluvium (Qa) deposits along the bed of Catherine Creek at RM 48.45 (near Catherine Creek State Park). Catherine Creek Tributary Assessment-Grande Ronde River Basin-Tributary Habitat Program, Oregon – Bureau of Reclamation – August 17, 2010.

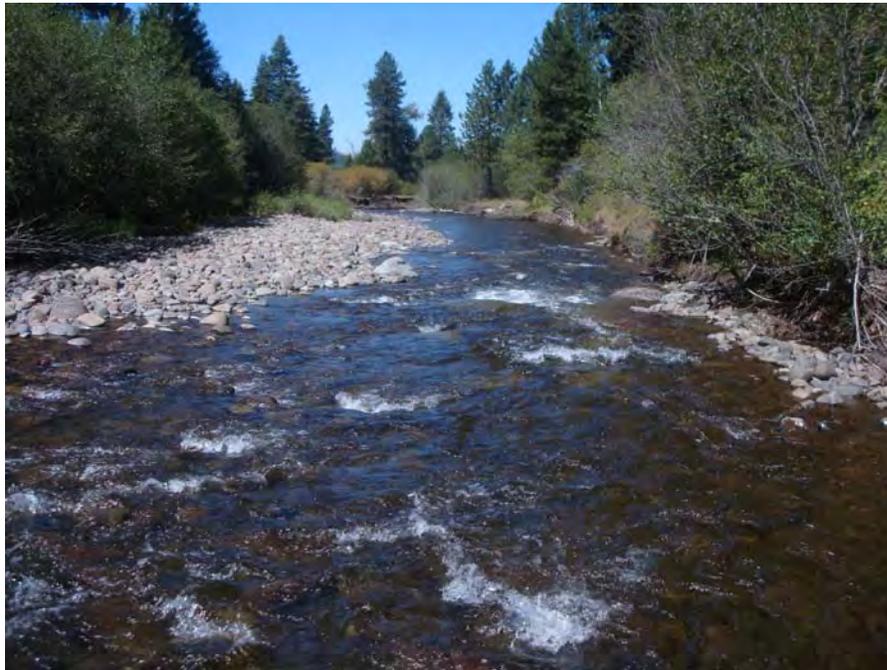
Figure 12. View looking downstream at active alluvium (Qa) deposits along the bed of Catherine Creek RM 51.40. Catherine Creek Tributary Assessment-Grande Ronde River Basin-Tributary Habitat Program, Oregon – Bureau of Reclamation – August 19, 2010.

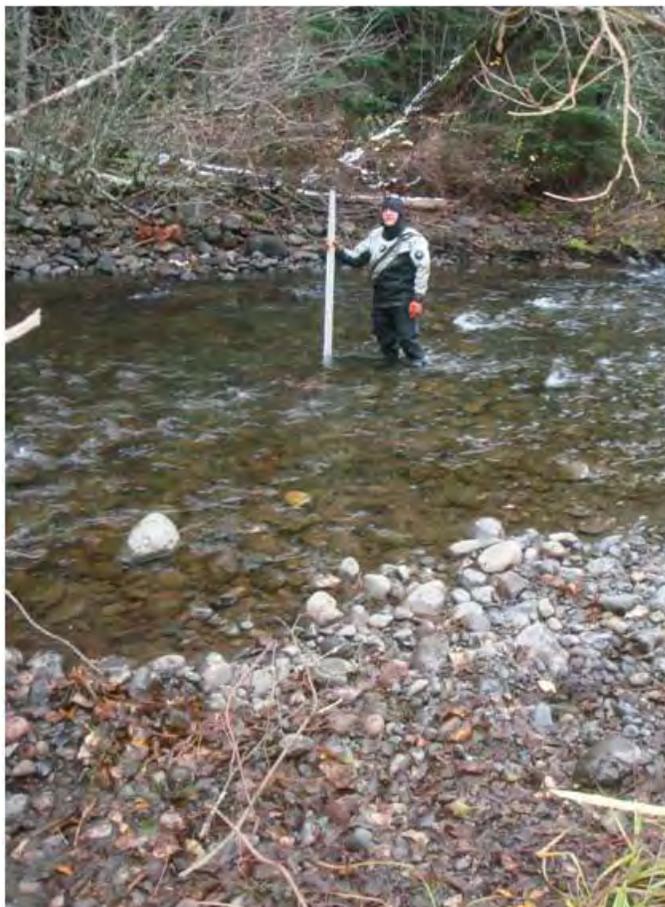
Figure 13. View looking from right to left at the active alluvium (Qa) forming the bed of Catherine Creek at RM 52.30. Catherine Creek Tributary Assessment-Grande Ronde River Basin-Tributary Habitat Program, Oregon – Bureau of Reclamation - November 10, 2010.

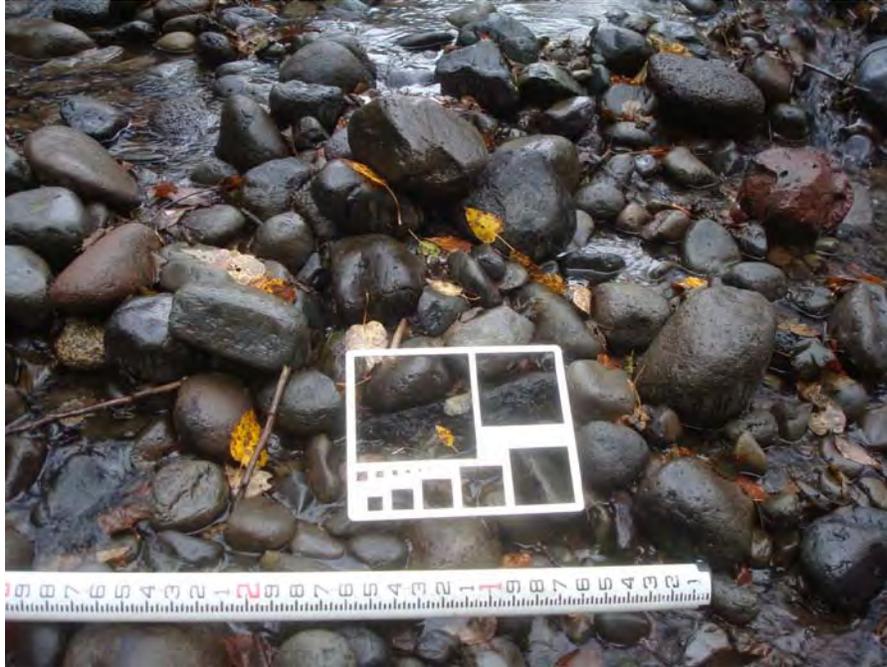
Figure 14. Close up view of active alluvium (Qa) deposit consisting of cobble (3- to 12-inch) size rocks, Catherine Creek at RM 54.86. Catherine Creek Tributary Assessment-Grande Ronde River Basin-Tributary Habitat Program, Oregon – Bureau of Reclamation – November 10, 2010.

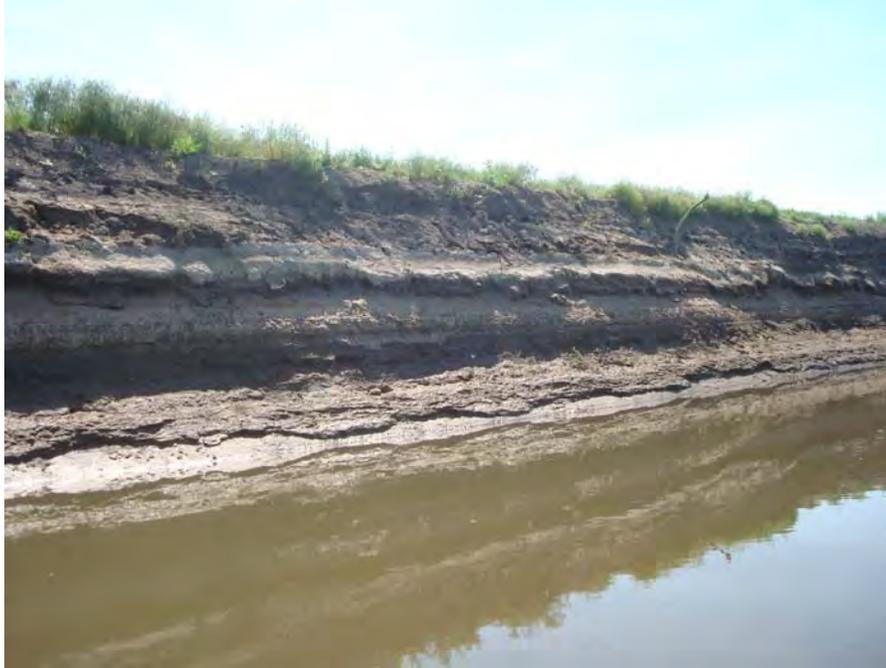
Figure 15. View looking upstream at fine-grained fluviolacustrine sediments (Qal1) exposed along the left bank of Catherine Creek at RM 21.28. Catherine Creek Tributary Assessment-Grande Ronde River Basin-Tributary Habitat Program, Oregon – Bureau of Reclamation – July 11, 2010.

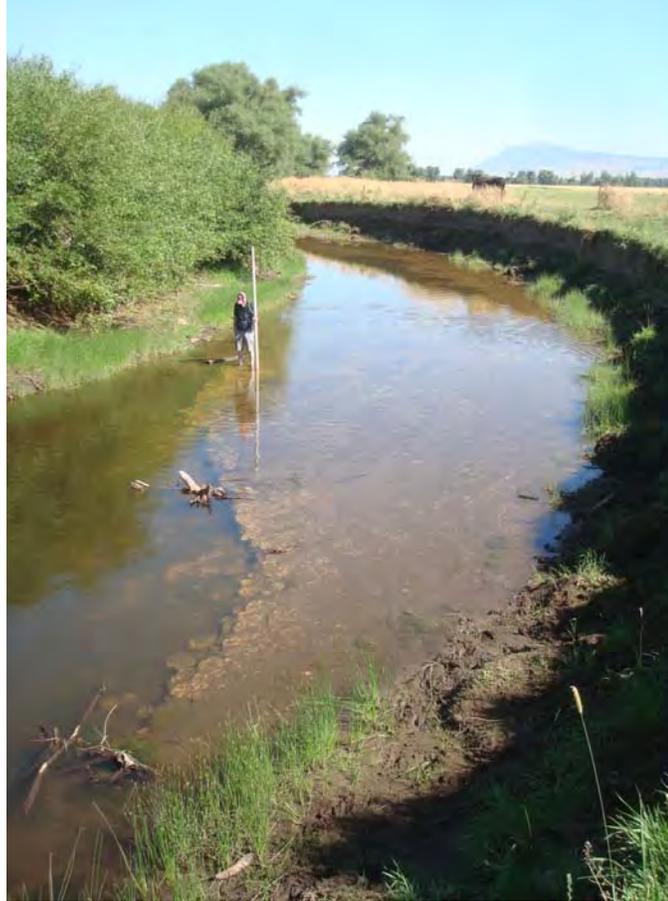
Figure 16. View looking downstream at fine-grained fluviolacustrine sediments (Qa1) forming the bed of Catherine Creek at RM 32.85. Catherine Creek Tributary Assessment-Grande Ronde River Basin-Tributary Habitat Program, Oregon – Bureau of Reclamation – August 1, 2010.

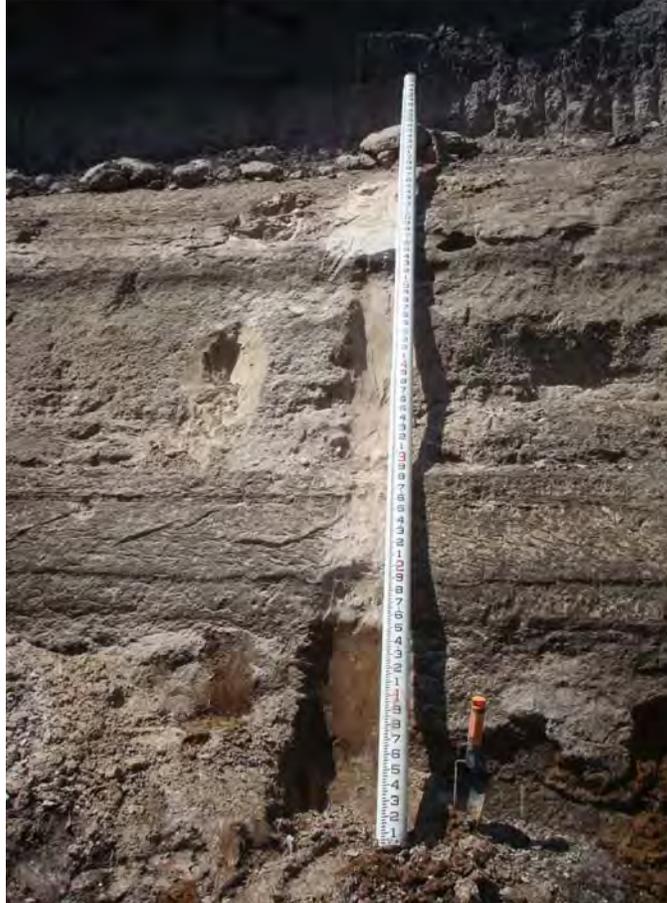
Figure 17. Close up of stratified fine-grained fluviolacustrine sediments (Qal1) exposed on the bank of Catherine Creek at RM 22.70, material consists of brown silty sand (SM) overlain by firm to hard light colored sandy silt and diatomaceous silt. Catherine Creek TA-Grande Ronde River Basin-Tributary Habitat Program, Oregon – Bureau of Reclamation – July 30, 2010.

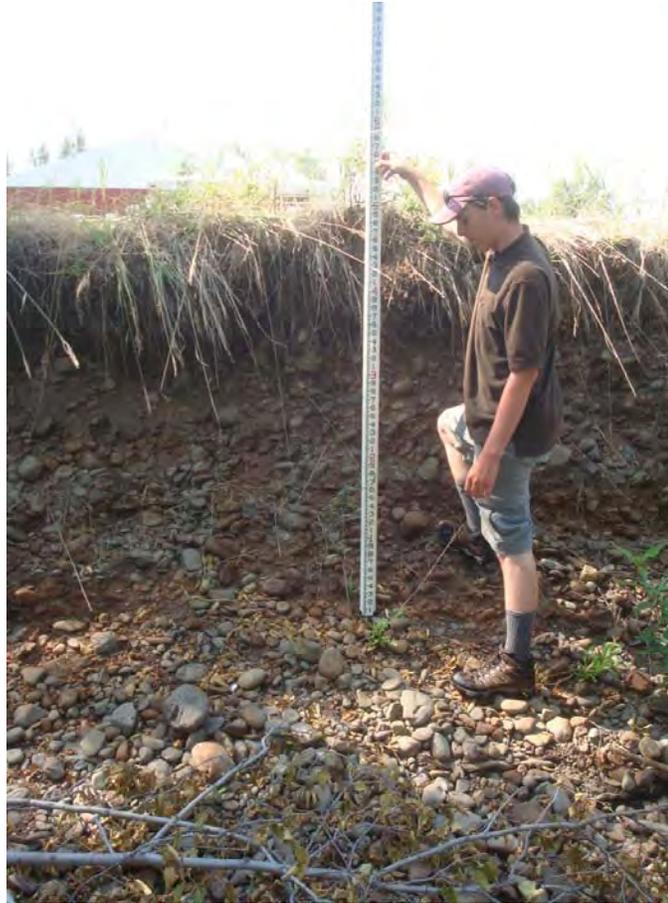
Figure 18. View of alluvial fan-delta deposits (Qfd) exposed along the left bank of Catherine Creek river mile 40.33 (union). Catherine Creek Tributary Assessment-Grande Ronde River Basin-Tributary Habitat Program, Oregon – Bureau of Reclamation - August 2, 2010.

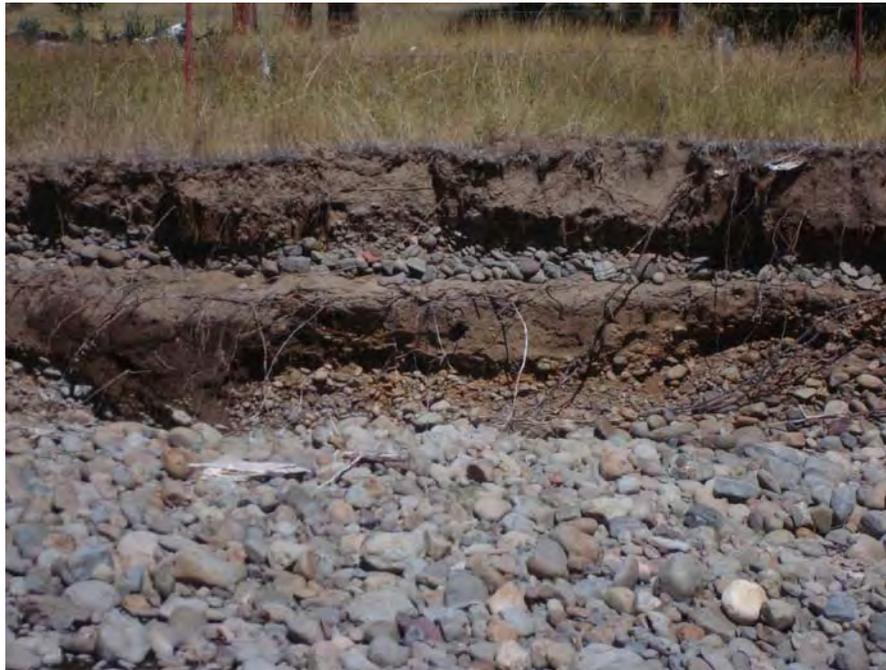
Figure 19. View of fluvial sediments interbedded with silty sand (Qal2) exposed along the right bank of Catherine Creek at river mile 51.02. Catherine Creek Tributary Assessment-Grande Ronde River Basin-Tributary Habitat Program, Oregon – Bureau of Reclamation - August 19, 2010.

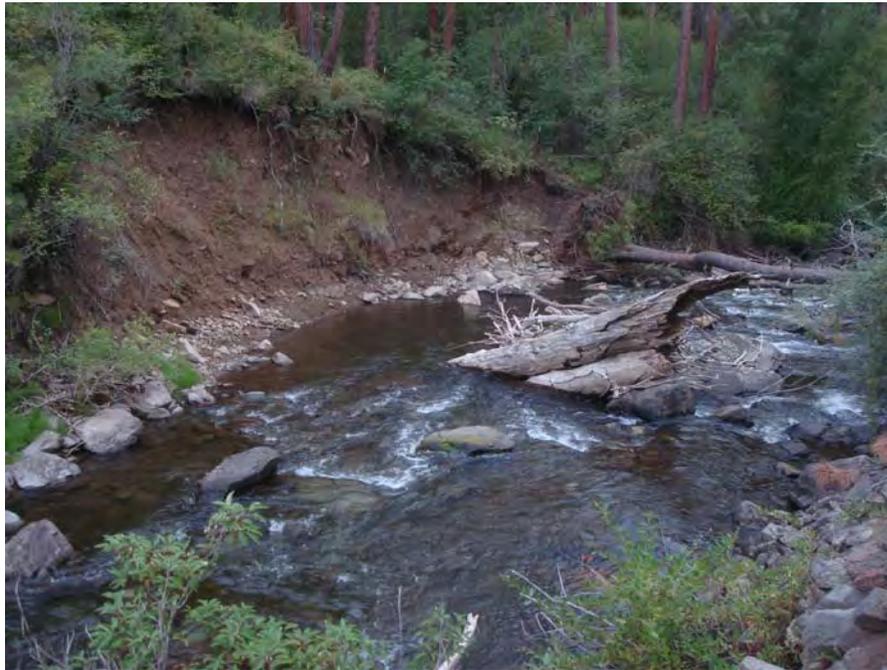
Figure 20. View looking downstream along a section where the left bank of Catherine Creek is comprised of landslide debris (Qls) near river mile 46.21. Catherine Creek Tributary Assessment-Grande Ronde River Basin-Tributary Habitat Program, Oregon – Bureau of Reclamation - August 18, 2010.

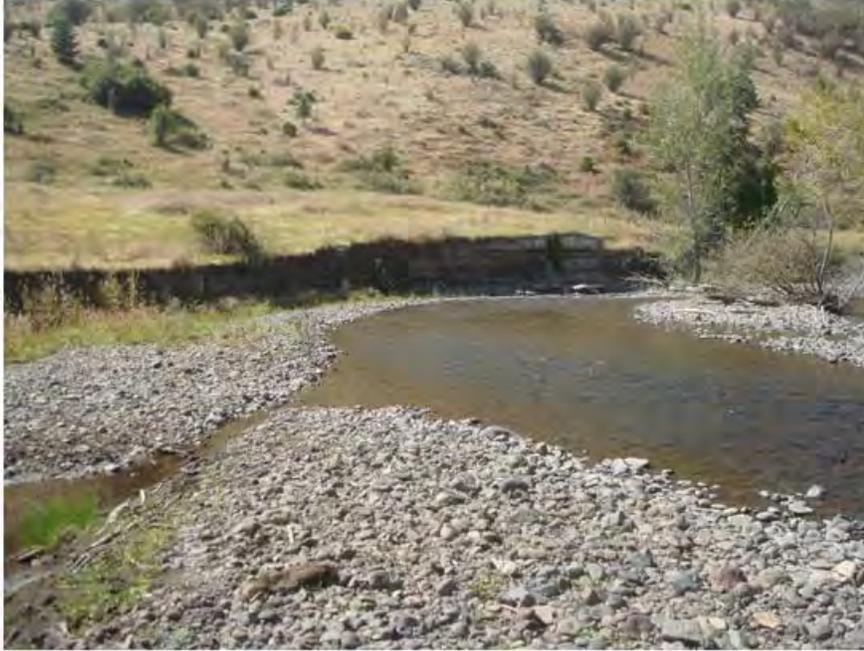
Figure 21. View looking downstream at colluvium (Qc) forming the left (south) bank of Catherine Creek near river mile 44.00. Catherine Creek Tributary Assessment-Grande Ronde River Basin-Tributary Habitat Program, Oregon – Bureau of Reclamation – September 9, 2011.

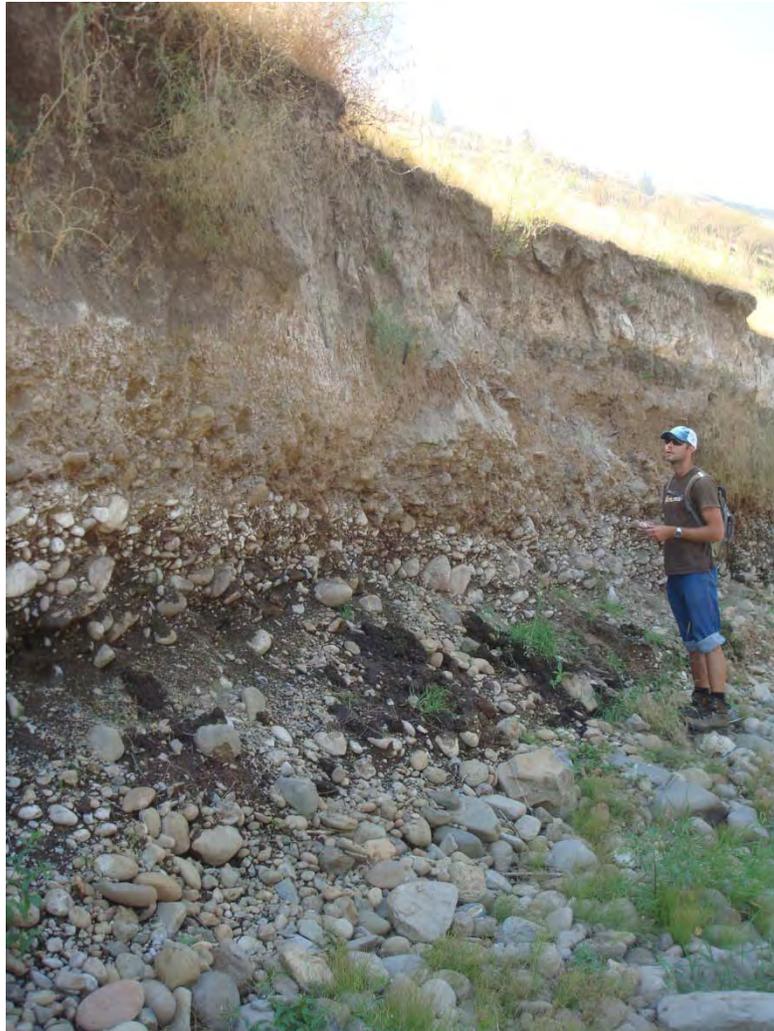
Figure 22. Close-up view colluvium (Qc) deposits along the left (south) bank of Catherine Creek near RM 44.00. Catherine Creek Tributary Assessment-Grande Ronde River Basin-Tributary Habitat Program, Oregon – Bureau of Reclamation – September 9, 2011.

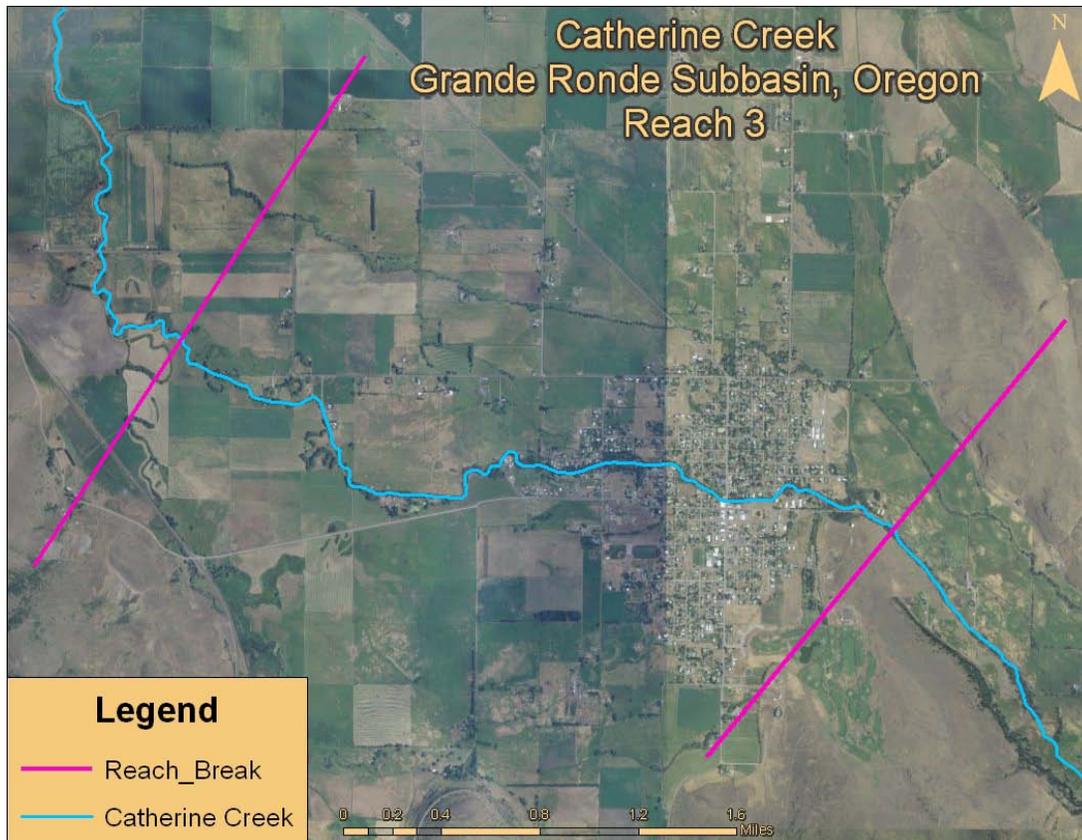
Figure 26. Location map of reach 3, which covers the Catherine Creek alluvial fan.

Reach 3 extends through the Catherine Creek alluvial fan from the downstream end of reach 4 at RM 40.78 downstream to the toe of the alluvial fan at RM 37.2 (Figure 26). The town of Union is located in the upstream half of the reach.

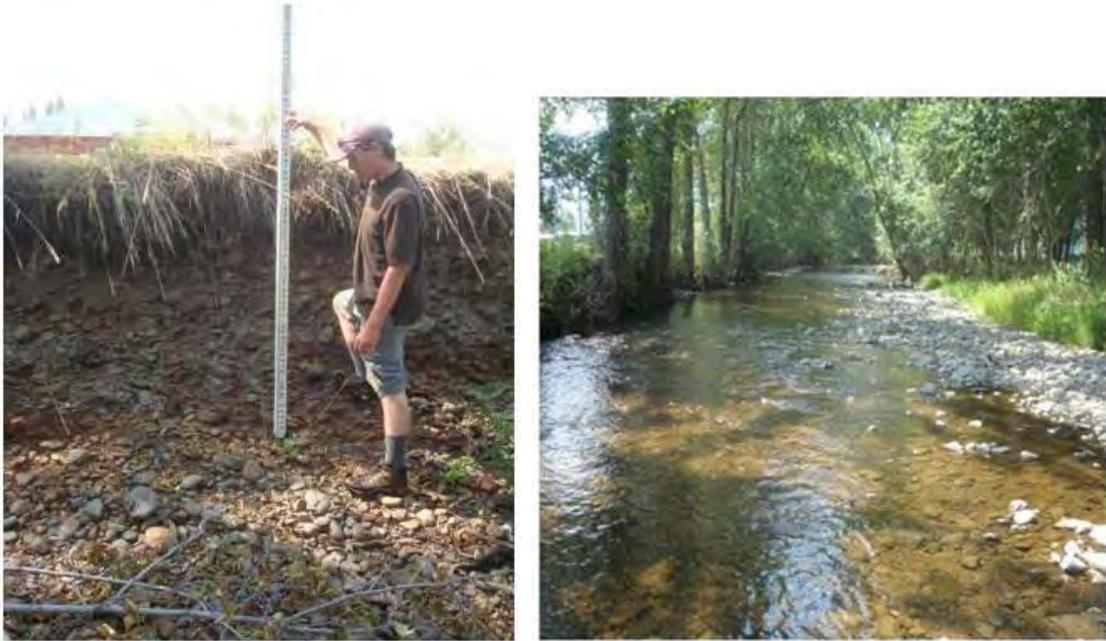
Figure 27. Various bank conditions, vegetation, and substrate in reach 3.

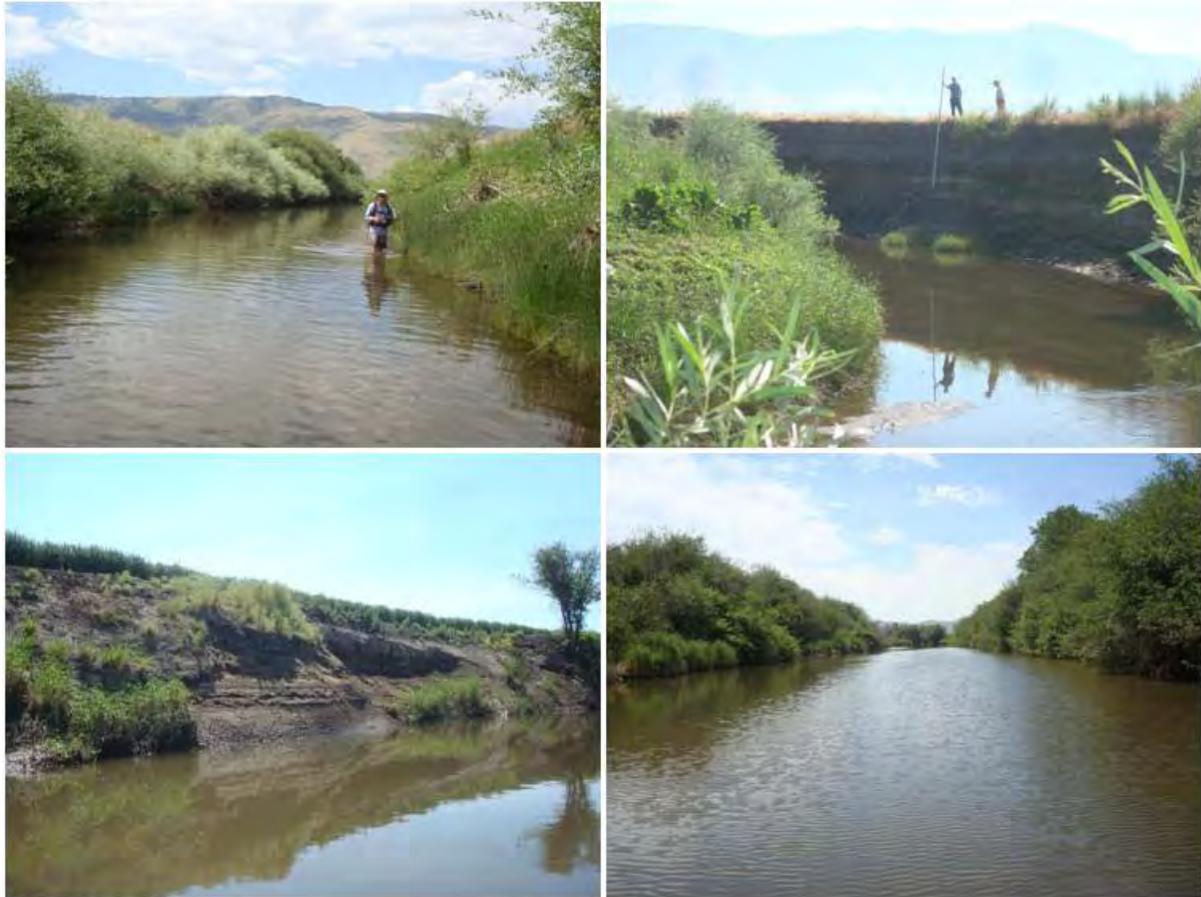
Figure 29. Various bank conditions, vegetation, and substrate in the Valley Floor Group.
