**Catherine Creek - 37 Stream and Fish Habitat Restoration**  
Completion Report

Bonneville Power Administration Project Number 1992-026-01

Contract # 58036

Completed by: Craig Schellsmidt, Kate Frenyea - Union Soil and Water Conservation District  
March 2013

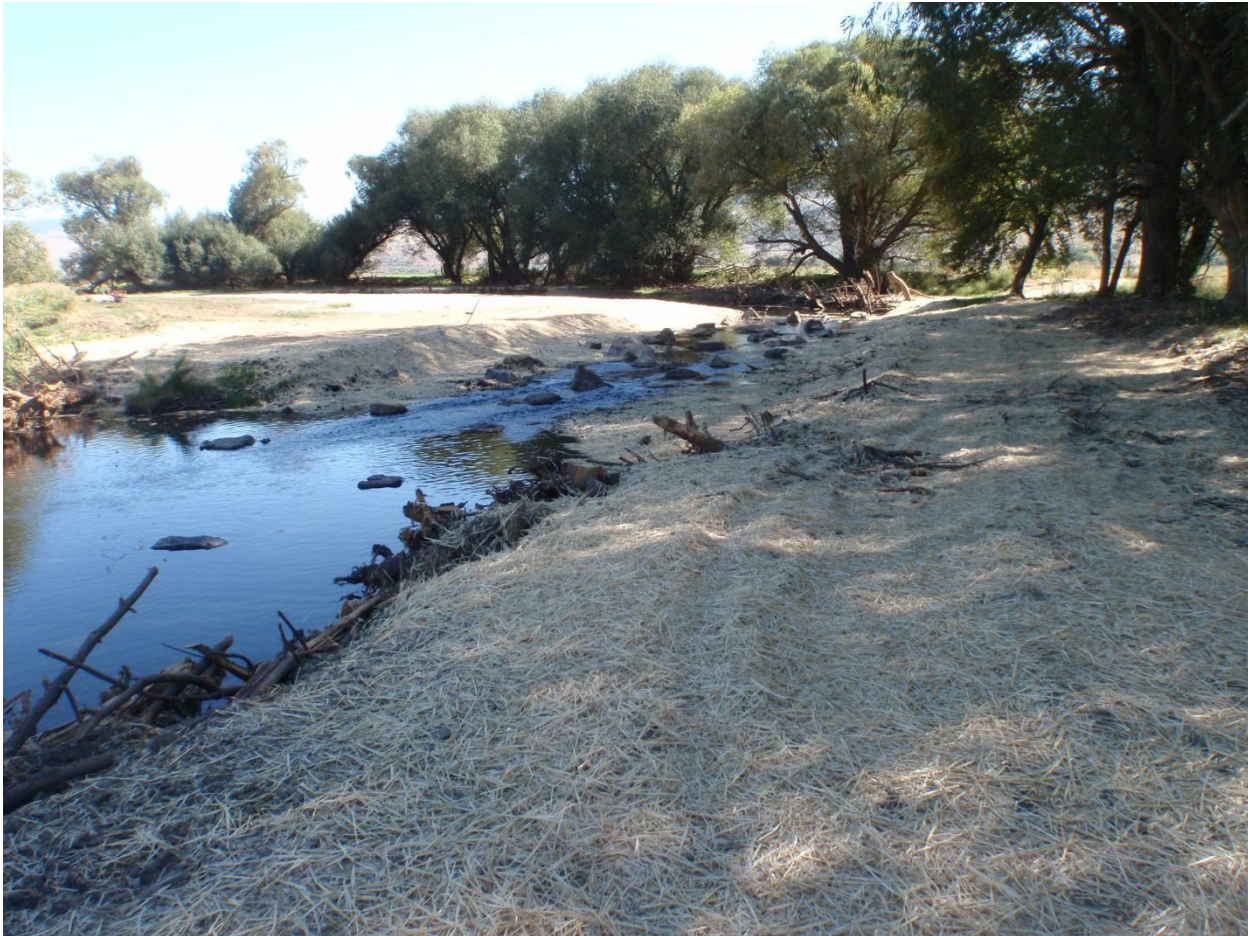
Photo 1: Completed Boulder, Large Wood Structure, Racking Materials, Sedge Mat Placement, Excavated Floodplain and Activated Old Meander Channel to become Main Stream Channel again, Preserve Old Meander Channel Existing Mature Trees, Re-seeded, Mulched, and Replanted with Willow Whips, Container Plants, and Protected with Panel Pods all Disturbed Riparian Areas.

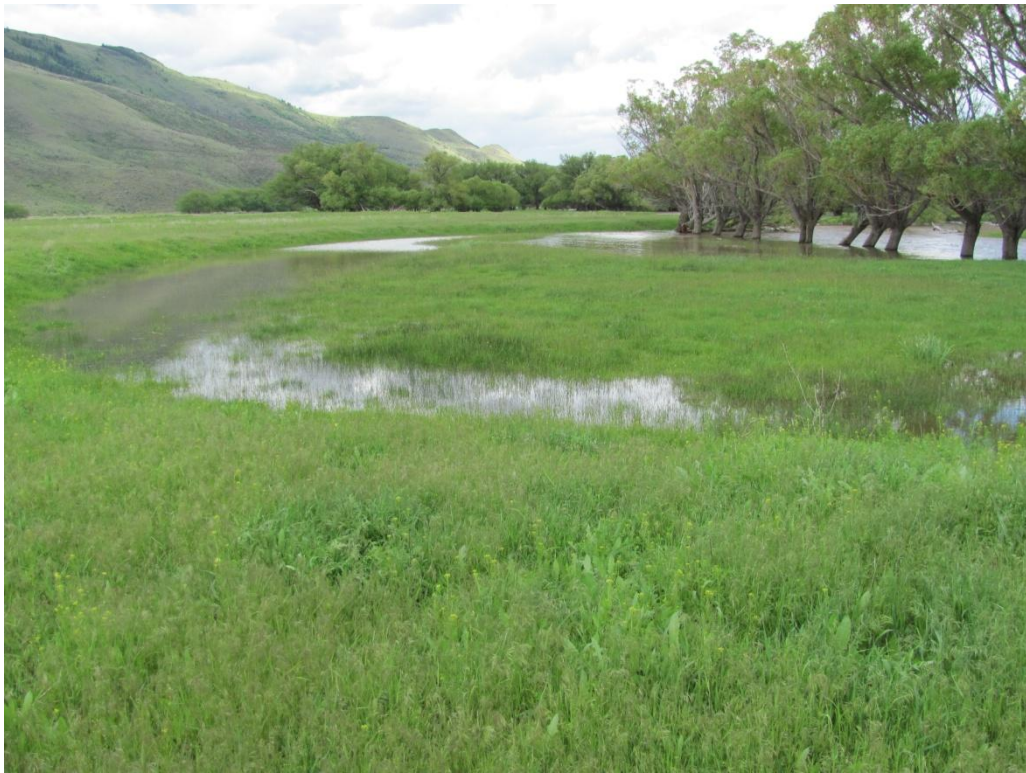
Photo 3. Southside location of upper side channel, pre-construction.

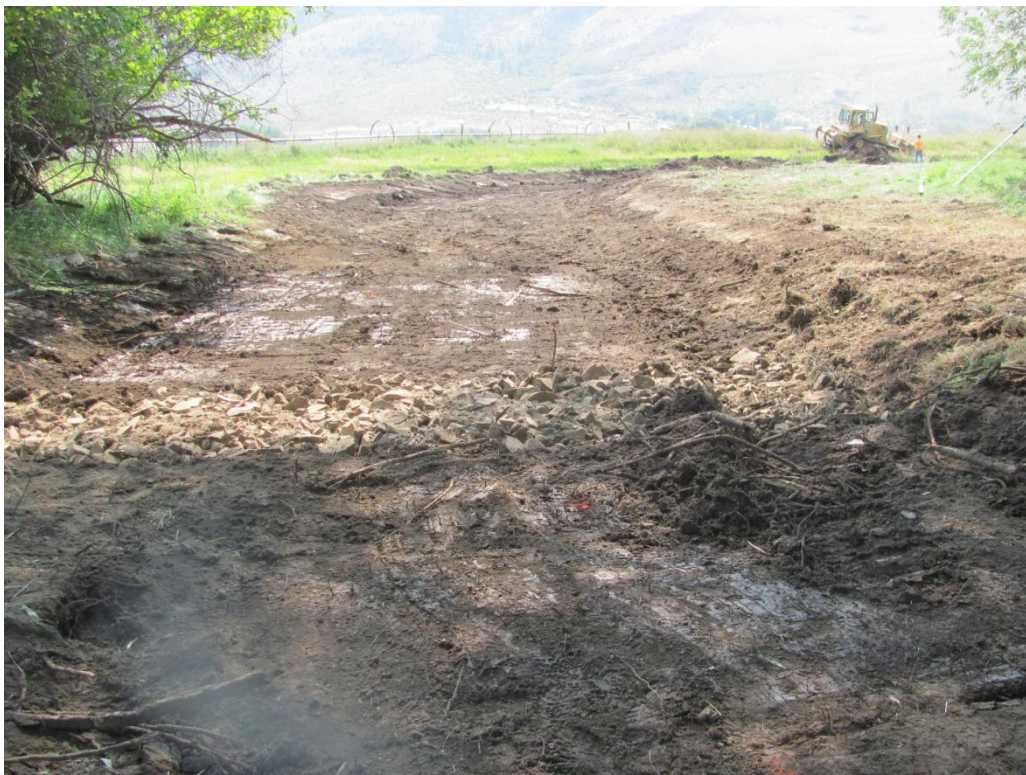
Photo 4. Completed upper side channel with entrance rock sill for sediment and flow control.

- A new 399 foot (0.36-acre) side channel was constructed. This channel will activate during typical spring flows. The channel incorporated a buried rock sill at the inlet to prevent possible head cutting and capture by the main channel.

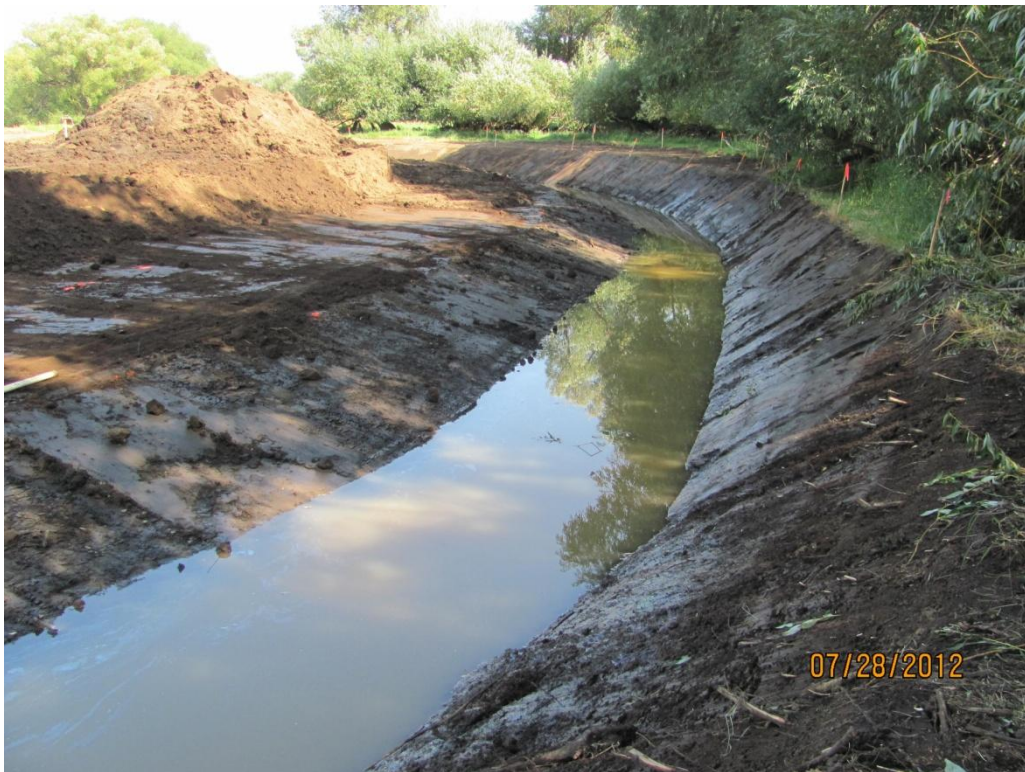
Photo 6. Excavation of new meander.

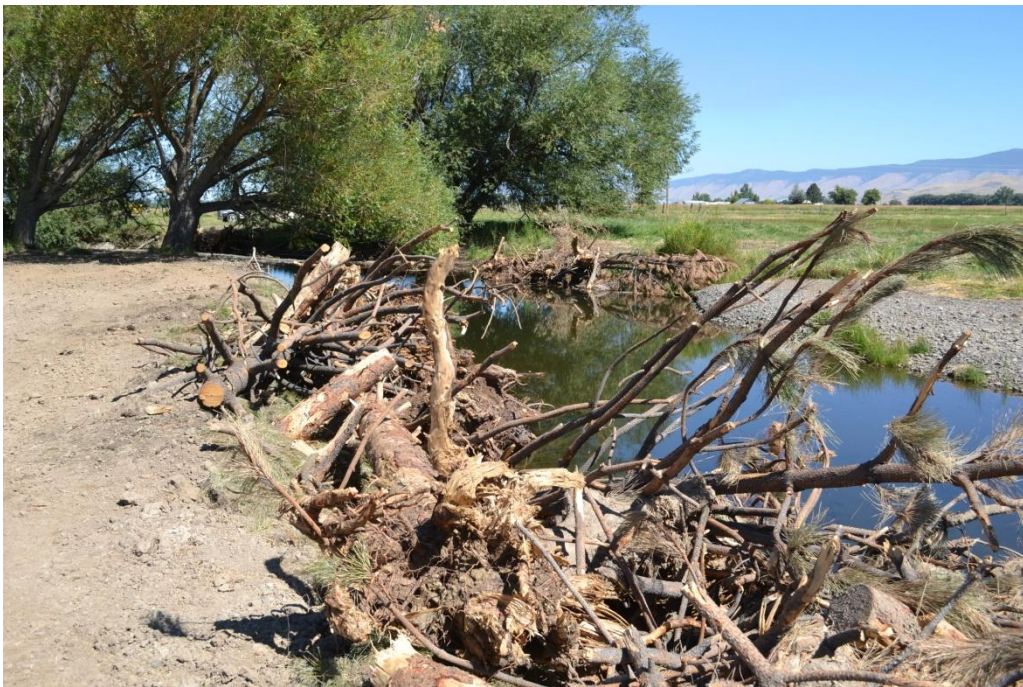
Photo 16. Excavated and re-sloped (3:1) vertical banks and widened floodplain. Large wood structures, racking materials, and sedge mat placement. Banks were mulched, re-seeded, and planted with whips, container plants, and protected with panel pods.
