1. **Project Name:** Lick Creek Culvert Replacement Project
2. **Applicant:** Wallowa Resources / Wallowa-Whitman NF
3. **Participating Landowner(s) and Agencies:**

## 7. Project Description

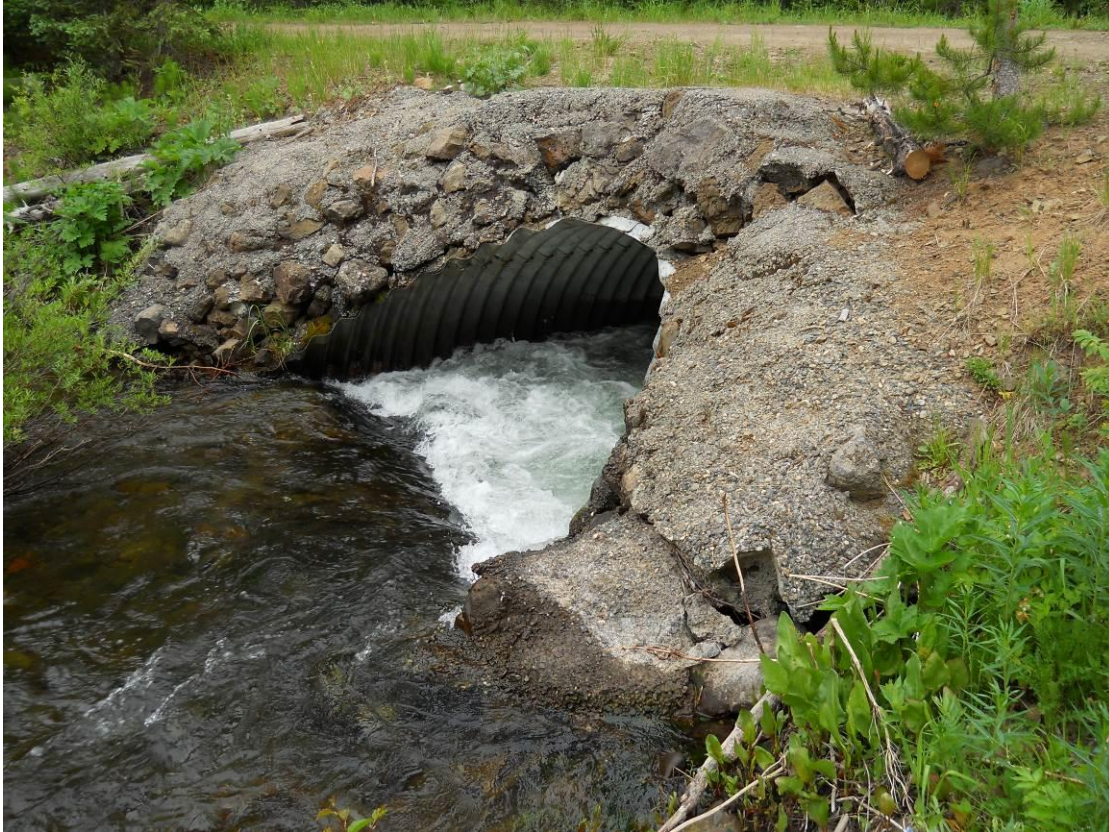
**Figure 2. Lick Creek Culvert, upstream view (2011).**

Existing condition – The current culvert at the FR 3925-015 crossing was identified as a barrier to juvenile salmonids as part of the BPA-funded NPT culvert survey project in Wallowa County in the mid 2000's. The culvert was constructed with a concrete lip at the intake that creates a velocity/jump barrier to juvenile salmonids under most flow conditions. The culvert is undersized and creates a velocity barrier to adult salmonids during high flows.

The USFS has been monitoring the condition of the culvert since 2006 when cracks started to form in the concrete abutments on the upstream side of the culvert. Since 2006, the condition of the culvert has continued to decline (Figure 2). Failure of the culvert would likely result in degradation to an estimated 1 mile of spawning and rearing habitat for all species present below the culvert. Since failure would likely occur during spring runoff there is a high likelihood of smothering of redds resulting in the death of salmonid embryos.
