Monitoring report – Wallowa Mountain Loop Road (Bridge portion)

Application Number: 219-5024-16570

Submitted by: Grande Ronde Model WS Foundation

Exhibit D - 1. Project Background and Assessment

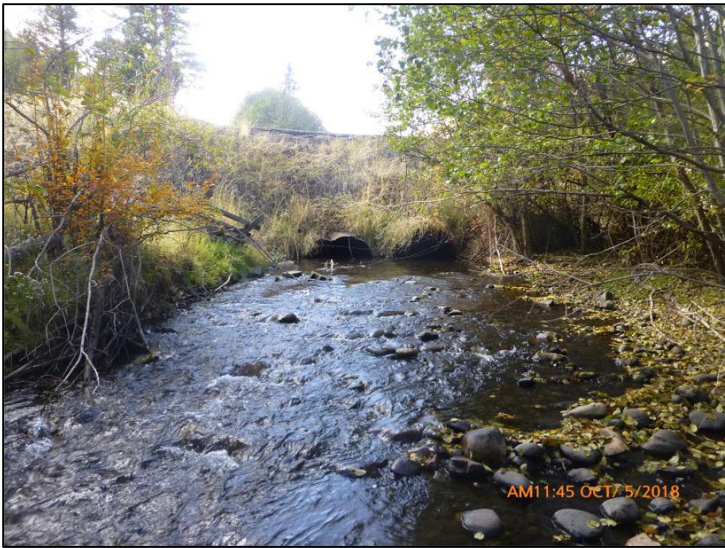
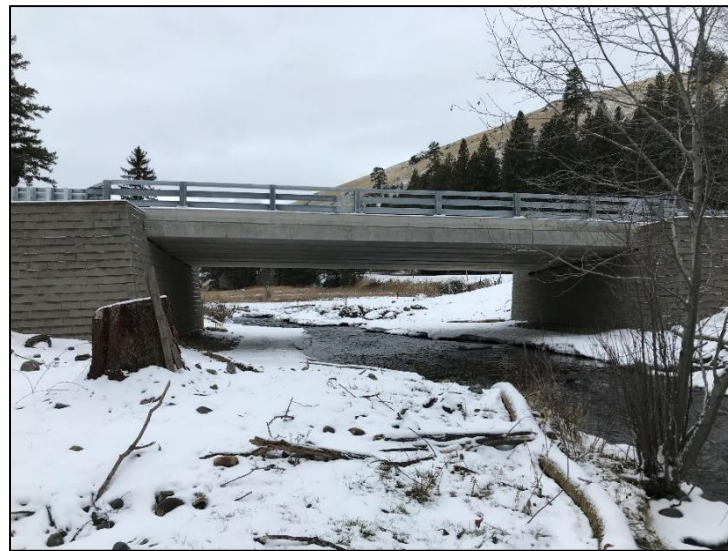
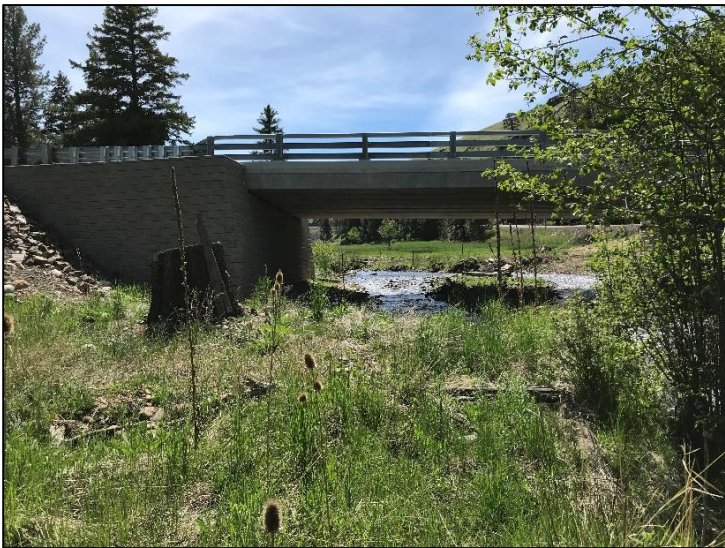
Photo 1: Top left: standing downstream of double culvert (2018). At high flow water velocity high enough to preclude fish passage and at low flow water depth through culverts is too shallow to allow fish passage. Top right: new bridge following completion of project with improved fish passage (2019) and bottom left (2021)

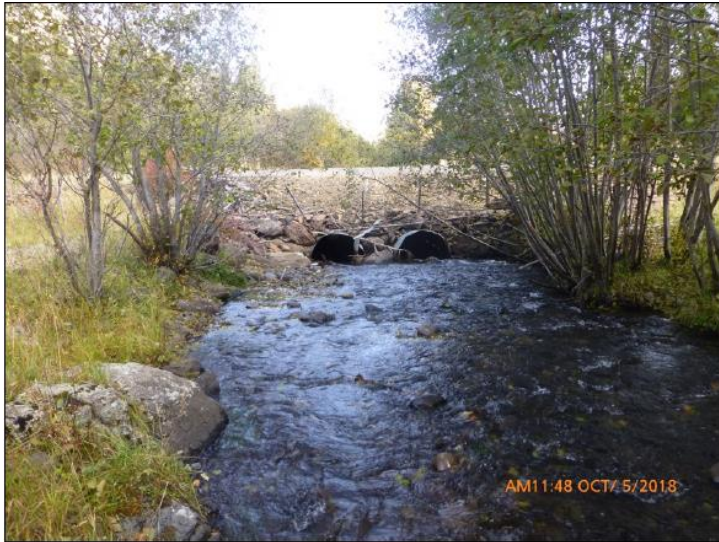
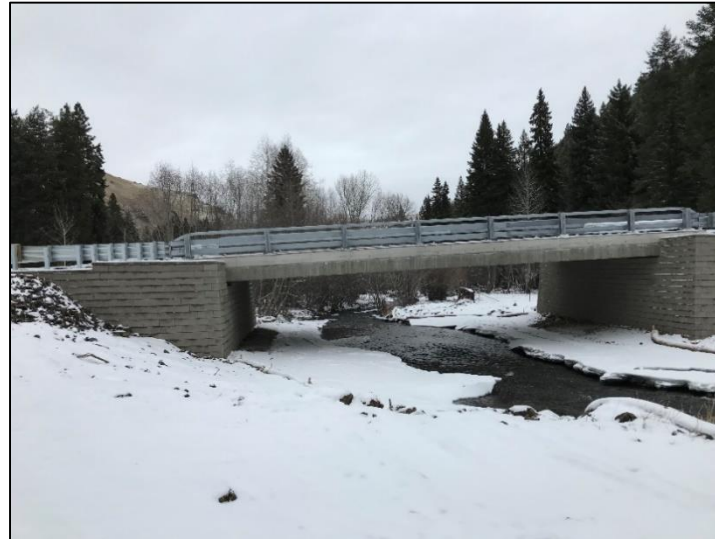
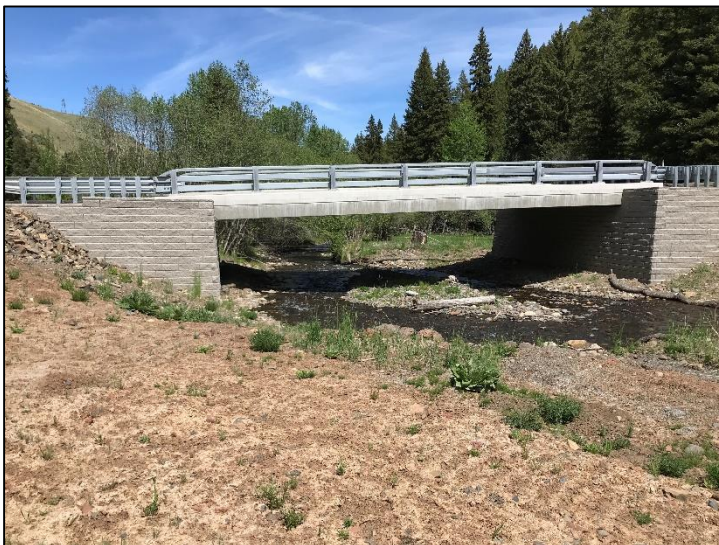
Photo 2: Top left: standing upstream of double culvert (2018). Stream substrate and debris aggrades at top end of culverts causing a jump height barrier to fish passage. Top right: Upstream view of new bridge and improved fish passage (2019) and bottom left (2021).

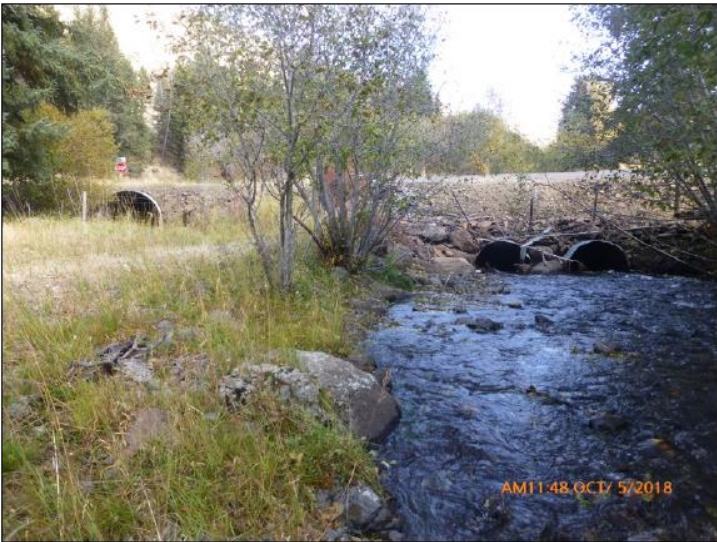
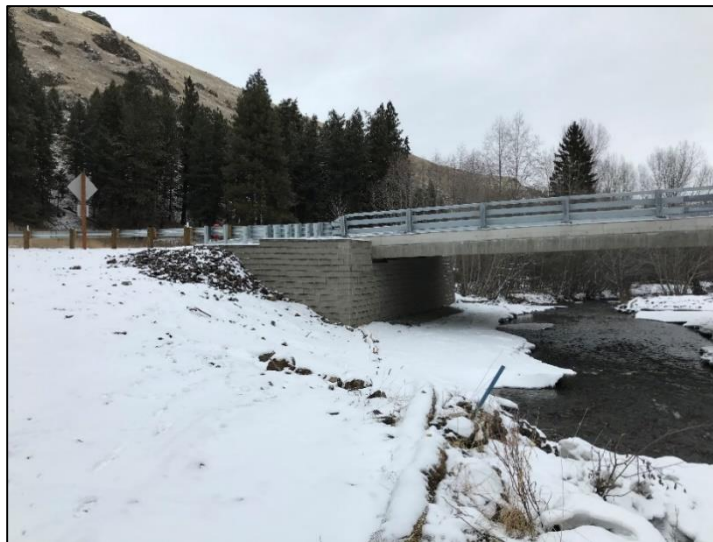
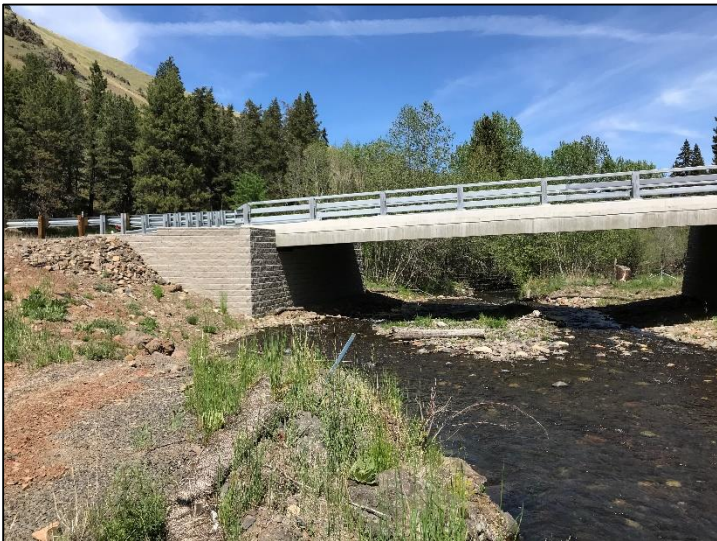
Photo 3: Top left: Standing upstream of culverts (2018). Culvert on the left is a flood relief culvert for times of high flow or when the two primary culverts are plugged. All 3 culverts will be removed and replaced with a bridge. Top right. New bridge without the need for overflow culverts (2019 and bottom left (2021).

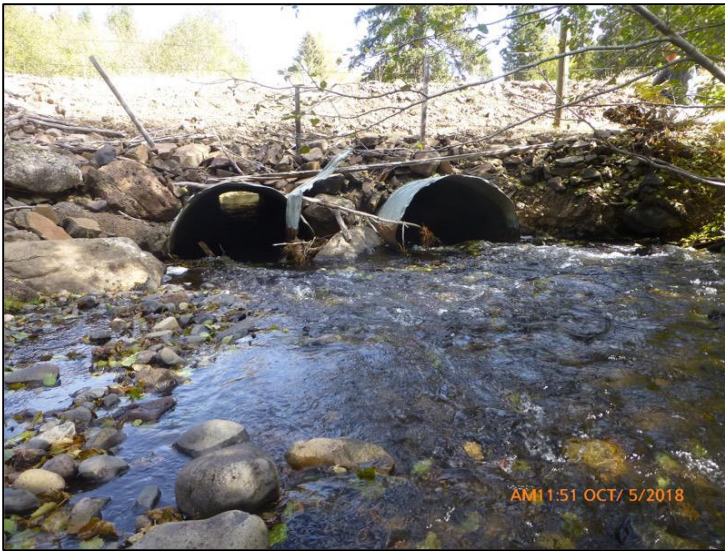
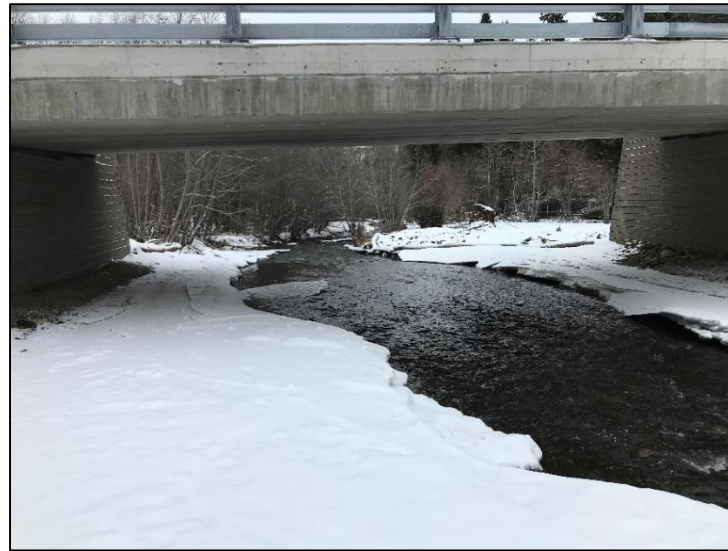
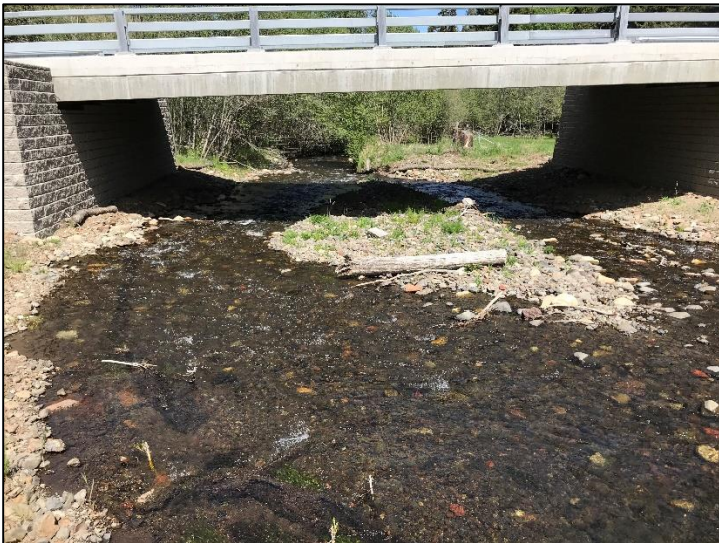
Photo 4: Top left: Close-up photo of culverts at upper end showing channel substrate build up, debris and compromised inlets (2018). Top right: Close-up photo showing lower velocity, ability for substrate and debris to transport (2019) and bottom left (2021).

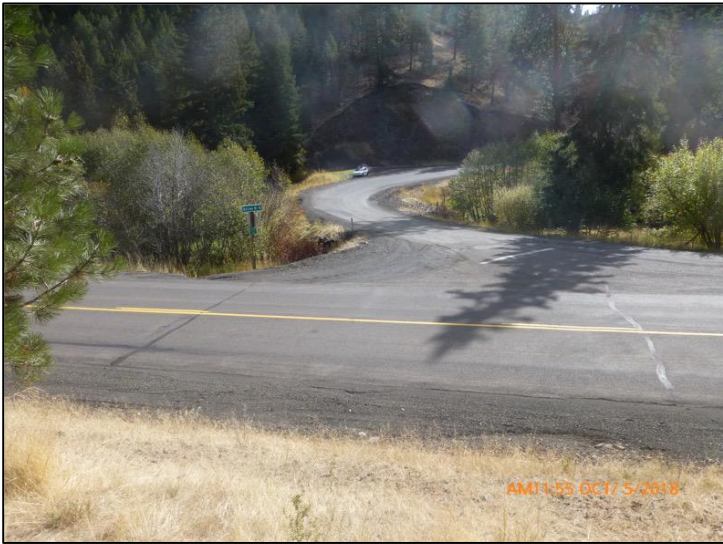
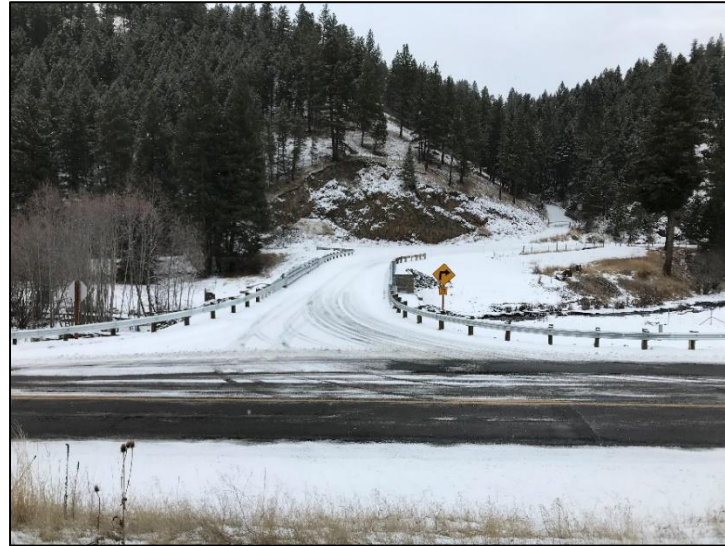
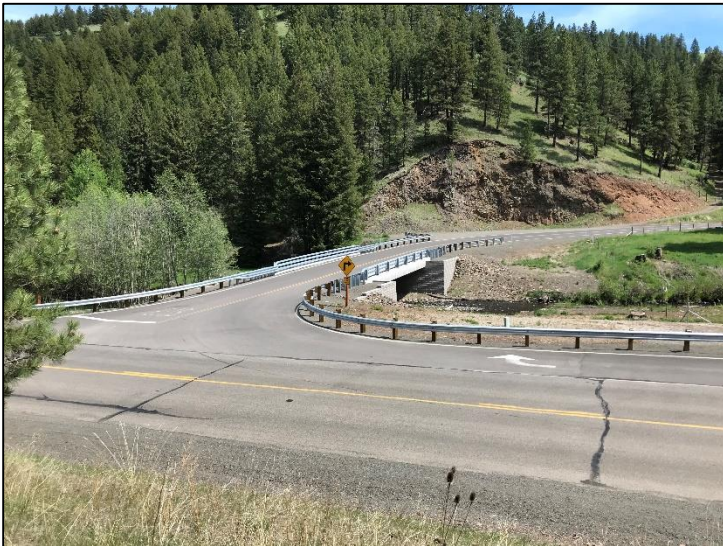
Photo 5: Top left: Standing across State Route 350 and looking east at former road alignment (2018). 4602 road skew was eliminated, a turn off lane from SR 350 was constructed, and the bridge was installed at the approximate center of the road curve. Top right: New road alignment and bridge (2019) and bottom left (2021).

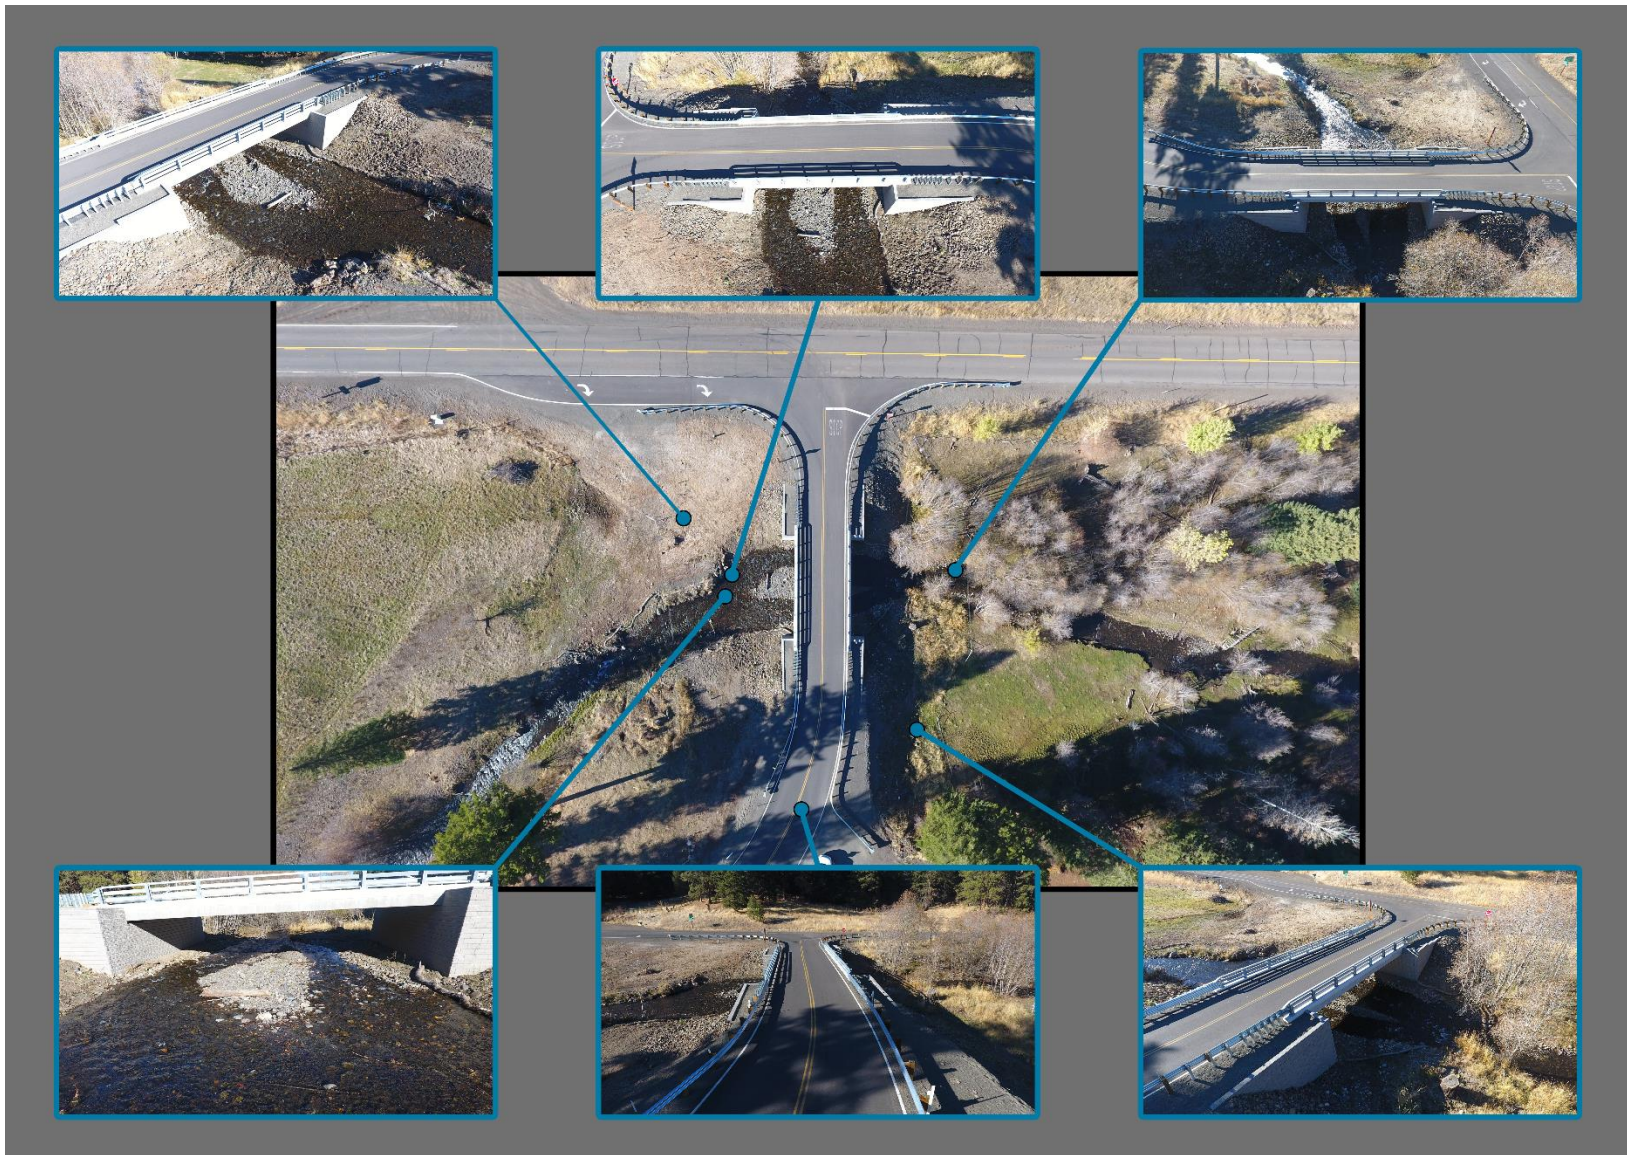
Photo 6. Drone imagery captured post project in 2020. The images show the improved sediment transportation and sorting as well as the new bridge alignment.

- (b) The improved sediment transportation and sorting as a result of the project now provides appropriate substrate size for steelhead to spawn. This was observed while taking photo points in 2021 and from the drone imagery in Photo 6.
- (c) Other than the photo points and drone imagery, there has been no additional data collected that is directly related to this project. However, the Nez Perce Tribe continues to supplement Little Sheep Creek with steelhead carcasses to benefit macroinvertebrate production and improve juvenile fish rearing conditions.
