Lostine Wetland and Side Channel Complex

COMPLETION REPORT

September 28, 2020 – August 31, 2022

Nez Perce Tribe

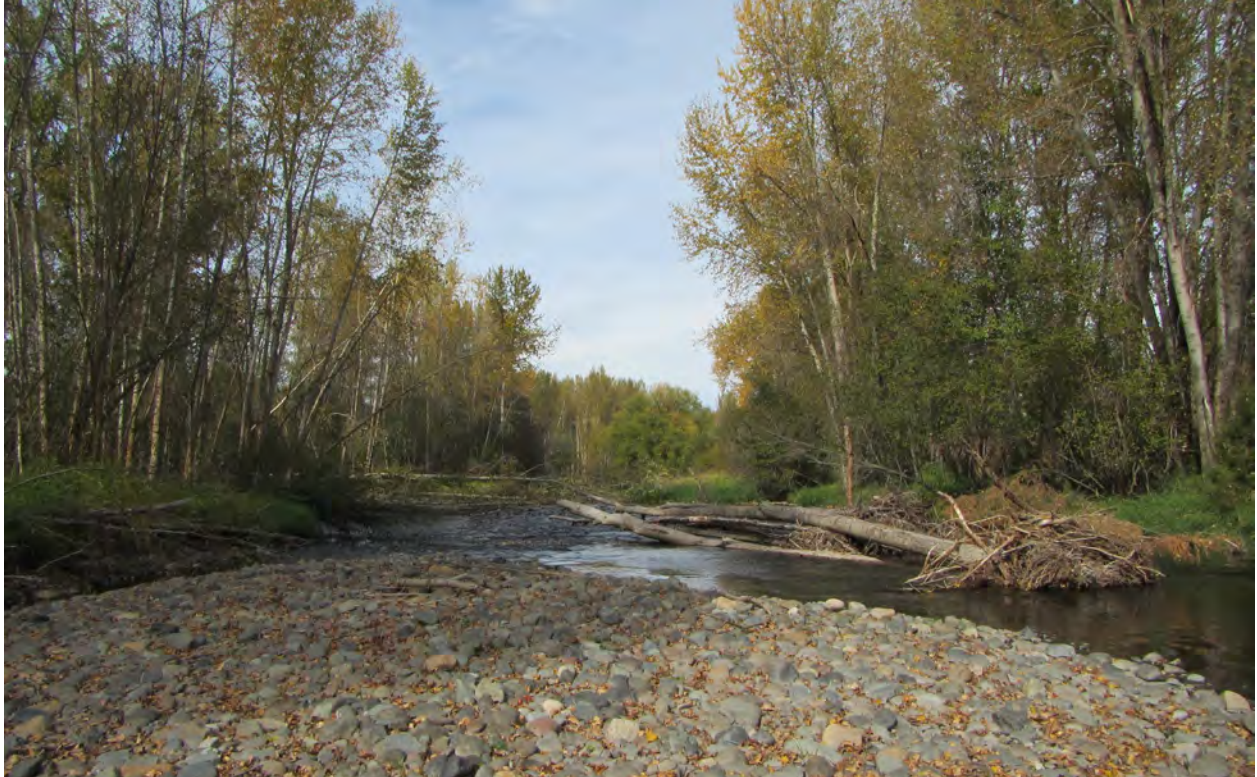
Figure 2. Pre-implementation photo taken mid-channel in the Lostine River, looking downstream toward the confluence with the Wallowa River. Photo shows existing intact riparian and instream habitat, taken October 2020.

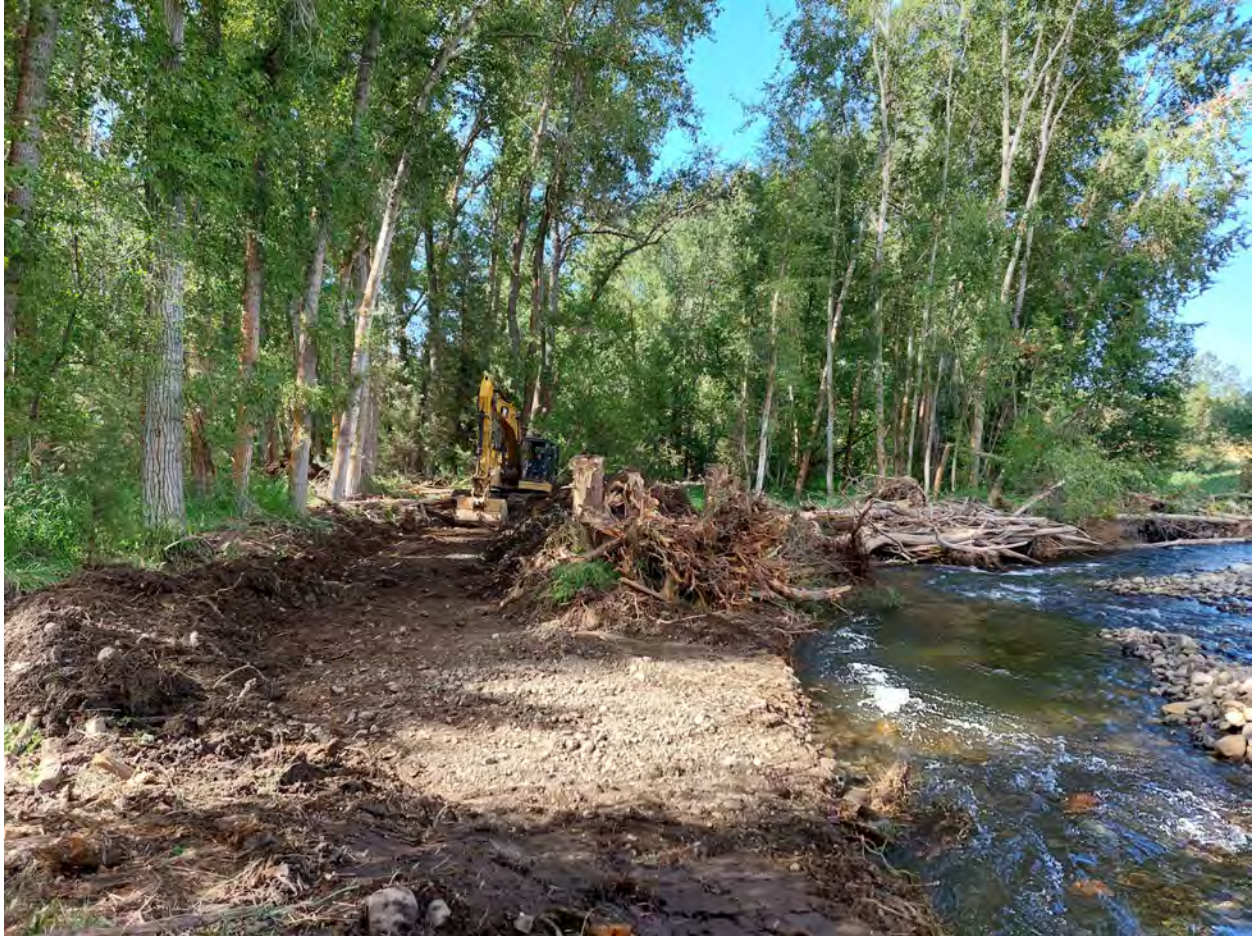
Figure 3. Looking downstream from river left at Pilot Channel 2-Inlet grading and associated small apex jam, taken during construction on August 4.

- Levee breaching and grading of two pilot channel inlets and one pilot channel outlet, connecting relic side channels to allow main channel flows above 1-year discharge events to inundate the floodplain and maximize rearing habitat for juvenile fish (Figure 3).

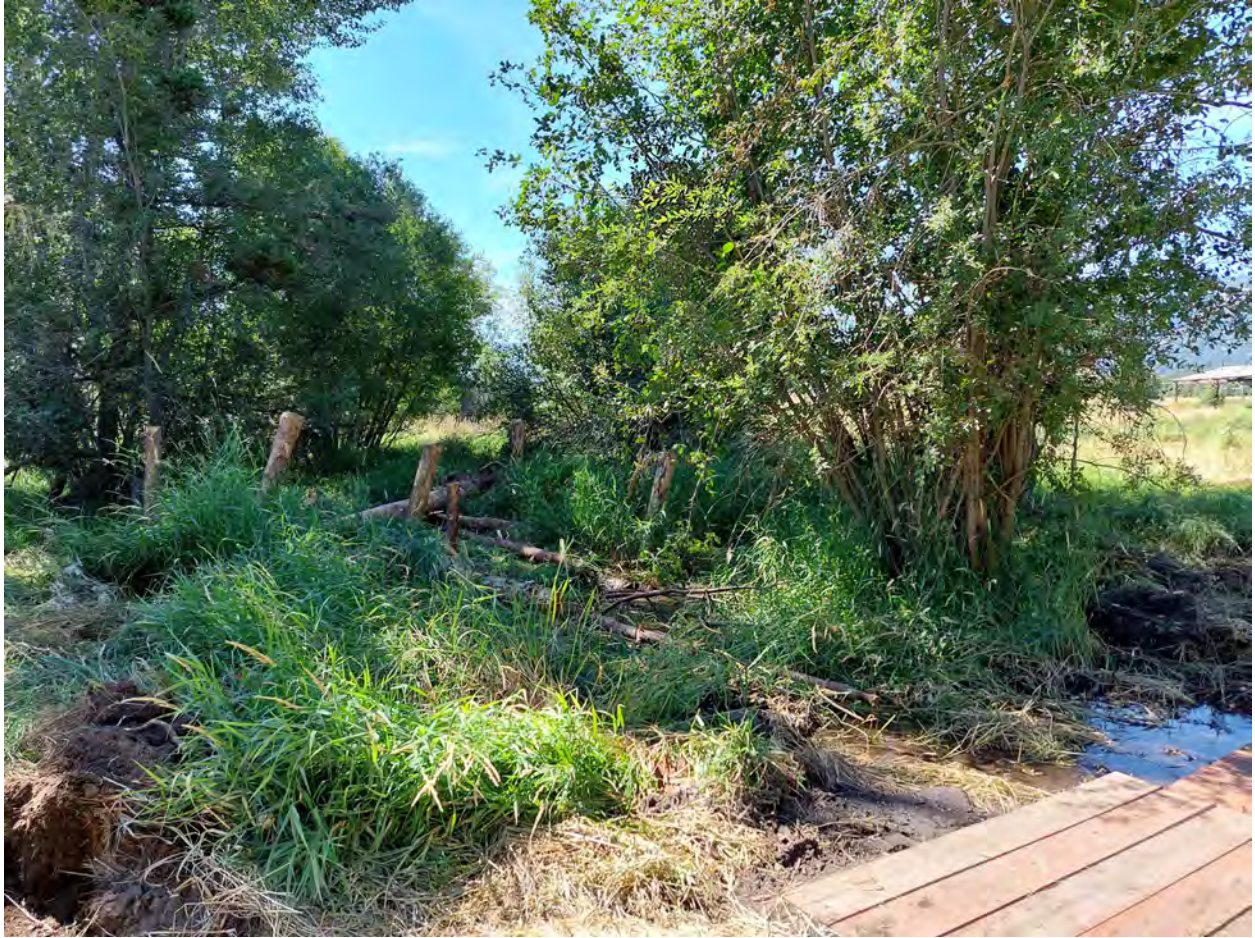
Figure 4. Vertical post array installed in floodplain swale, taken during construction on August 5.

- 19 vertical post arrays installed within the alcove, pilot channels, and floodplain swales to maximize floodplain inundation, enhancing existing wetland conditions and riparian vegetation (Figure 4).

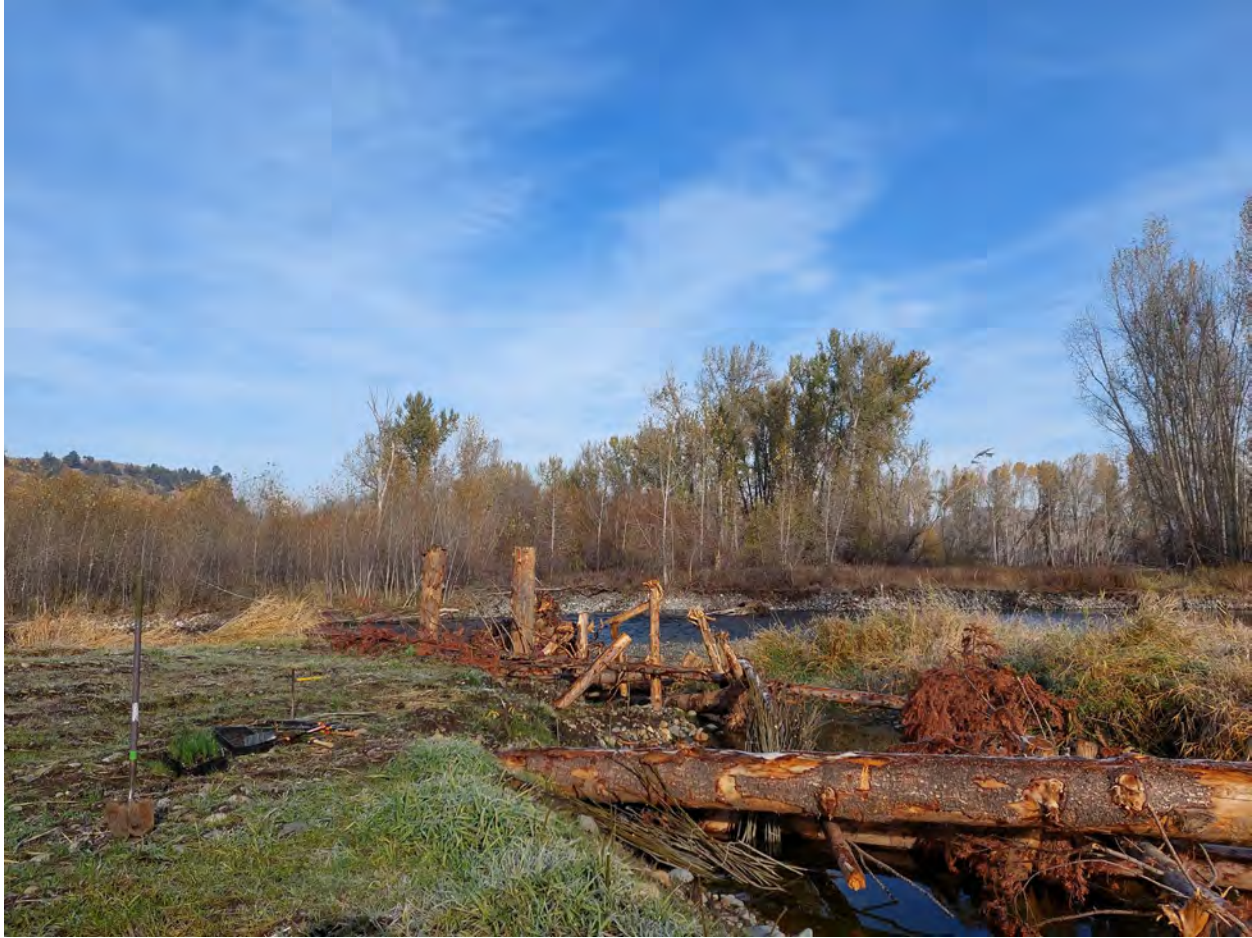
Figure 5. In-progress containerized wetland plug and willow stake planting in Pilot Channel 1-Outlet, taken October 27.

- >1,000 willow cuttings (various species) and >200 slough sedge (*Carex obnupta*) 10-cubic inch wetland plugs were planted in association with large wood structures, alcove and pilot channel graded areas to compete with invasive species like Reed Canary Grass, and provide native vegetative cover and bank stability (Figure 5). A wetland/riparian seed mix including Nebraska sedge, Tufted hairgrass, American sloughgrass, and Basin Wildrye was spread over ~1.8 acres, while an upland seed mix containing native varieties of Orchardgrass, Fescue, Ryegrass, Meadow brome, and Clover was spread over ~2.4 acres.

The remainder of the planting and seeding/mulching was completed by the contractor on 10/26-10/27, which included additional willow stakes, wetland plugs, and riparian and upland seed mixes.

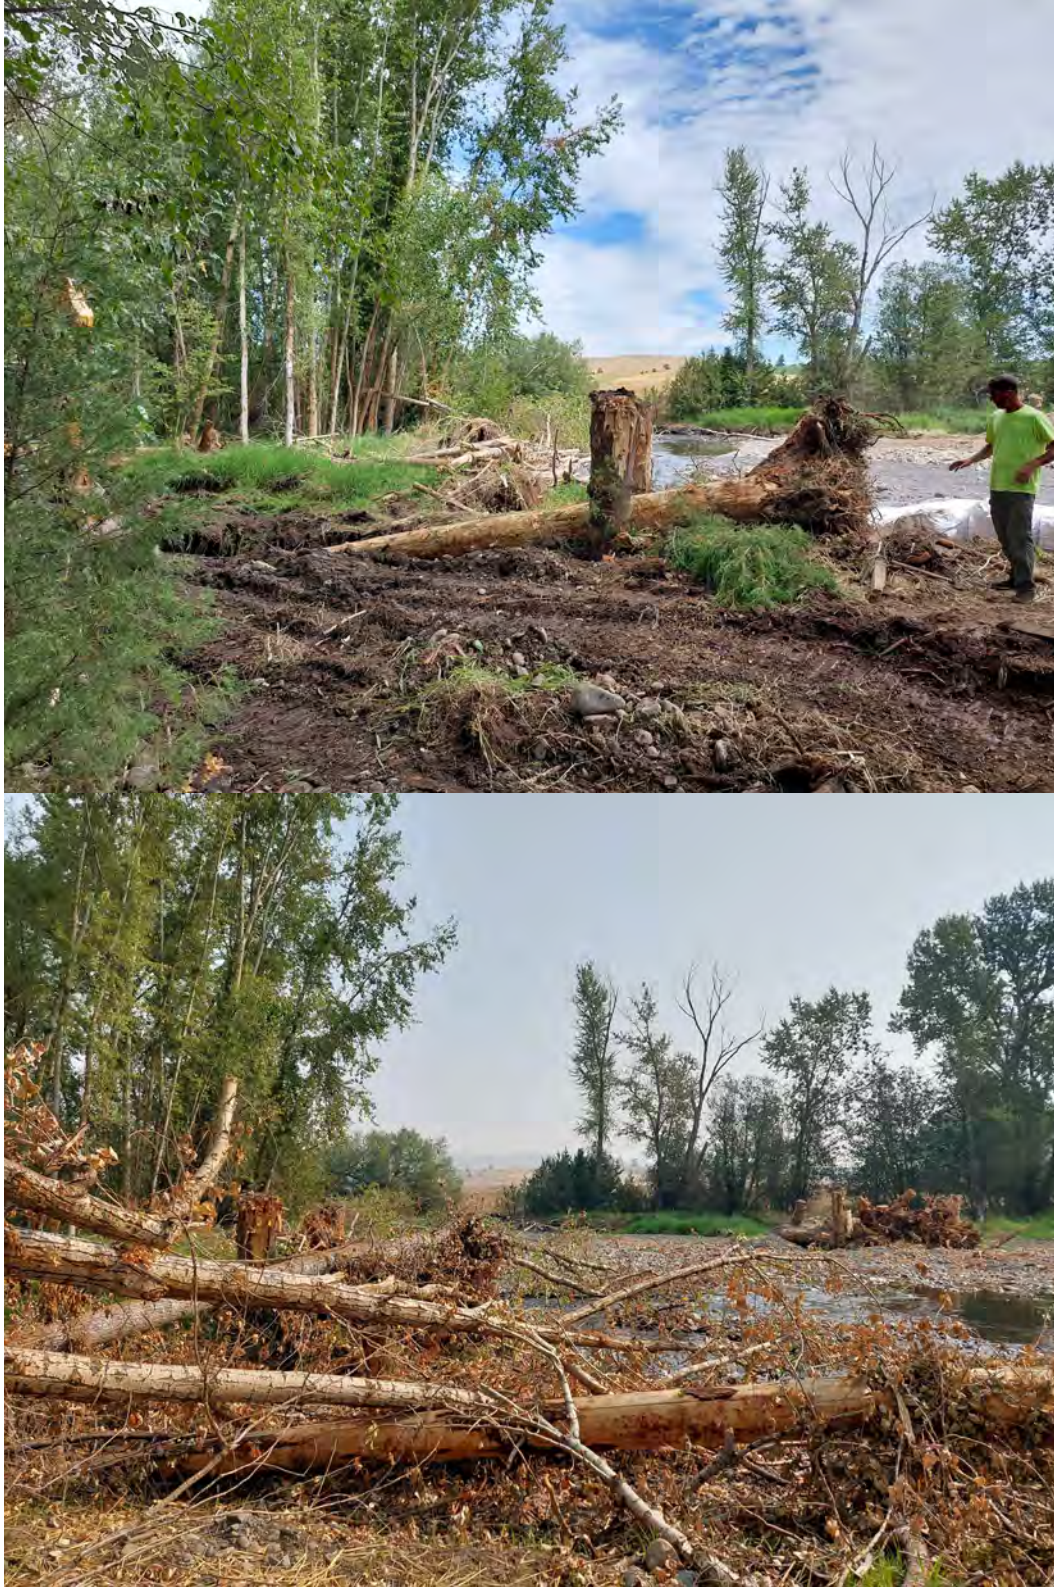
Figure 6. Looking toward Losine River at Small Apex Jam in Pilot Channel 2-Inlet during construction (top) and after windstorm wood addition (bottom).

An intense windstorm hit the project area and nearby town of Wallowa on August 11, just six days following construction demobilization. This storm dropped dozens of large cottonwood trees throughout the project footprint, within the main Lostine River and on top of constructed wood structures within and outside of the main channel (Figure 6 and 7). This unexpected disturbance and large wood recruitment event is anticipated to improve and advance the project objectives of increasing in stream complexity (e.g., pool formation, substrate sorting, fish cover/holding water, etc.), and water conveyance and inundation on the floodplain.

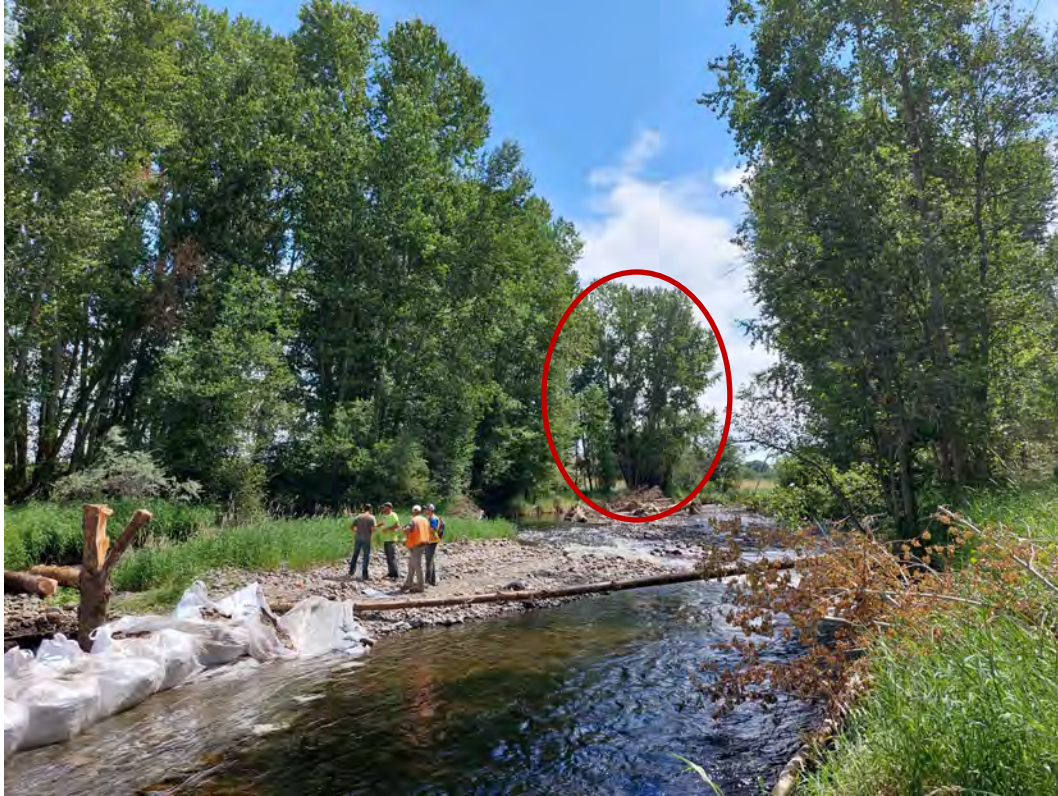
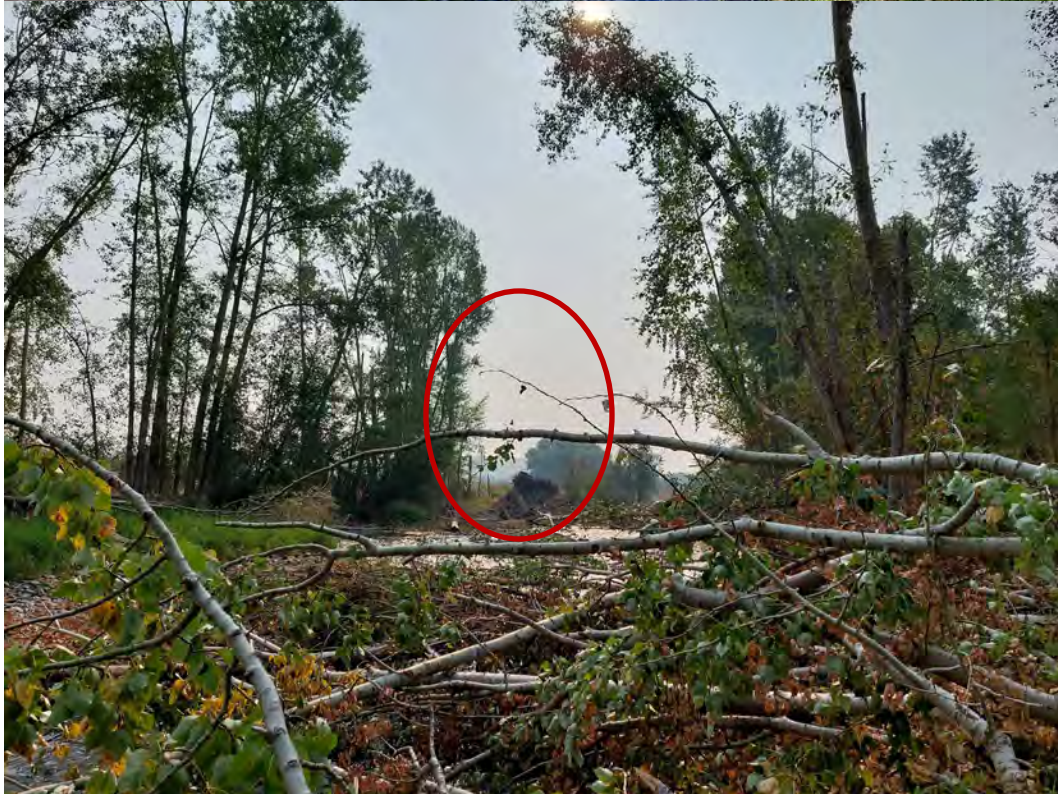
Figure 7. Looking across and upstream of Large Apex Jam 1 at large mature cottonwood cluster present during construction (top) and following large windstorm (bottom).

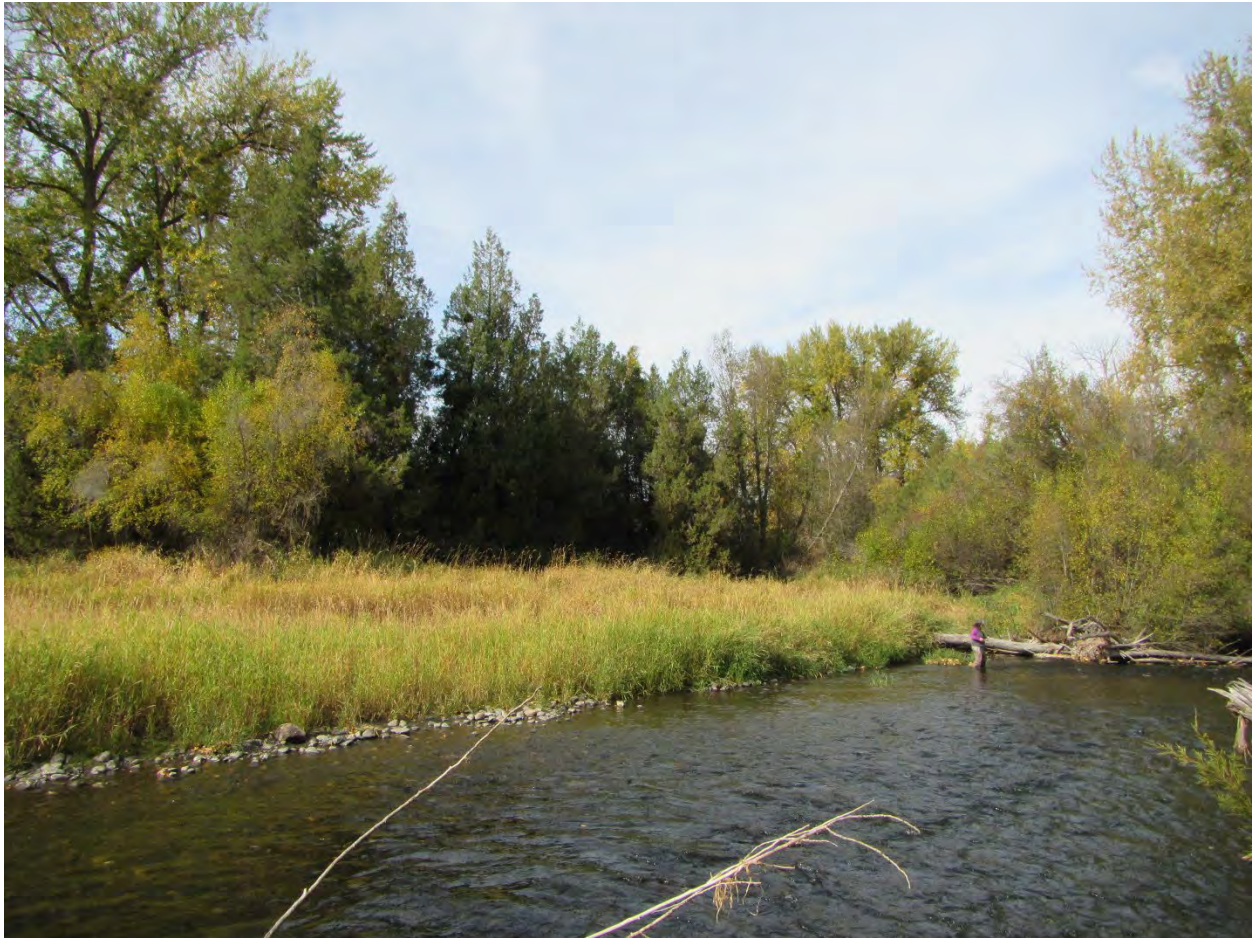
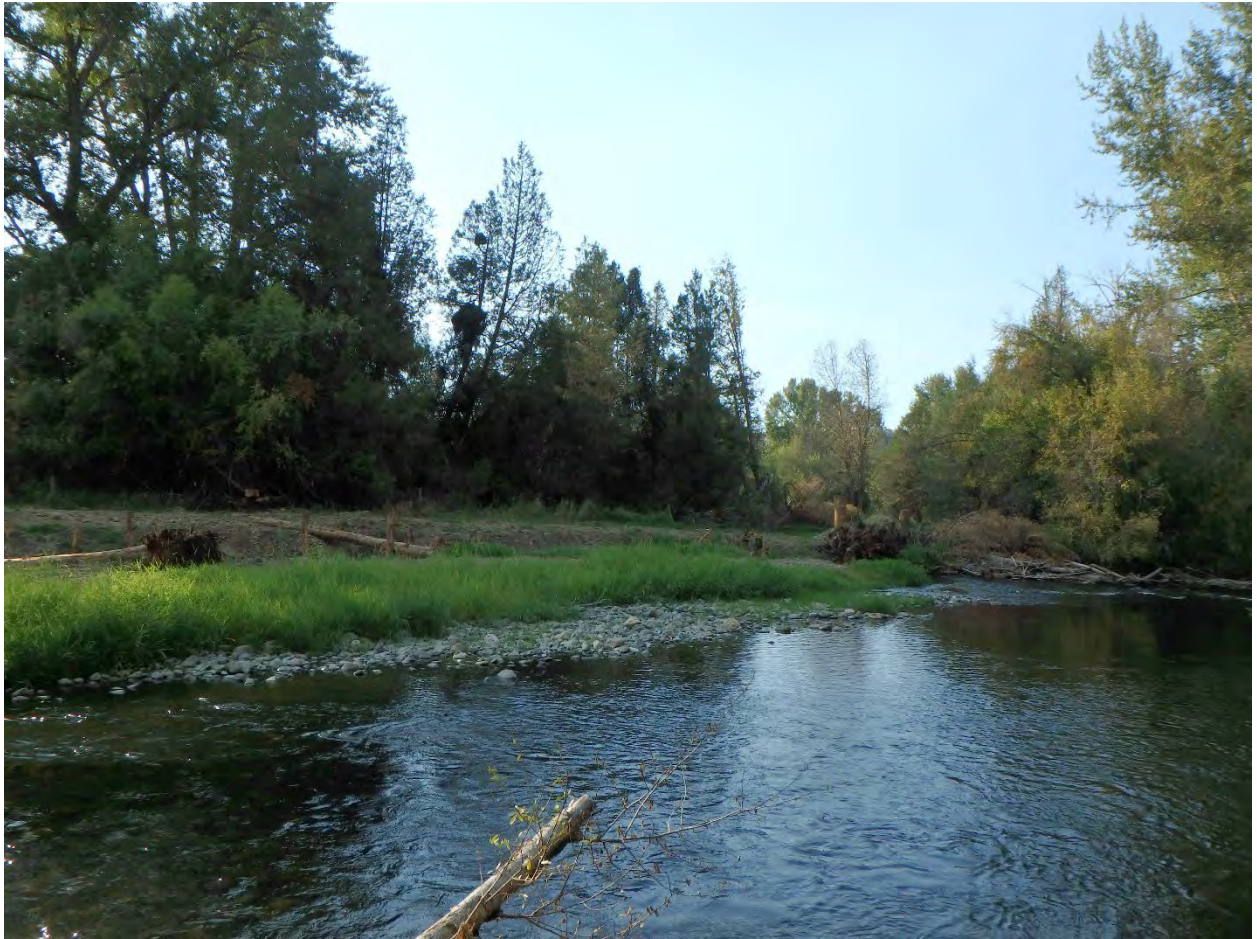
Photo Point 1:

Looking NW from Lostine River mainstem, downstream at proposed (a) and actual (b) Alcove 1-Outlet.

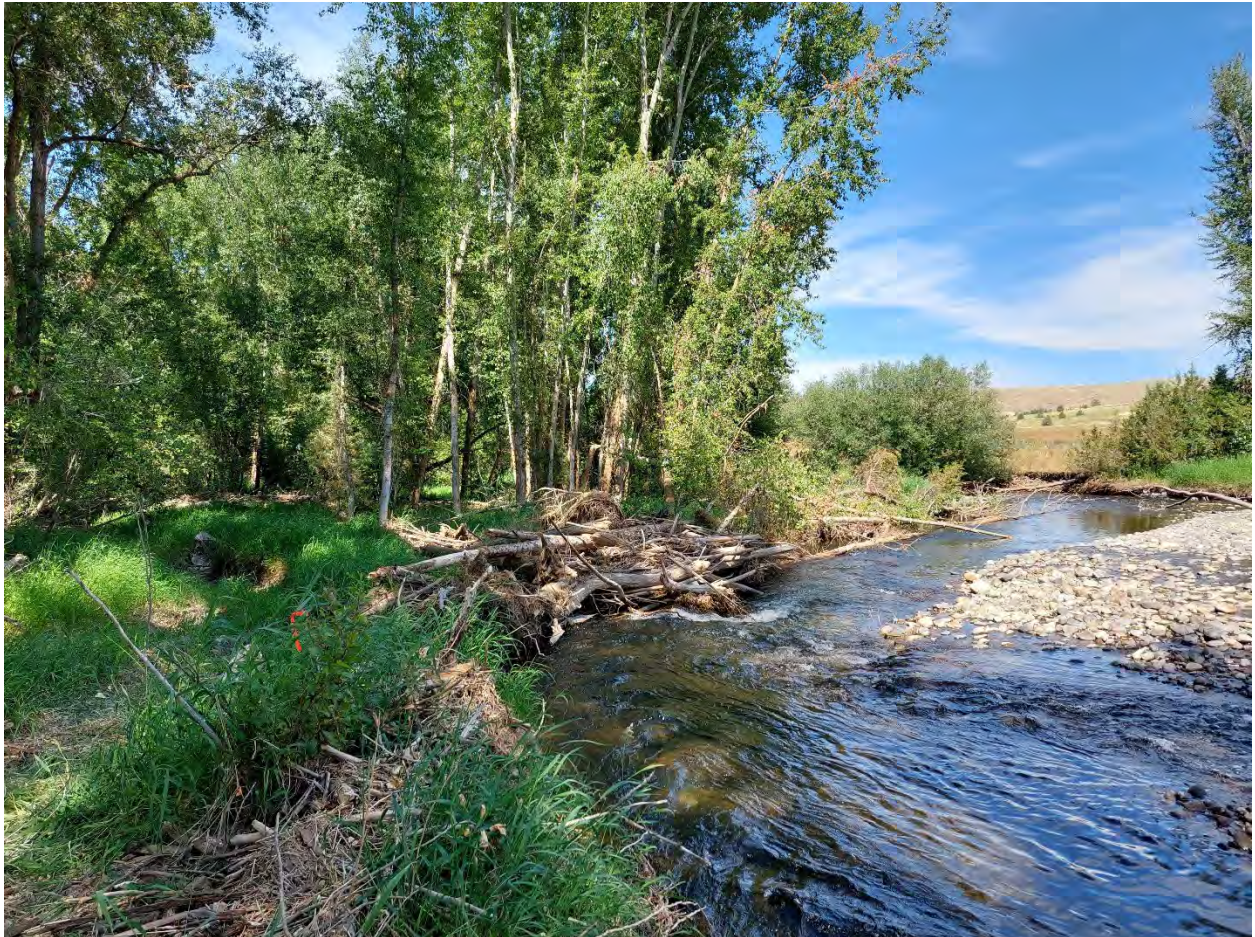
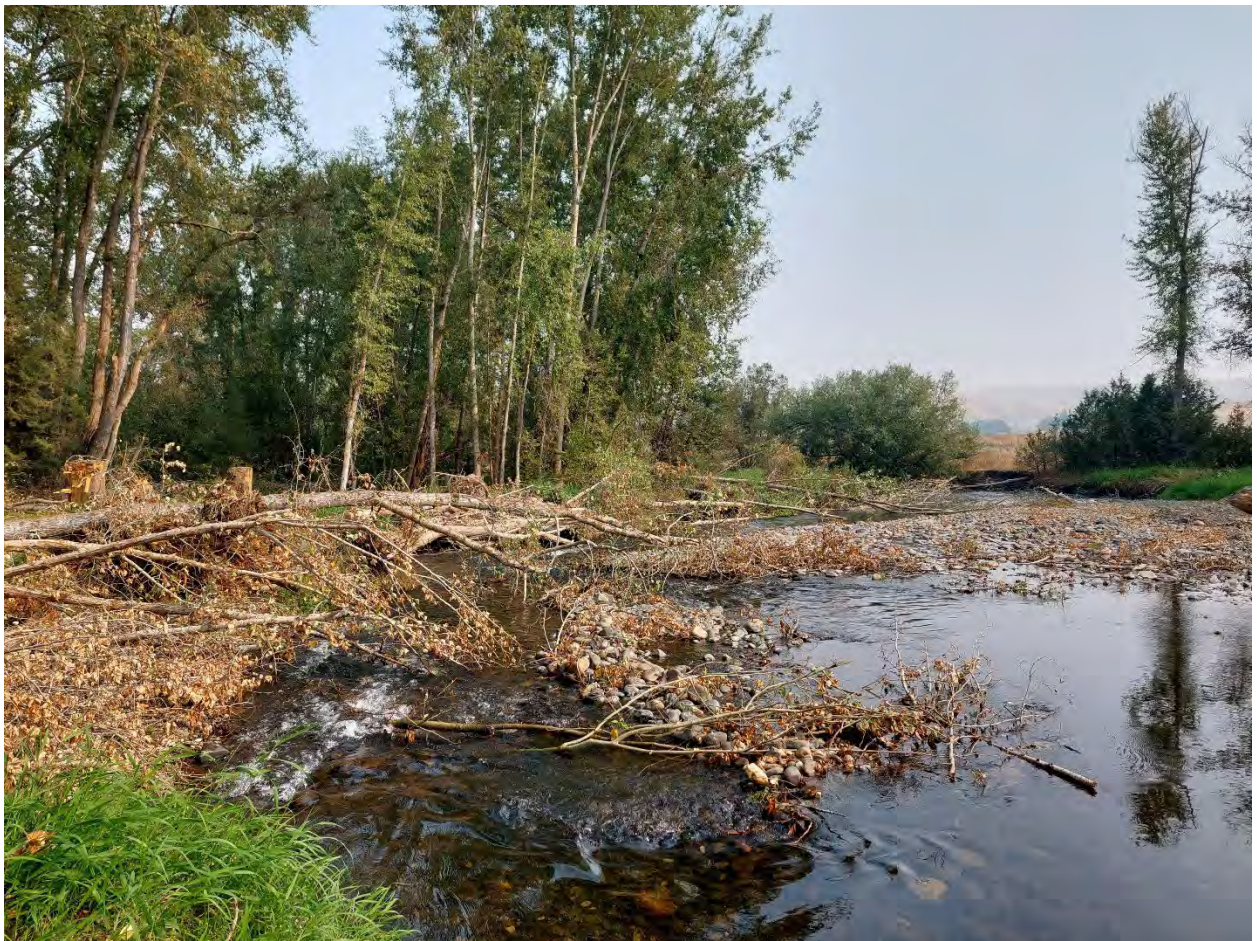
Photo Point 2:

Looking N downstream from left bank of Lostine River at proposed (a) and actual (b) PC2-Inlet.

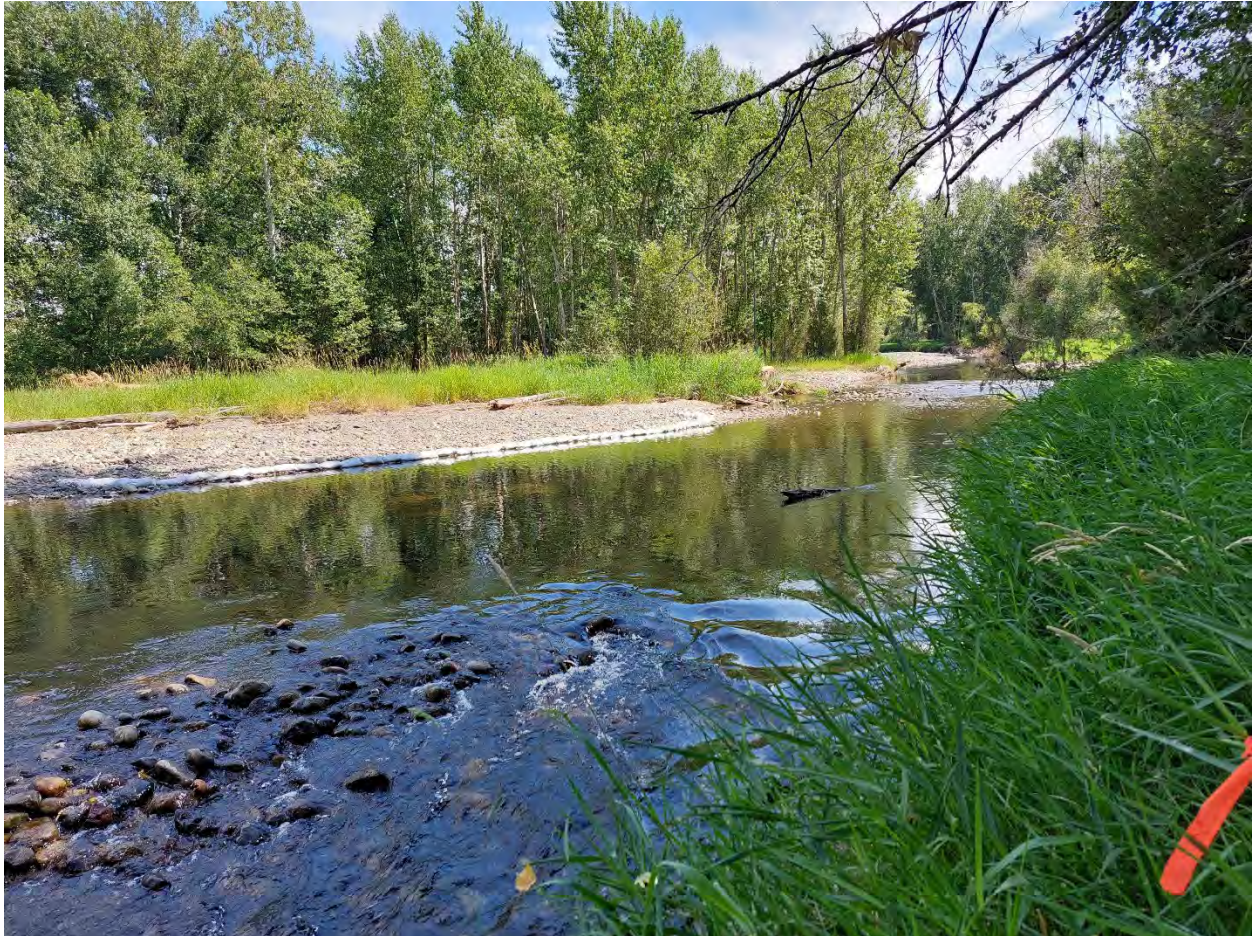
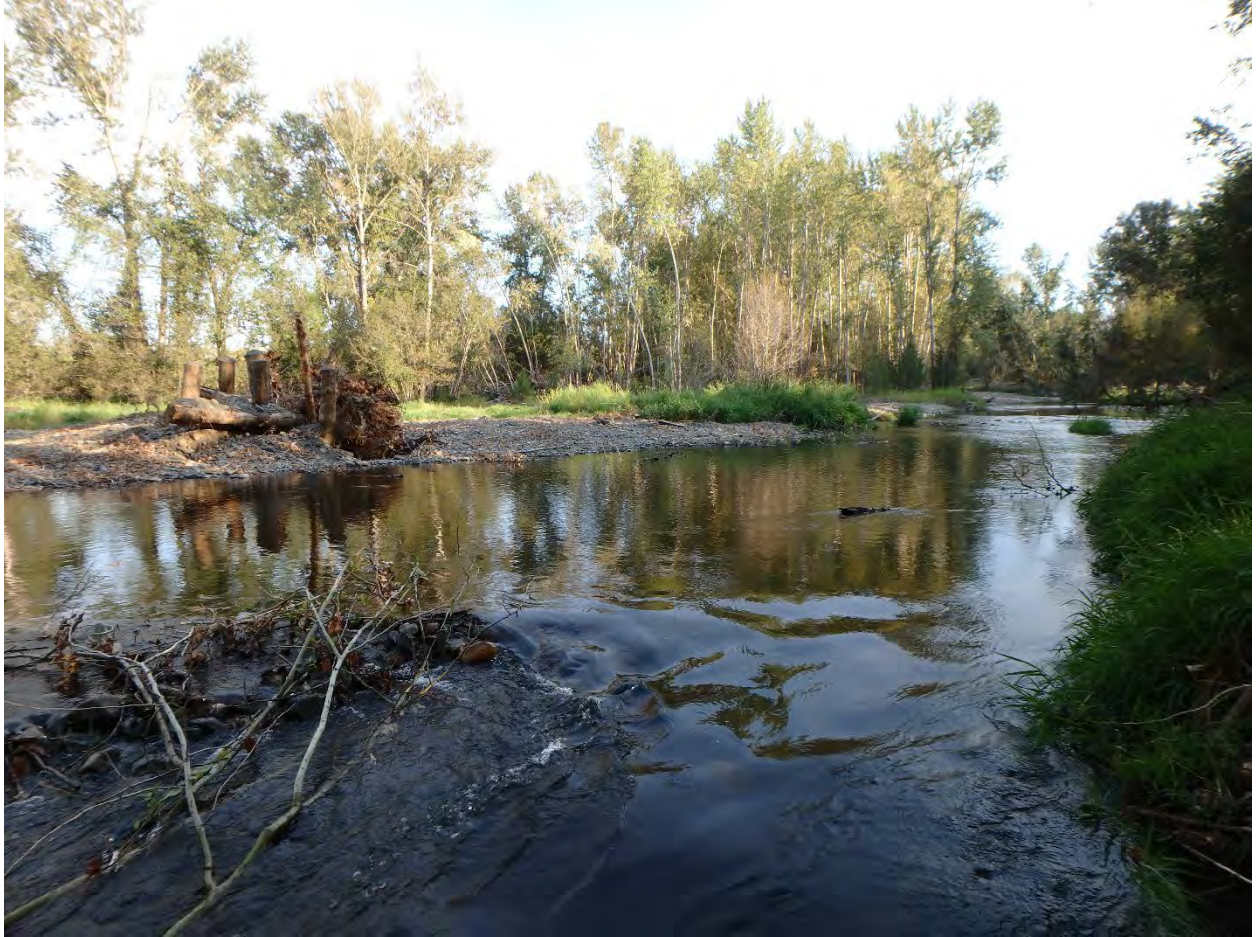
Photo Point 3:

Looking SE upstream from left bank of Lostine River at proposed (a) and actual (b) Large Apex Jam (A3).

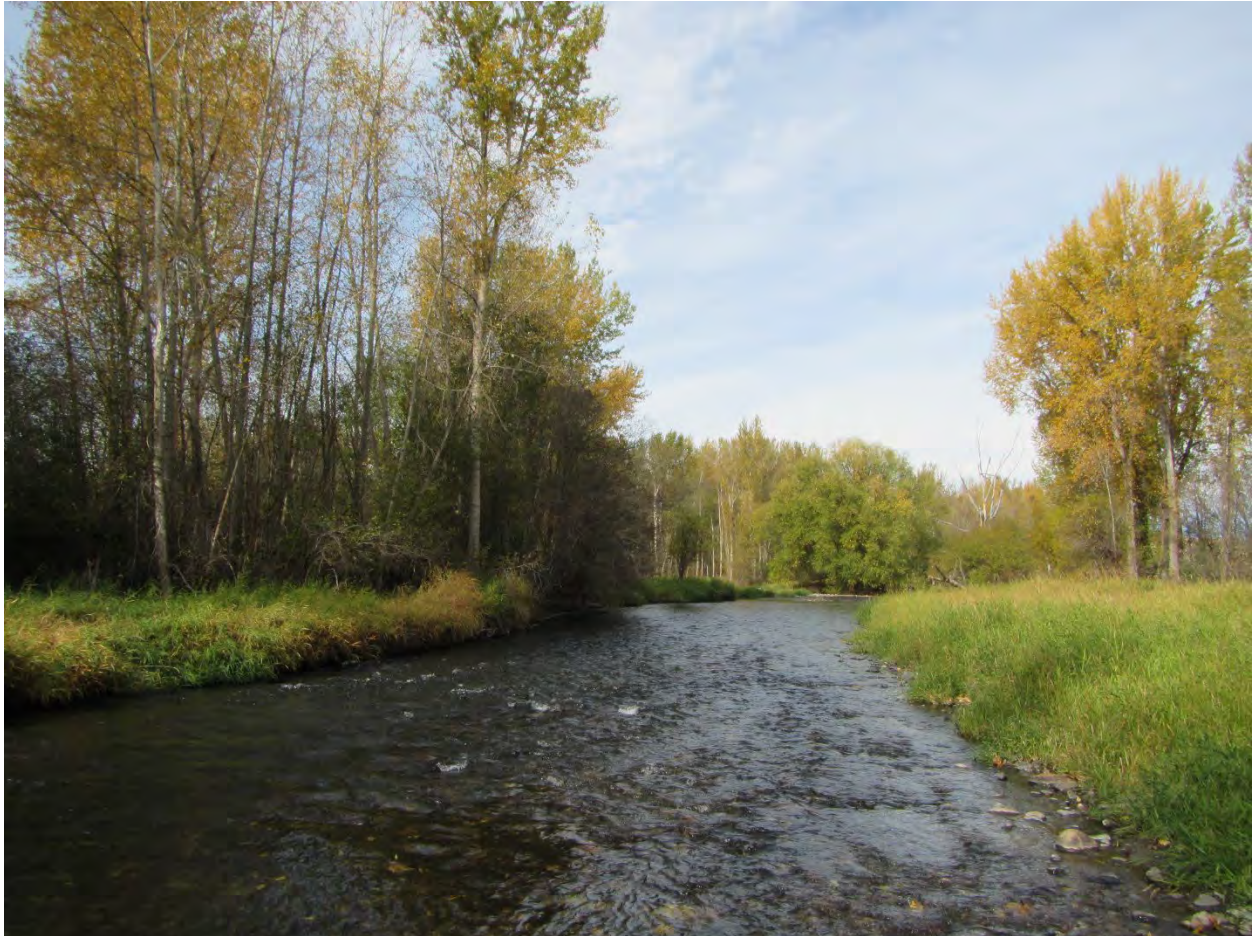
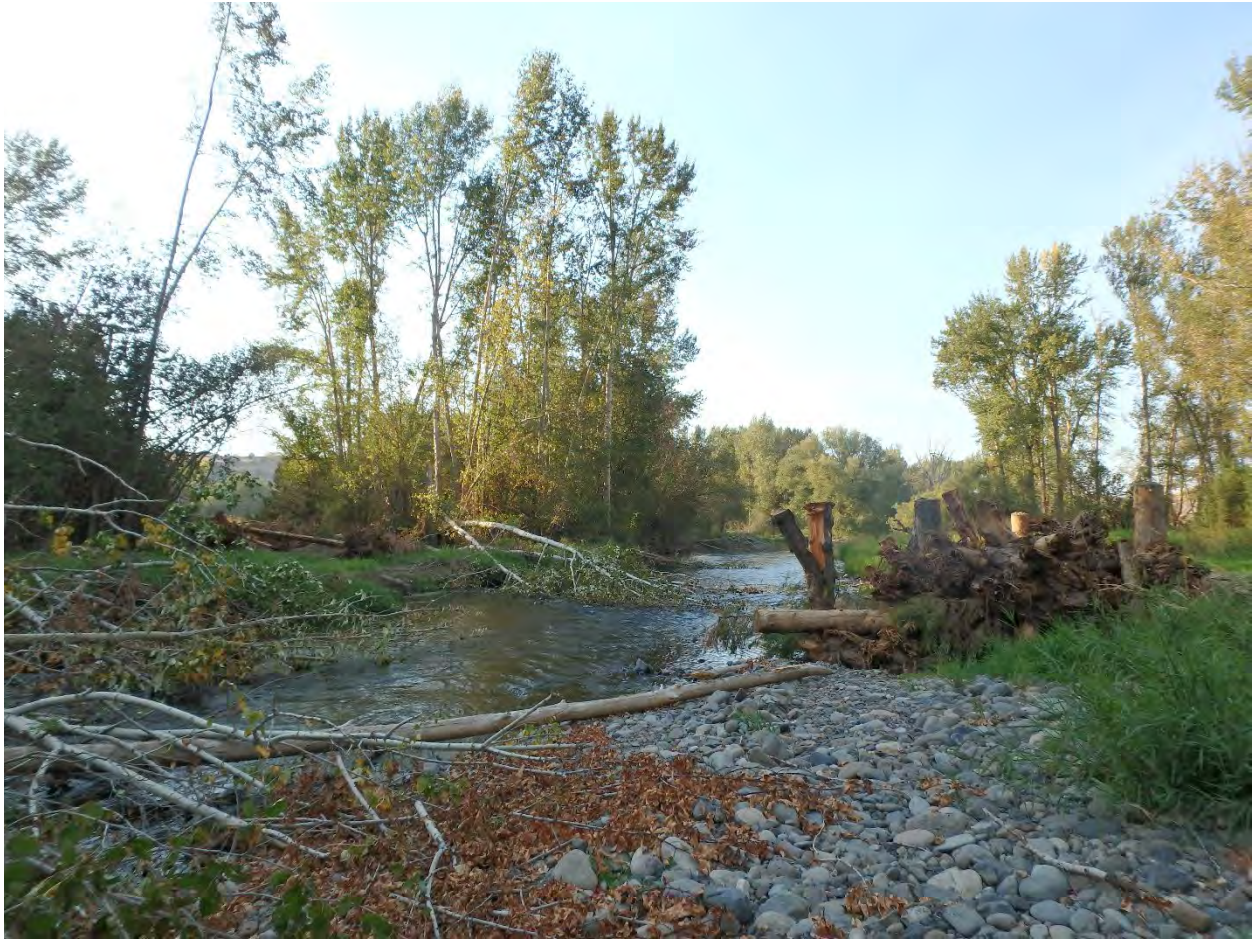
Photo Point 4:

Looking N downstream from right bank of Lostine River at proposed (a) and actual (b) Large Apex Jam (A1) to the right and Pilot Channel 1 Inlet to the left.

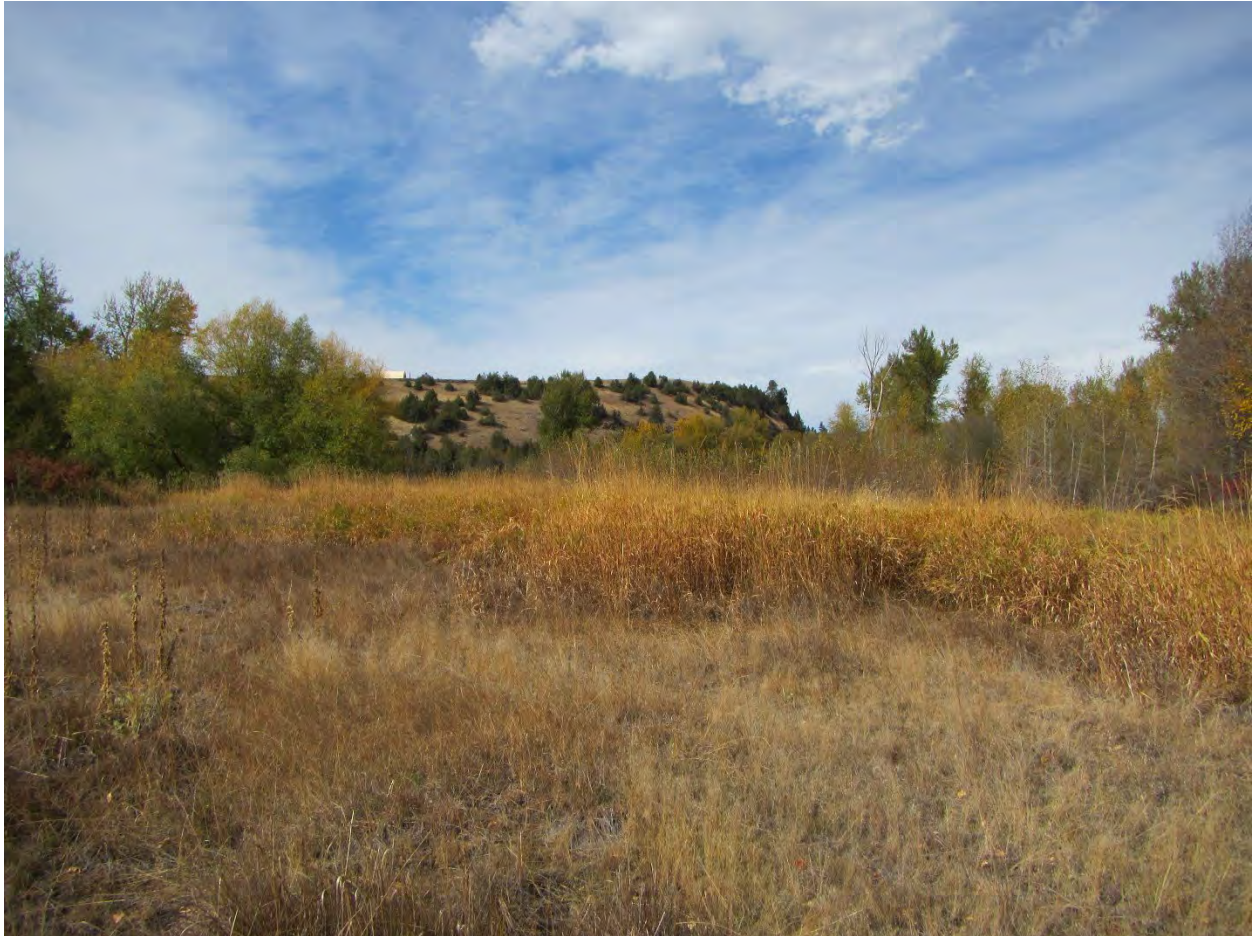
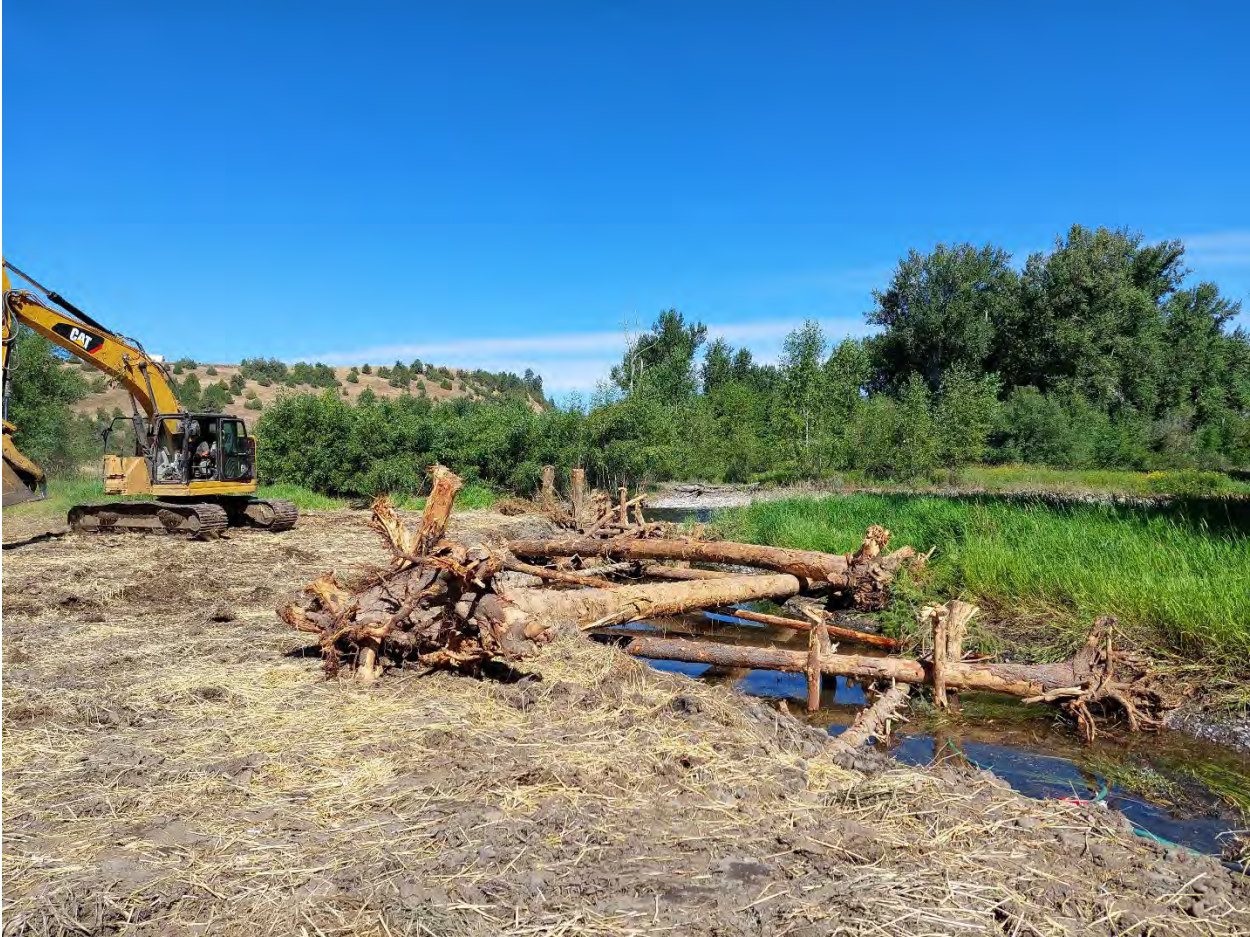
Photo Point 5:

Looking N towards the Wallowa River at proposed (a) and actual (b) Vertical Post Arrays and Small Apex Jam in Pilot Channel 1 Outlet.
