# **2006 Joseph Creek Watershed Upland Water Rehabilitation**

**BPA Contract #00028948  
BPA Project #1992-026-01**

## **Completion Report April, 2007**

The 2006 Joseph Creek Watershed Upland Water Rehabilitation Project was successfully completed from July – October, 2006. Twenty-seven new troughs, 15 springboxes, and 3,100 feet of new drainage were installed and nearly two miles of fence constructed at 26 different sites across the uplands of Upper and Lower Joseph Creek watersheds.

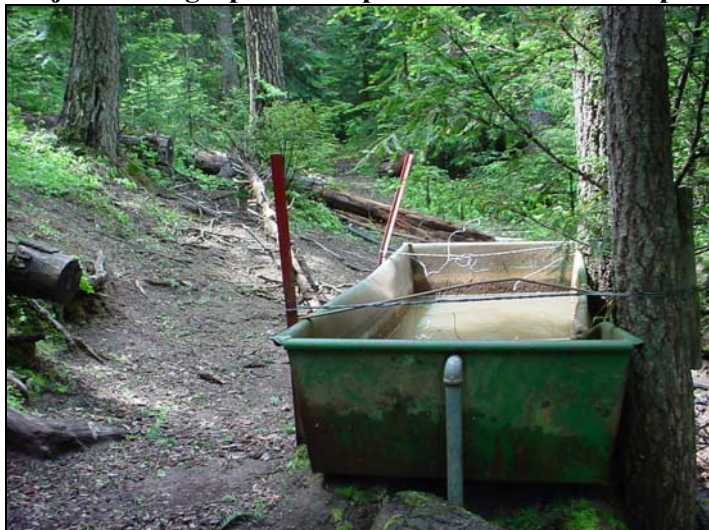
Coyote site before improvement.

| Spring Name | Notes | Troughs | Springbox | Fence (feet) |
|---|---|---|---|---|
| Coyote | Replaced/relocated trough (moved to other side of draw) | 1 | 0 | 381 |

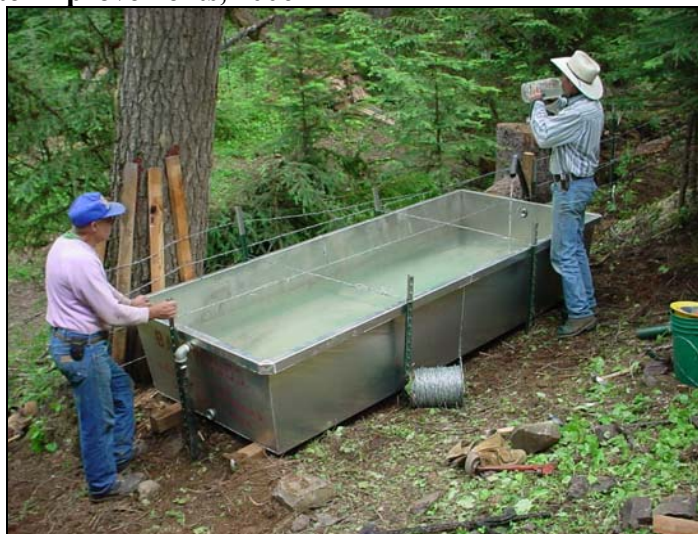
Coyote site after improvement.

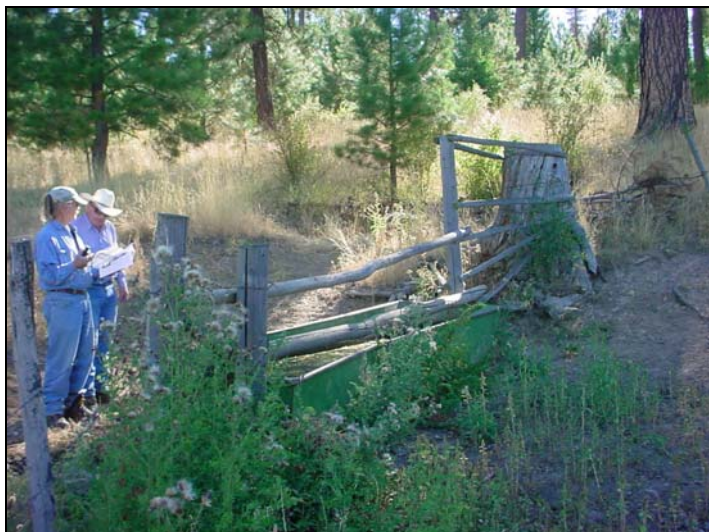
Wilder site before improvement.

| Spring Name | Notes | Troughs | Springbox | Fence (feet) |
|---|---|---|---|---|
| Wilder | Replaced/relocated trough (~220 ft downstream on old road bed); built little exclosure around springbox. | 1 | 0 | 126 |

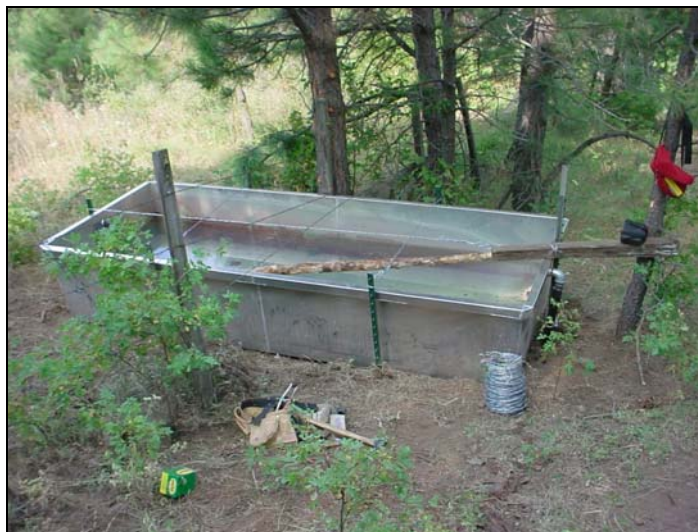
Wilder site after improvement.

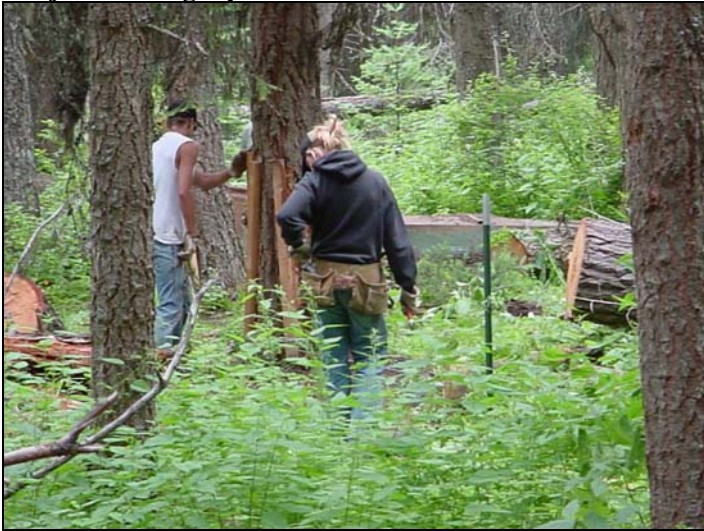
TEC youth crew building fence at Huckleberry spring.

| Spring Name | Notes | Troughs | Springbox | Fence (feet) |
|---|---|---|---|---|
| Huckleberry* | Replaced and relocated trough/springbox (moved out of draw ~50ft) | 1 | 1 | 225 |

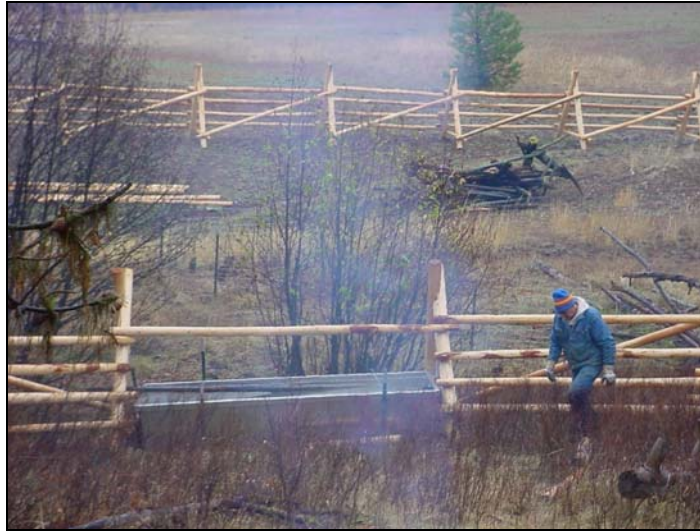
New trough and buck & pole fence at Dougherty spring.

| Spring Name | Notes | Troughs | Springbox | Fence (feet) |
|---|---|---|---|---|
| Dougharty | Replaced and relocated trough (moved out of draw); built buck & pole fence | 1 | 0 | 943 |

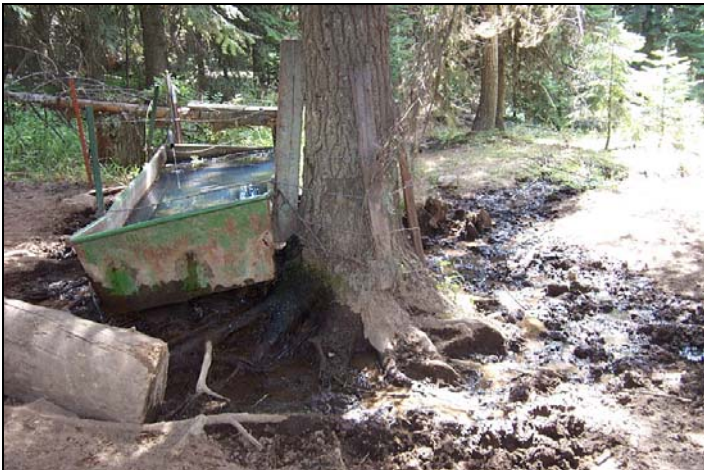
Summit Spring site before improvement – provided here as particularly bad before condition.

| Spring Name | Notes | Troughs | Springbox | Fence (feet) |
|---|---|---|---|---|
| Summit | Replaced trough and installed drain | 1 | 0 | 471 |

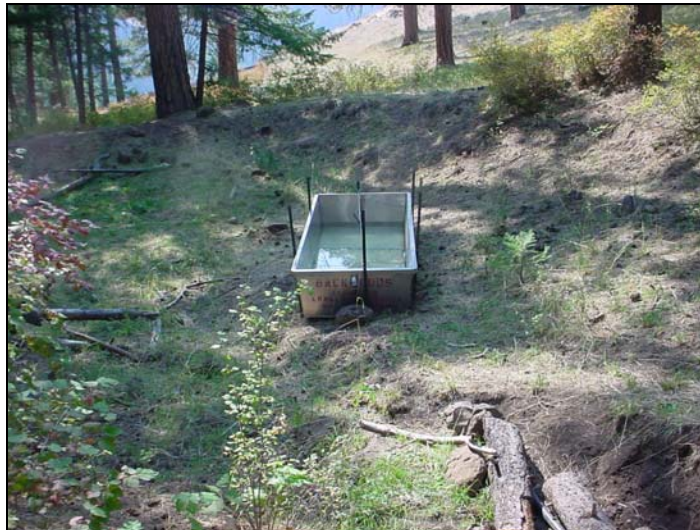
Rock Carin site after improvement – provided here as an example of better condition following improvement.

| Spring Name | Notes | Troughs | Springbox | Fence (feet) |
|---|---|---|---|---|
| Rock Carin | New Site. Installed 1 trough & 2 springboxes - 2 sources for 1 trough/box; put poles around spring for protection | 1 | 0 | 0 |
