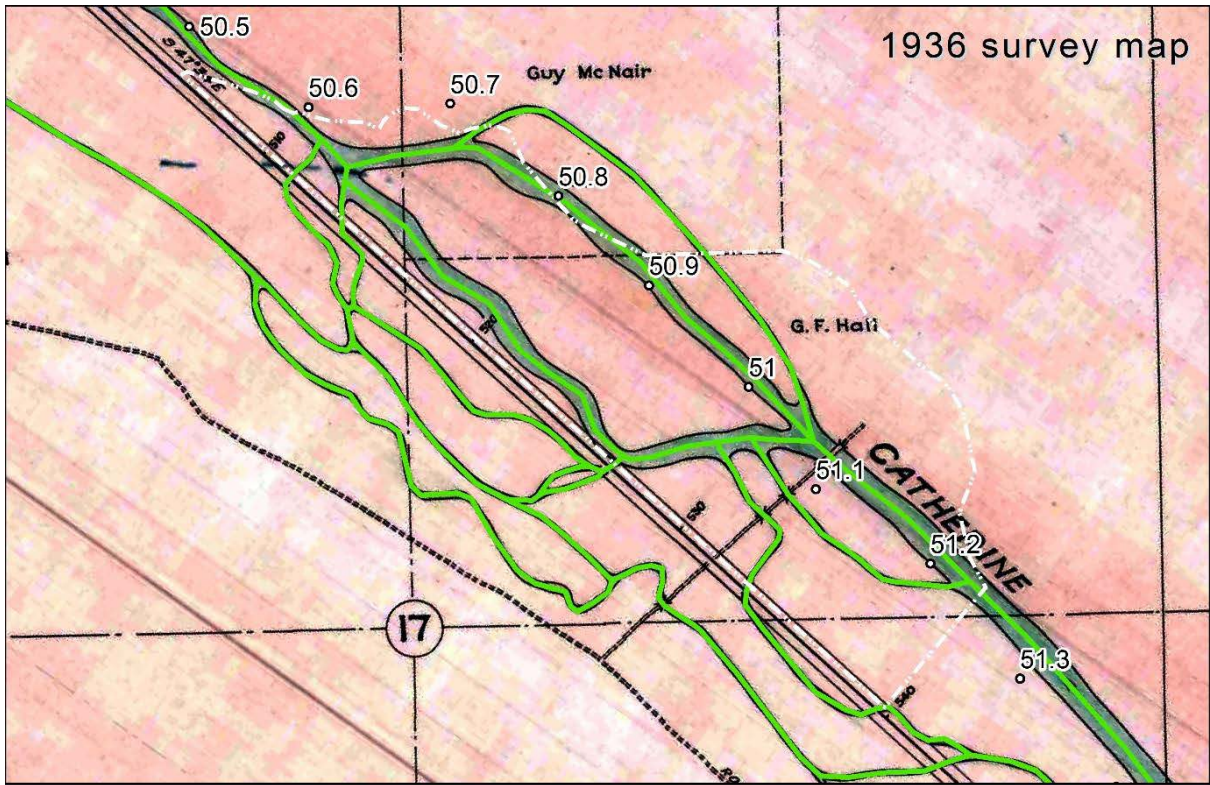
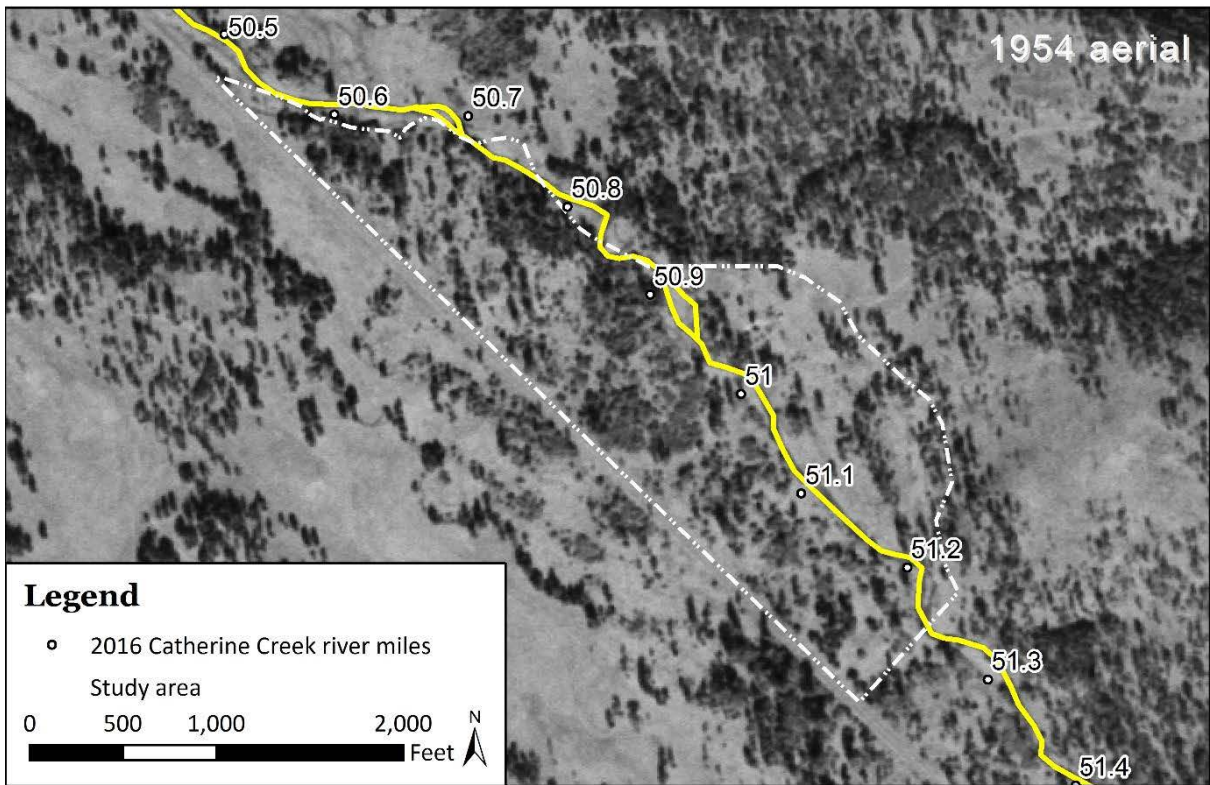
**Figure 3.** Historical imagery and centerlines of Catherine Creek in the project area vicinity, 1936 and 1954. The Study area encompasses Phase 1 of the Hall Ranch project. Phase 2 encompasses the entire Hall Ranch.

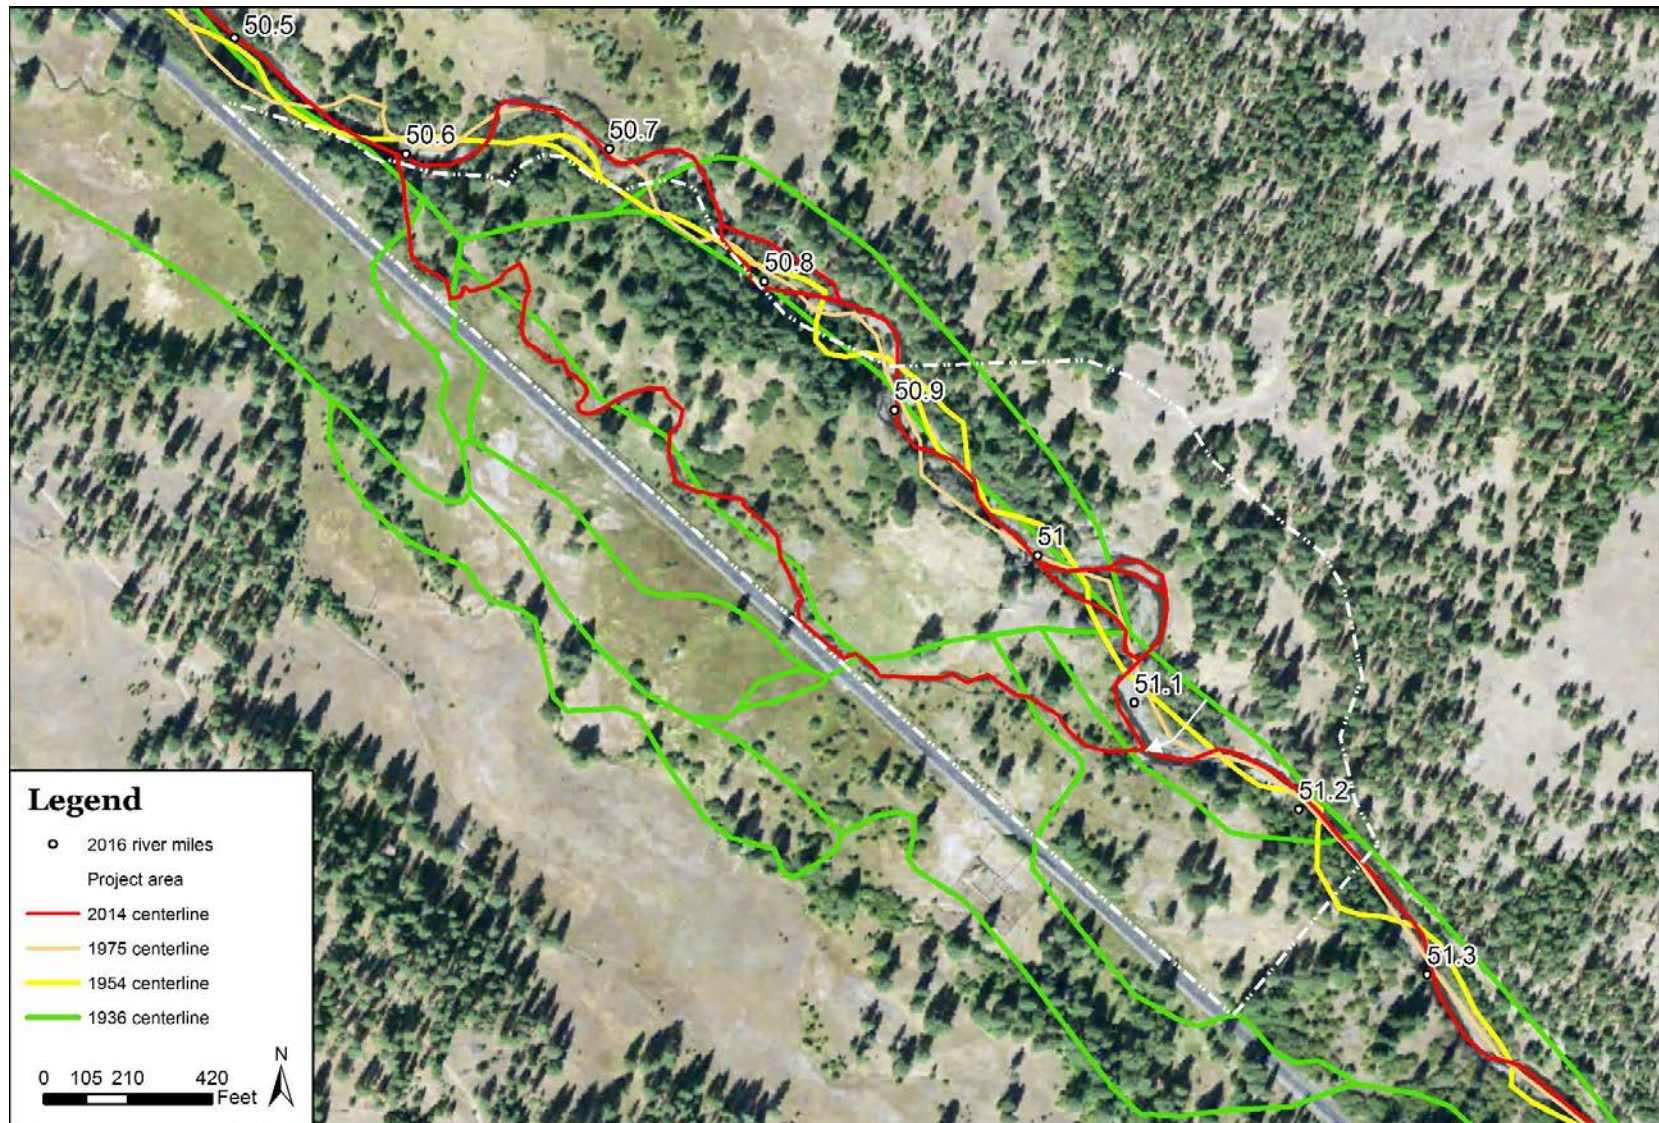
**Figure 4.** All historical centerlines of Catherine Creek on a 2014 image. White arrow shows area of consistent southwest channel migration since 1936.

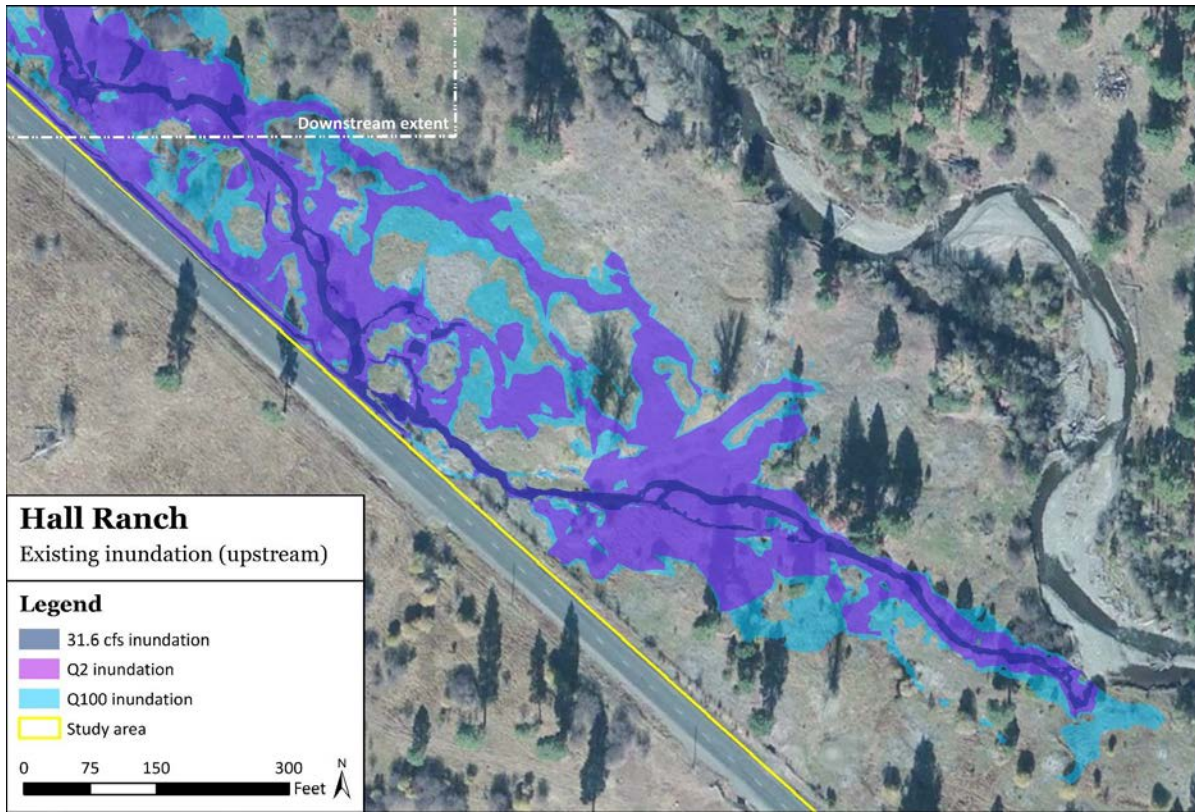
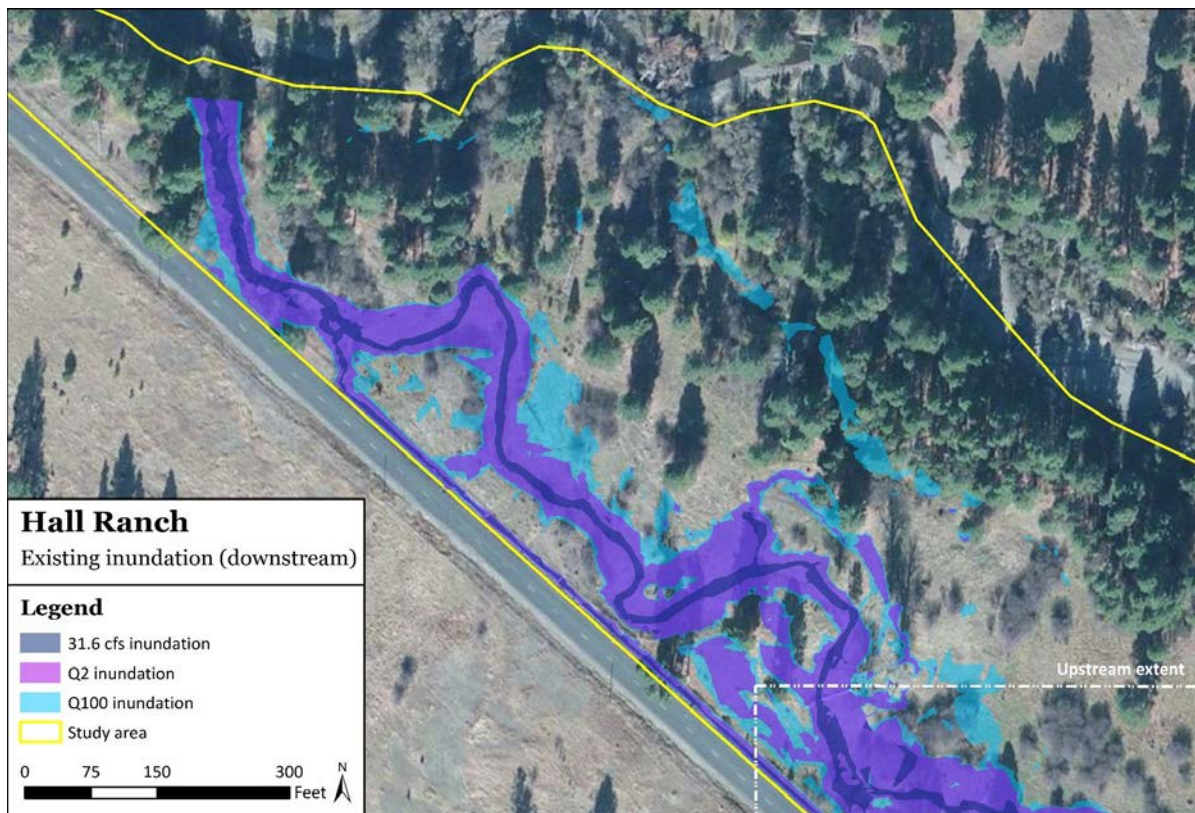
**Figure 5.** Modeled Inundation under Existing Conditions for the upstream and downstream portions of the side channel complex on the Hall Ranch property.
