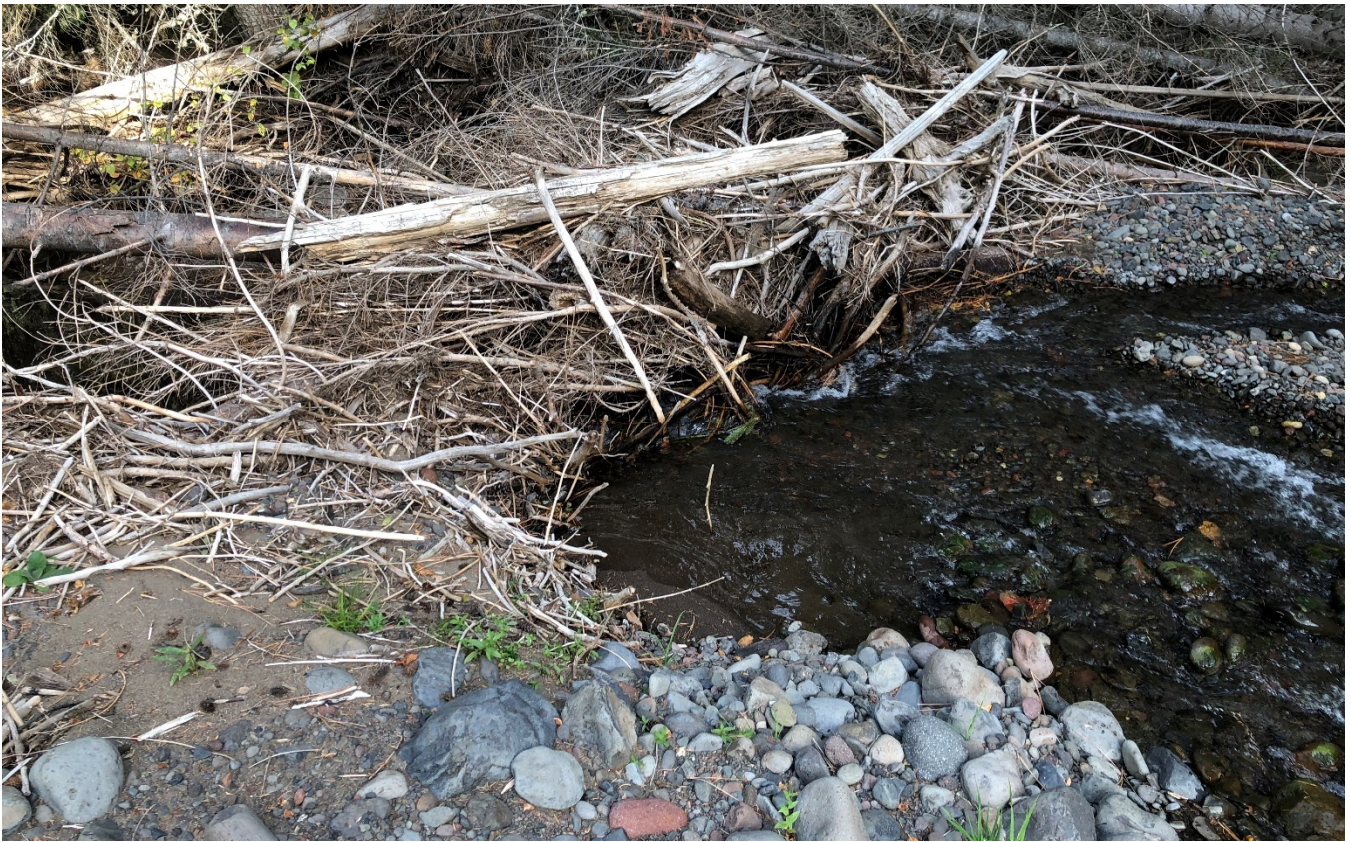
*Figure 3-3. Photo of an avulsion blocked by a jam at RM 5.3. Note the gravel material deposited upstream.*

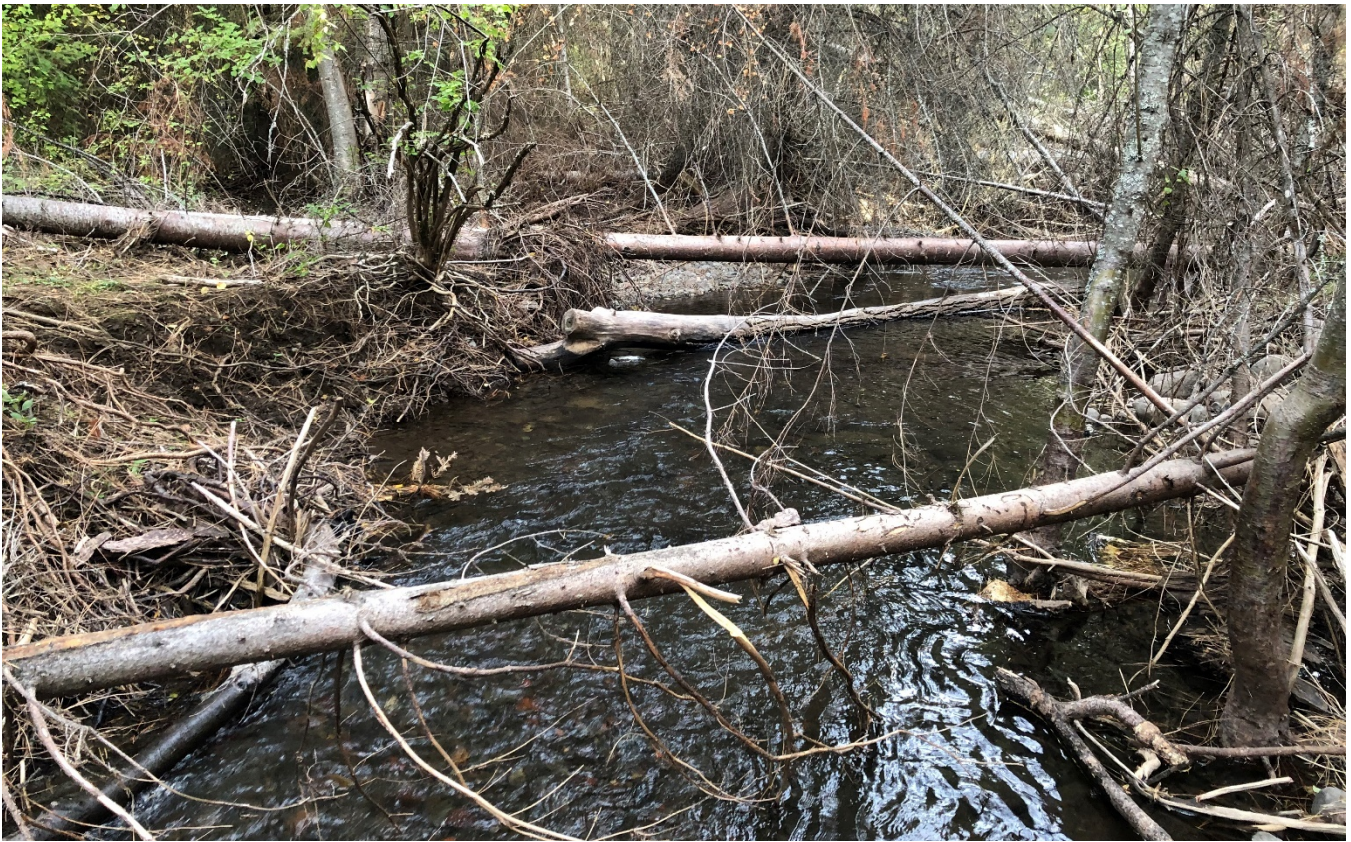
*Figure 3-4. Photo of an avulsion channel that has cut through the densely forested floodplain at RM 5.2. Note the low width-to-depth ratio, the large wood, and the bank vegetation.*
