Bear Creek-Sauvage Fish Habitat Restoration Project 80% Basis of Design Report

For Grande Ronde Model Watershed and Oregon Department of Fish and Wildlife
November 2025

Prepared by Rio Applied Science & Engineering
RioASE.com | Boise, ID

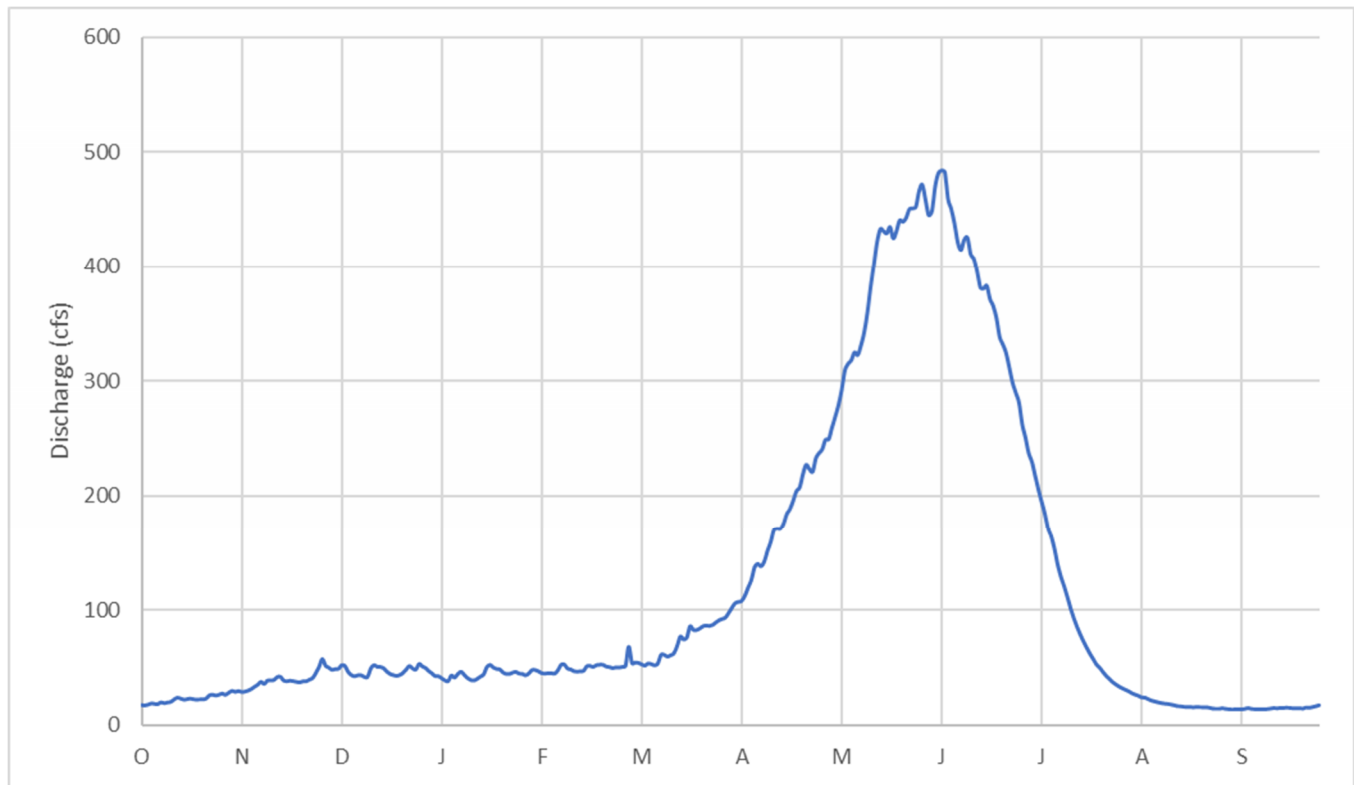
Figure 3-1. Average daily discharge for the period of record for gage 13330500.

Based on the annual flow hydrograph, there are four typical seasons observed throughout the year: winter flows (December–February), spring freshet (May–July), summer base flow (August–September), and fall rains (October–November). Figure 3-1 shows the average daily discharge for gage 13330500 over the water year (October–September). In addition to annual seasonal flows, the four seasonal flows were analyzed and estimated for flows at the downstream end of the project site (Table 3.2).

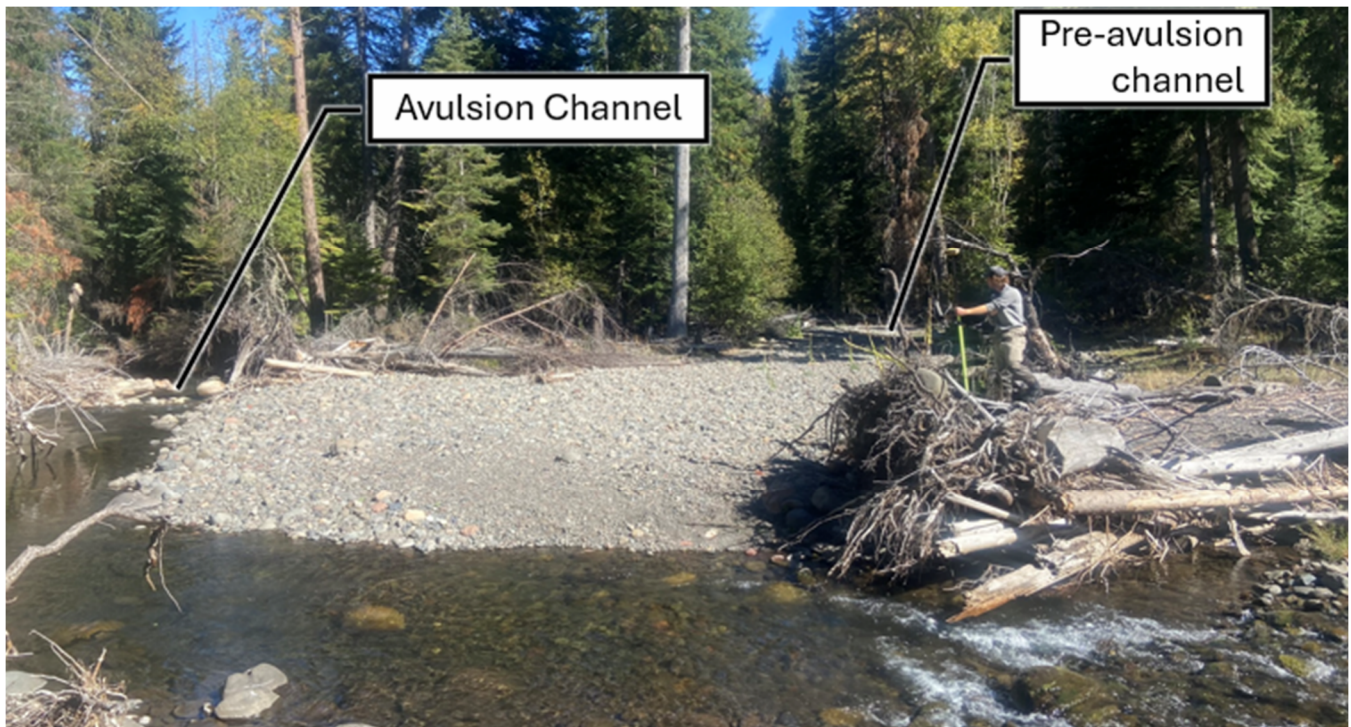
Figure 3-2. Photo of reference reach at a recent channel avulsion (RM 4.5). Note the smaller sediment size deposited in this reach, the large wood, and the varied hydraulics.

The project area remains heavily influenced by its geological and glacial past. The granitic intrusion forming the Wallowa Mountains created relatively steep topography and high-gradient streams, resulting in high stream energy and sediment transport capacity. In areas where concentrated flow and stream energy is effectively dissipated by large and periodically channel-spanning log jams, sediment transport capacity is diminished and fine-grained (sand/gravel) alluvial sediment has been deposited. These areas are characterized by diverse, multi-threaded channel formations with complex riffle-pool morphology. Channel evolution within these areas is driven by a combination of migration and avulsion. The largest obstructions abruptly redirect the channel through the adjacent floodplain, creating a new channel via avulsion, while smaller obstructions tend to influence bank erosion, resulting in relatively gradual migration and meander formation. Both avulsion and migration processes result in dynamic channel planforms, the recruitment of woody debris and gravel sediment, and the creation of highly variable hydraulic conditions and complex habitat. These areas were treated as reference reaches during project development (Figure 3-2, Figure 3-3, and Figure 3-4).
