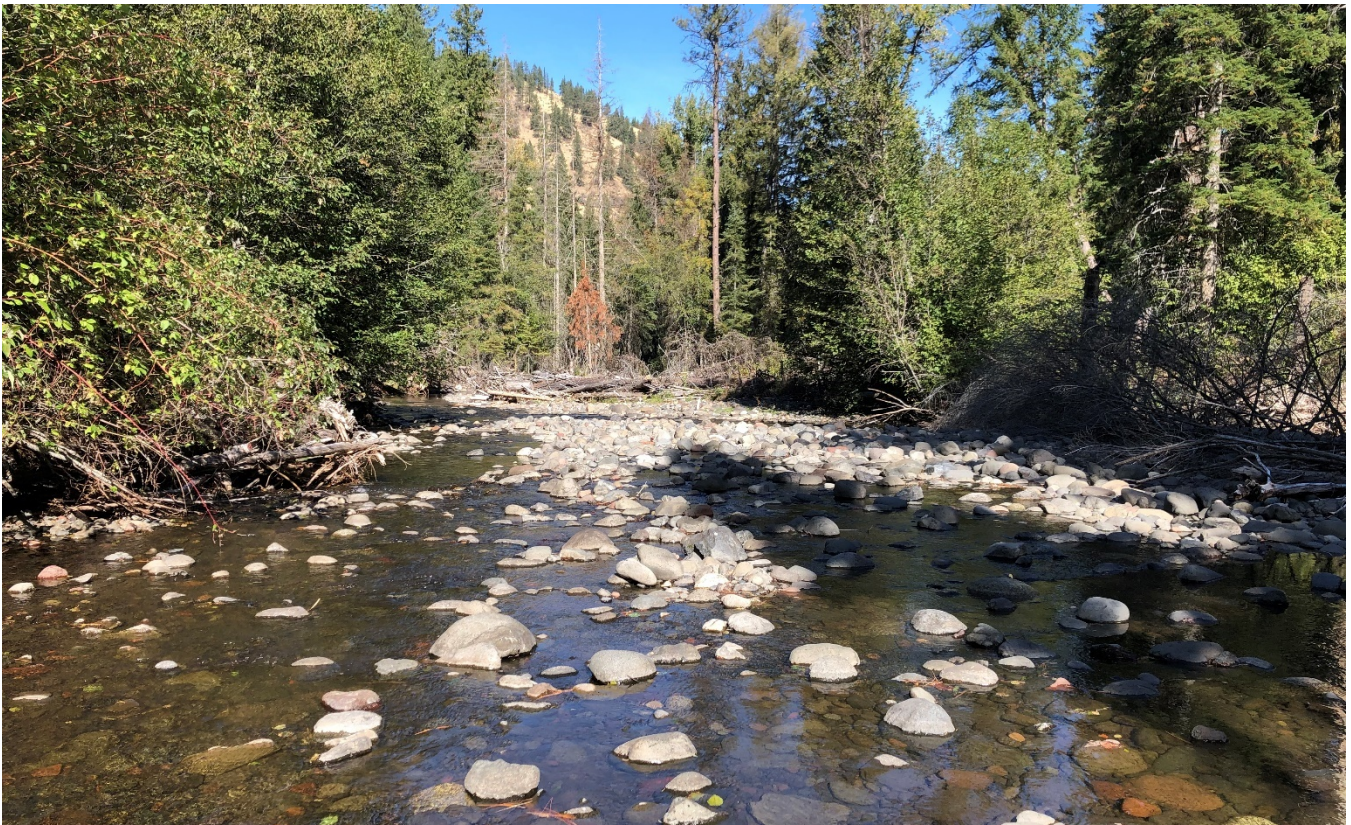
*Figure 3-5. Photo example of a straight, homogenous, armored, and over-widened channel segment found in the project area. Note the large material and lack of low-flow channel definition.*

The lack of habitat quantity and diversity on Bear Creek can be summarized as a lack of pools, a lack of spawning-sized sediment, and a lack of hydraulic diversity. All of these habitat concerns are inter-related and can be improved upon by leveraging the same processes. The existing channel bed material is characterized by an armor layer of large cobble and boulder material that is not readily mobilized. This is generally the case for the entire project area, but the size of the material is largest on the reaches that are straight and over-widened while various amounts of sand and gravel have been deposited in dynamic reaches influenced by large woody structures (see geomorphic discussion in Section 3.2 above). A straight, over-widened, and heavily armored channel is problematic from a habitat perspective for a number of reasons, including:

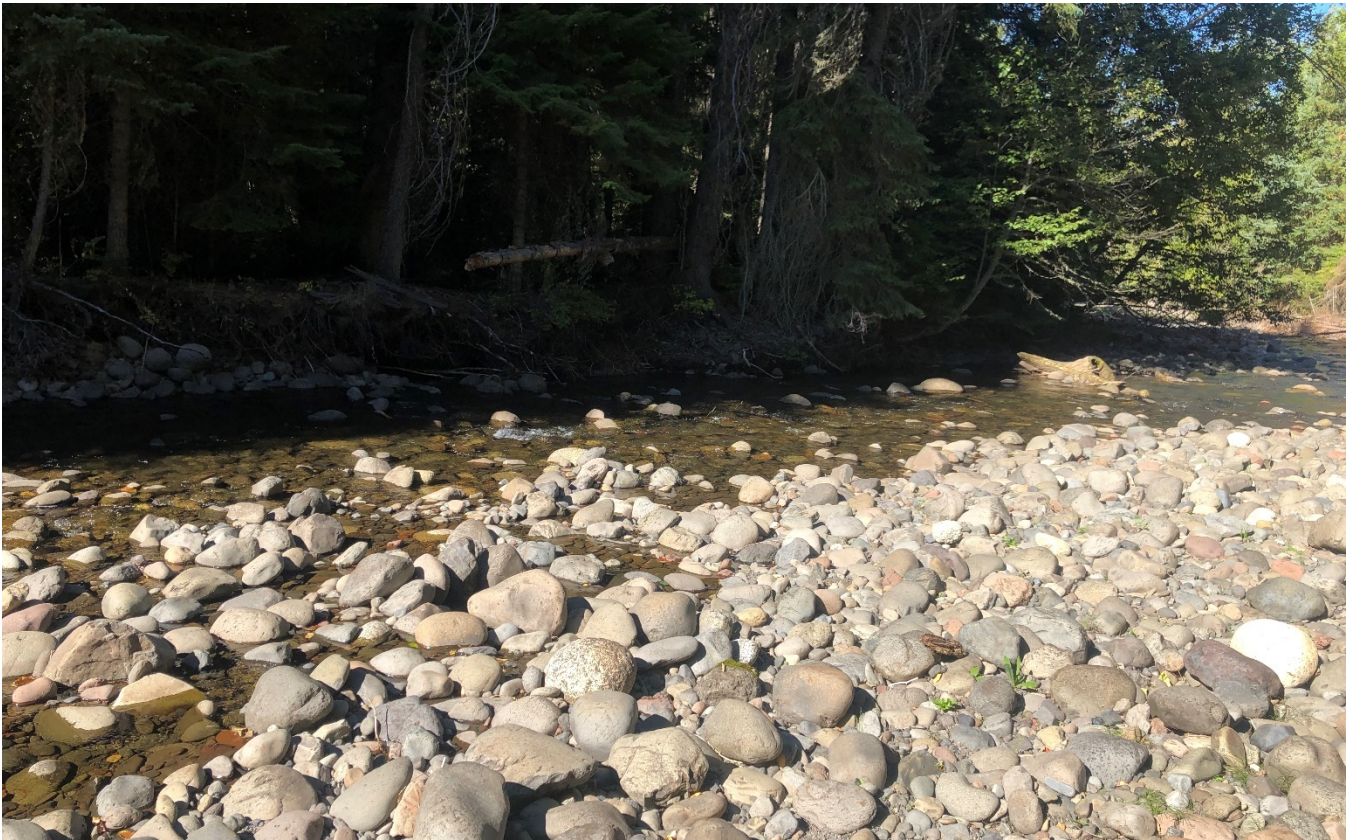
*Figure 3-6. Photo example of a straight, homogenous, armored, and over-widened channel segment in the project area. Note the large material and lack of habitat diversity.*
