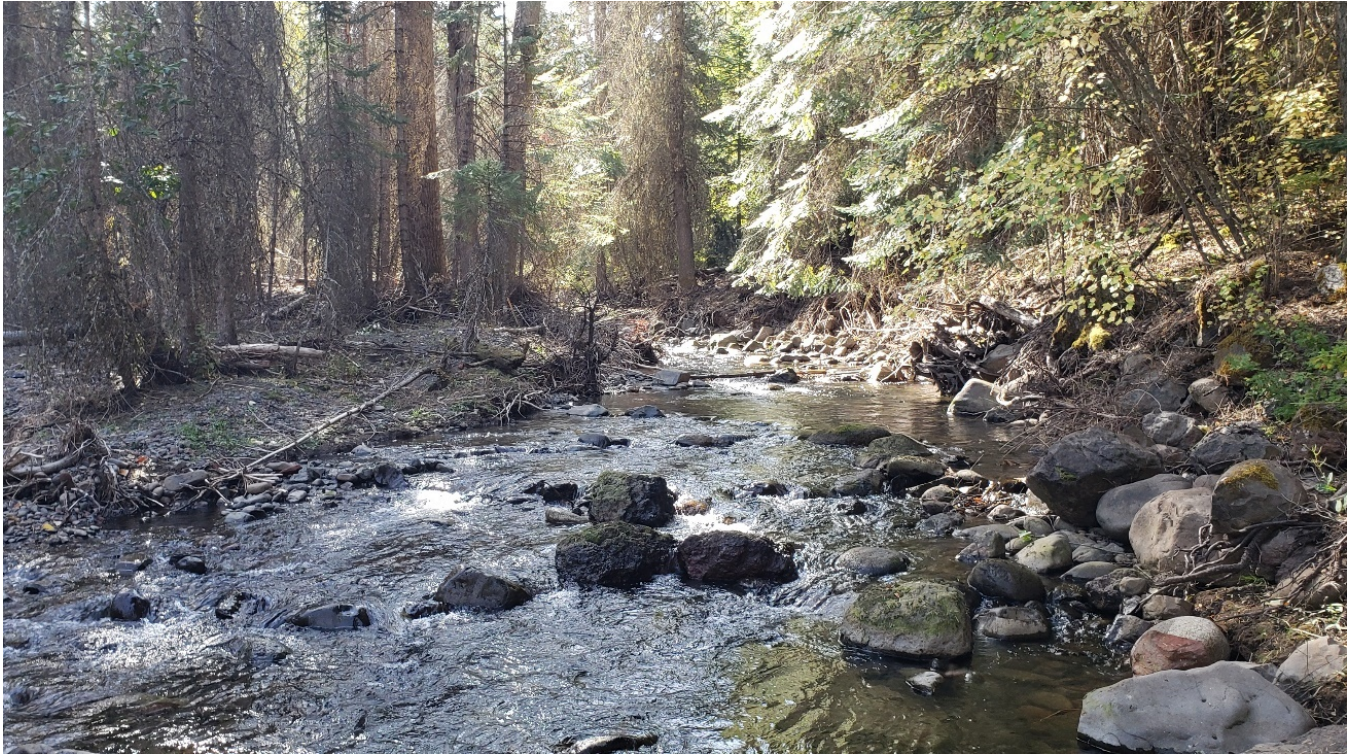
Figure 3-7. Example of densely forested floodplain vegetation from October 2024 site visit.

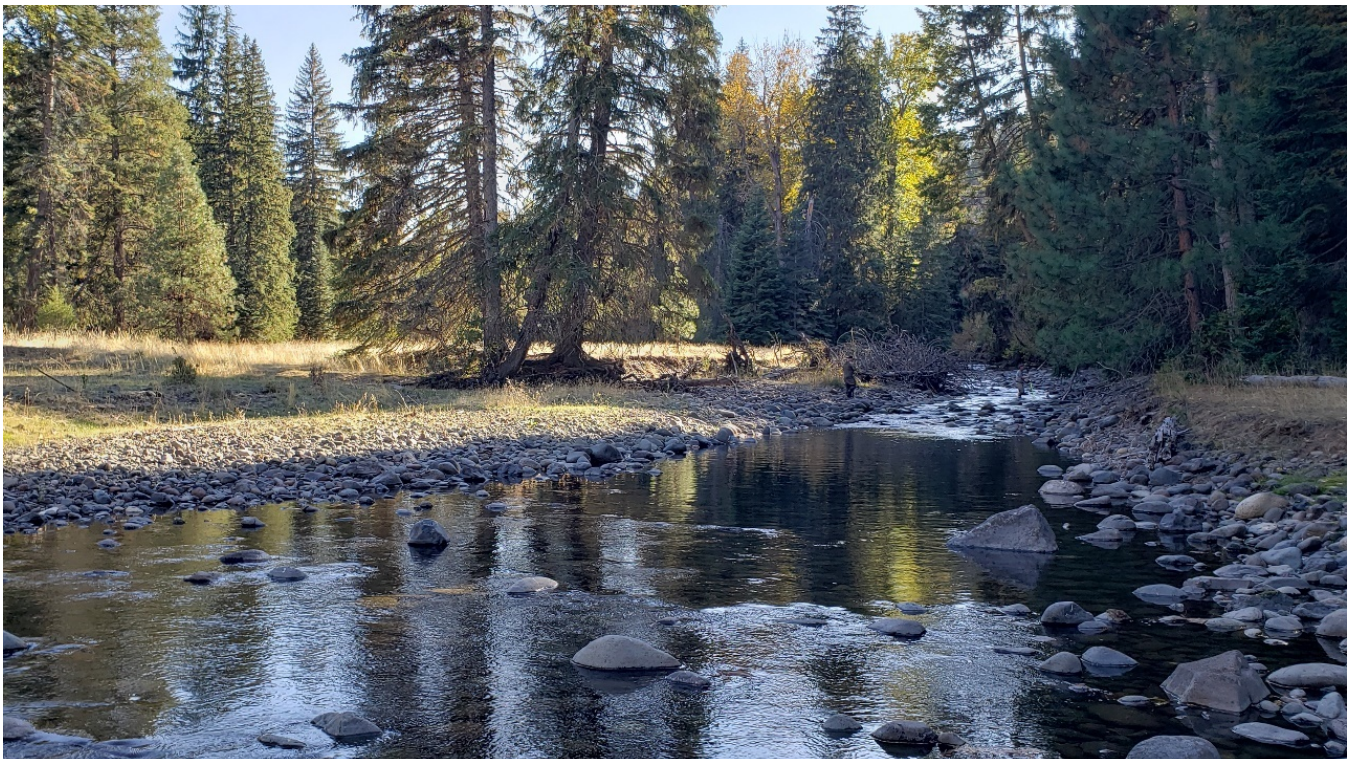
Figure 3-8. Grassy floodplain with poor bank vegetation and no willow or cottonwood recruitment.

shown in Figure 3-8. Although relatively sparse within and adjacent to the main streamflow channels, facultative wetland forb species such as sedge (*Carex ssp.*) were observed. Several Palustrine Emergent (PEM) wetland complexes were identified upgradient along the floodplain. In addition, weedy forb species were observed within relatively disturbed areas (e.g., along Bear Creek Road). These included mullein (*Verbascum thapsus*), ragweed (*Ambrosia psilostachya*), dock (*Rumex crispus*), and spotted knapweed (*Centaurea stoebe*).

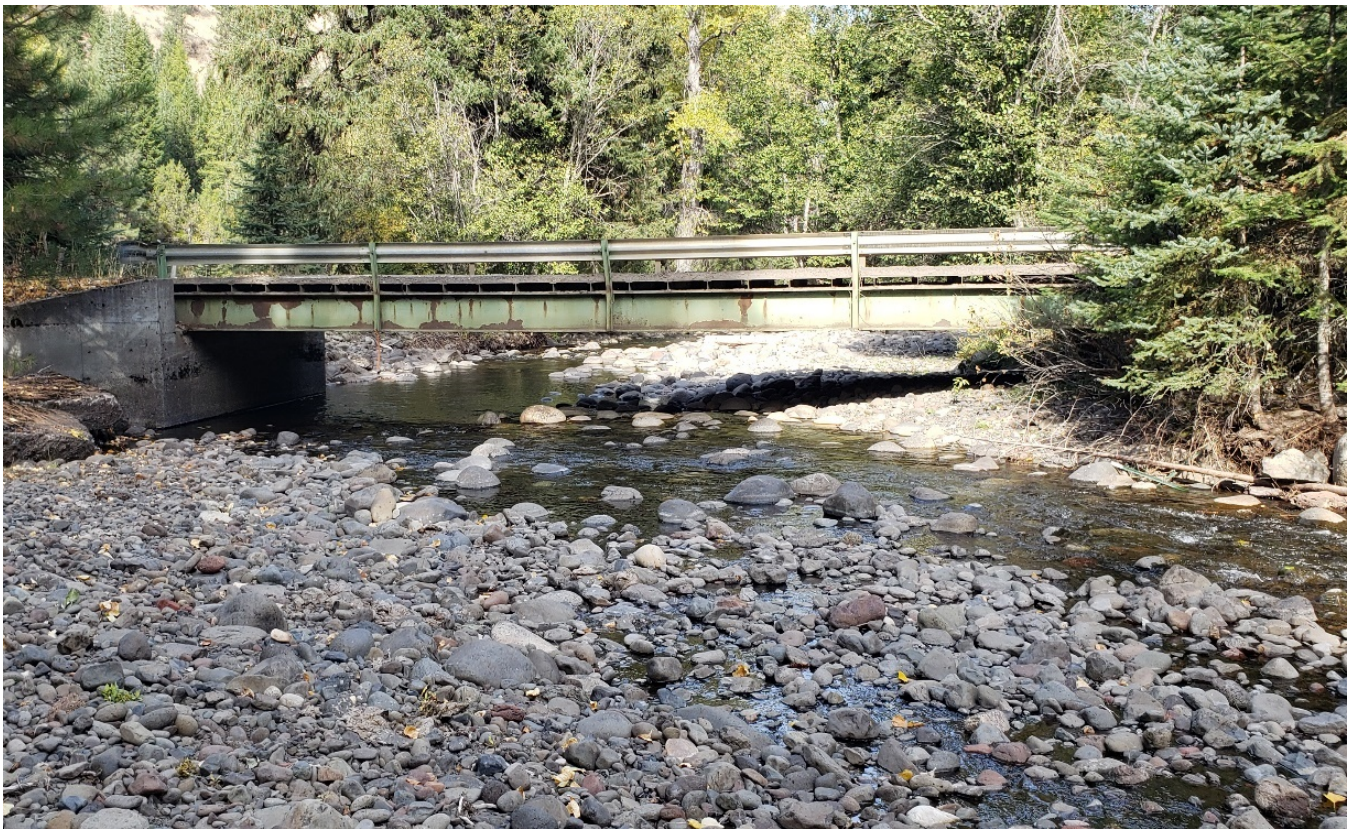
Figure 3-9. The existing Wallowa County bridge is located halfway through the project at RM 4.3.

There is limited infrastructure within the project area. At the upstream project boundary, the McDaniel property has a cabin that is on the valley margin, offset from Bear Creek, but only 0.6 feet above the modeled existing 100-year WSE. There is an existing Wallowa County-owned bridge roughly halfway through the project area at RM 4.3 (Figure 3-9). At the 100-year recurrence interval flood, it is estimated that the low chord of the bridge is 1 ft below the modeled WSE, indicating that the bridge opening is undersized and at risk of failure during flooding. Near the county bridge there is a small parcel that has a cabin that is currently 4 ft above the existing modeled 100-year WSE. However, this parcel is for sale—the project team is looking at acquiring the property and may remove or relocate the structure. There is a private bridge, owned by the Sauvage family, at the downstream end of the project area that the landowner indicated could be removed (Figure 3-10). Coordination with OWRD is ongoing to determine if the existing stream gage needs to be relocated. Hydraulic modeling suggests this bridge may become inundated and exhibit pressure flow at the 100-year recurrence interval flood. From the downstream end of the project at RM 3.1 up to RM 3.6, Bear Creek flows directly adjacent to Bear Creek Road. Existing conditions model results indicate that portions of Bear Creek Road experience flooding at the 100-year recurrence interval flood (Figure 3-11). Additionally, observations in the field indicate that maintenance has historically been performed to fix erosion hazards along Bear Creek Road through this reach, suggesting that erosion of the road prism has been a problem in the past and will likely continue in the future if no action is taken.
