# **CTUIR GRANDE RONDE WATERSHED RESTORATION LONGLY MEADOWS FISH HABITAT ENHANCEMENT PROJECT COMPLETION REPORT**

**Bonneville Power Administration-Grande Ronde Model Watershed**  
(1992-026-01, Contract #73982)

Confederated Tribes Umatilla Indian Reservation  
Department Natural Resources Fisheries Program  
Pendleton, Oregon  
Report Drafted: February, 2022

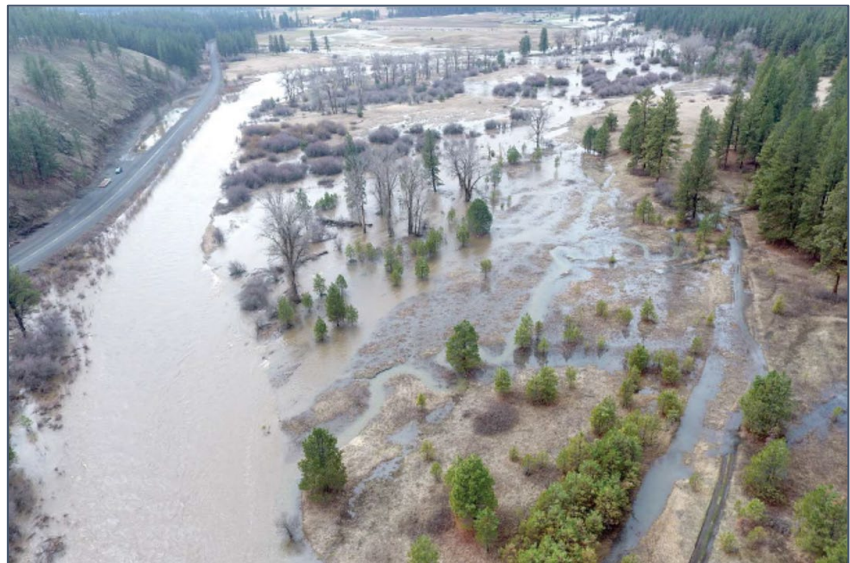
**PRE-PROJECT CONDITION DURING LARGE FLOOD EVENT ILLUSTRATING FLOODPLAIN POTENTIAL. PROJECT DESIGNED TO ACTIVATE FLOODPLAIN ON AN ANNUAL BASIS**

Previous attempts at restoring this reach consisted of the placement of instream structures including rock weirs, rock barbs, and large wood buried in banks. These efforts have been marginally successful due in part to the scale of previous attempts, winter ice issues, and a lack of existing large streamside trees within the reach. Ice that forms tends to create jams, which then break and raft through the reach. Ice processes are naturally occurring, but have likely been exacerbated by loss

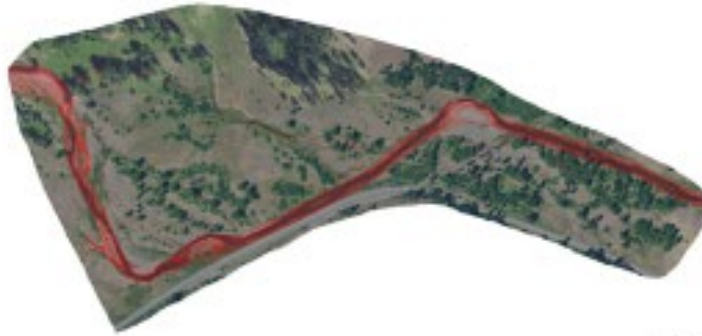
Existing Condition Bankfull (1.25 Yr. ~1,450 cfs)

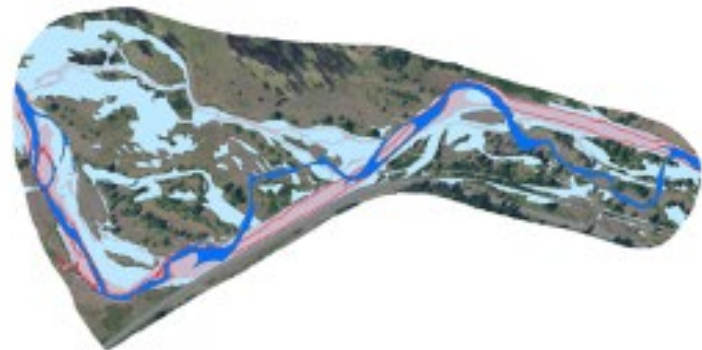
Existing Bankfull and 5 Year Floodflow  
w/ Design Base flow (dark blue) (approx. 18 cfs)

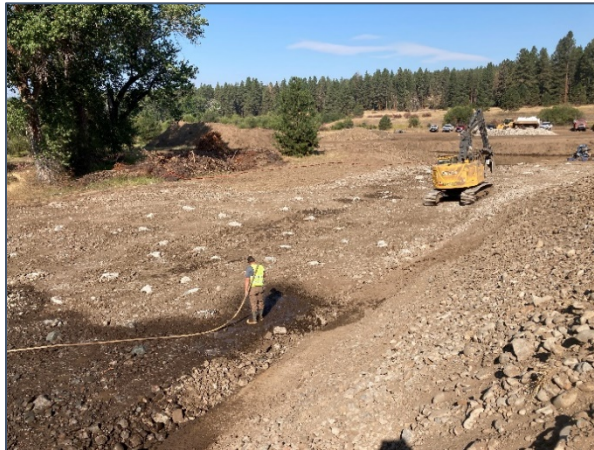
Constructed riffles were intended to be at least as stable as those found upstream of the Project to allow for dynamic adjustments while providing vertical stability. In general, constructed riffles crests will be stable for discharges at and below the 10-year return interval flood, and most riffle faces will be stable through the 2-year return interval. At discharges exceeding the 2-year peak, it is expected that channel substrate at riffle

locations may adjust within the Project area similar to natural stream reaches in this setting. To determine the required gradation for the riffle matrix, the GeoHECRAS 2D modeling outputs for the 2 and 10-year shear stress were evaluated at each of the riffle locations. The maximum shear stress was recorded for each riffle for the evaluated design flows which was then used to determine the gradation required for the riffle matrix.

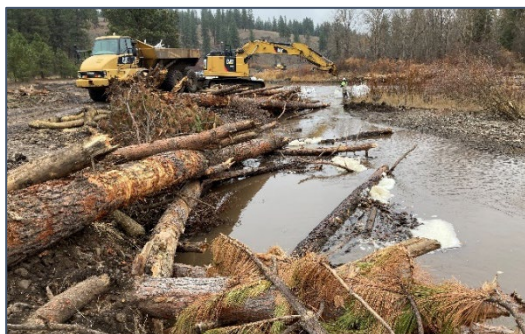
LWM structures were designed and strategically placed to create habitat complexity, overhead cover, velocity refuge, and as hydraulic forcing agents to create and maintain pools, split flows, and/or to provide bank stability. The locations and structure types vary in size and complexity. Types of large wood

structures include apex (mid-channel), meander bend, channel margin, floodplain roughness, and reinforced habitat structures, as well as sweeper logs and cover logs. Structures were designed to be overtopped by raft ice at key locations to promote sustainability and longevity. Pool structures were designed to encourage energy dissipation, abrupt forcing scour to maintain pool depths, and submergence of LWM during low flow conditions. Design of all wood structures attempted to mimic natural large wood accumulations using locally sourced large wood.

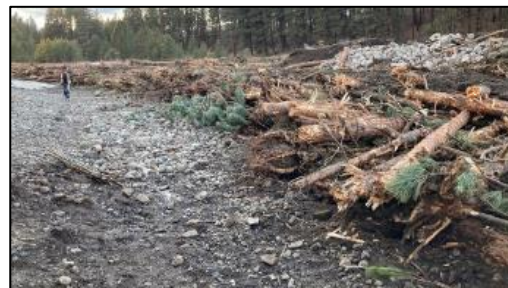
Constructed sections of the mainstem and side channels were reinforced with woody bioengineering to provide bank stability and facilitate establishment of native riparian vegetation. Bank treatments incorporated native vegetation and large wood to mimic natural channel banks. They were designed to provide energy dissipation and erosion resistance to allow natural vegetation to become established for long-term riparian development, shading, large wood

recruitment, and to promote natural rates of channel migration. Placement was determined based on hydraulic modeling to ensure that those areas with high shear stress were treated appropriately.

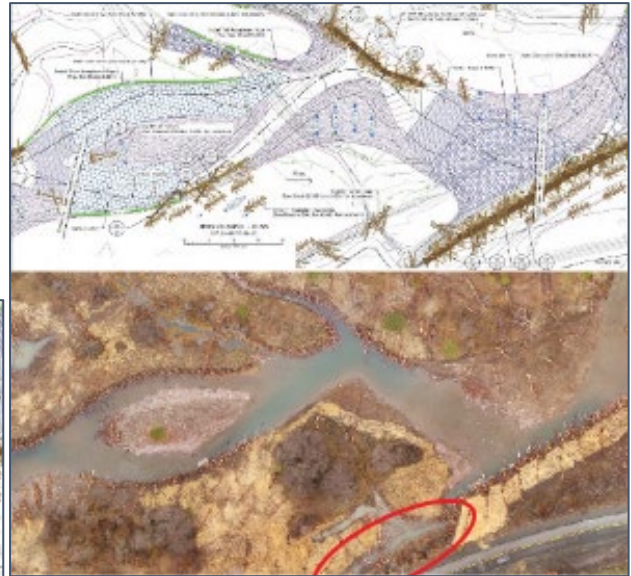
Examples of field changes are presented in the following. To right, main channel reclamation grading was adjusted in specific locations to increase off-channel alcove habitat (shown in red) and to minimize impacts to existing riparian vegetation while maintaining deep and complex off channel habitat with existing vegetation providing shade and bank structure.

Bypass channel between Sta. MC 41+00 downstream to entrance of MC-B. Before reclaiming this particular bypass channel the decision was made to establish the fill elevation slightly lower than original design. The reasoning was to increase channel capacity at high flows, resulting in lower velocities and sheer stress at the entrance to Side Channel (SC) 5 directly across channel from the adjusted bypass reclamation.

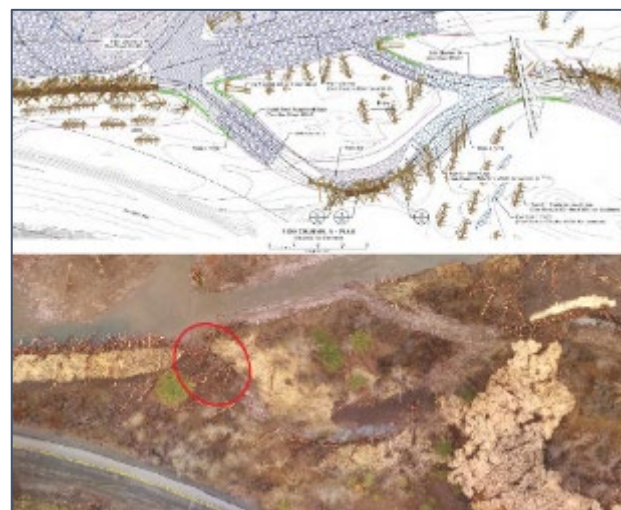
In addition to expanding channel capacity adjacent to the entrance to side channel 5 to relieve velocities and sheer stress at high flows, a bleeder log jam, spanning approximately 80 feet from the entrance to the side channel was installed to limit the risk of high water and potential ice flow from capturing the entire mainstem Grande Ronde River. The bleeder jam is illustrated in the image to the right, circled in red. Large logs were installed into both right and left banks of SC5 and spanned to the opposite bank in a crisscross configuration. The purpose of this adjustment from the original design was to reinforce SC5 and control high flow into side channel 5, helping decrease potential that more MC flows would be captured than intended during high water events.

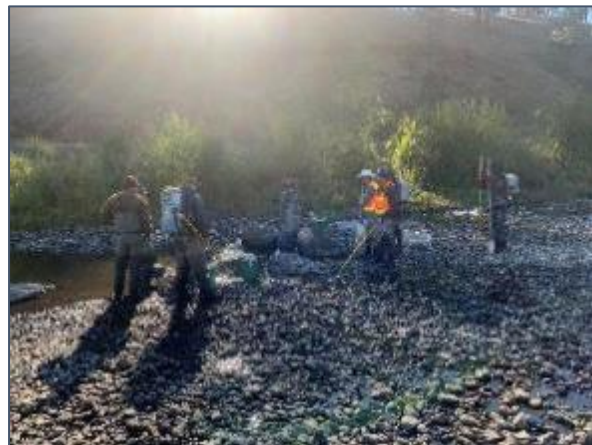
Bypass 1, located in the upper-most reach of the Project area was excavated through an existing point bar on river right from approximately MC Sta. 1 + 00 downstream to Sta. 7 + 00. Main stem flows were directed into the bypass channel which allowed the fish salvage crew (CTUIR) to begin relocating fish from the isolated section of main channel. The salvage crew made several initial passes using seine nets to coax the majority of fish out of the isolated unit before using electro-fishing methods to capture the remaining fish and relocating them to areas outside project disturbance.

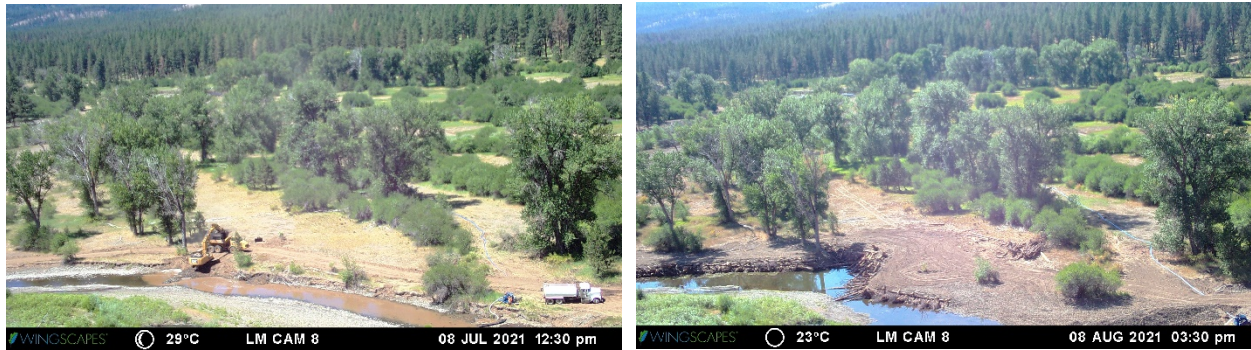
PHOTO POINT #8 JULY 8, 2021 AND AUGUST 8, 2021

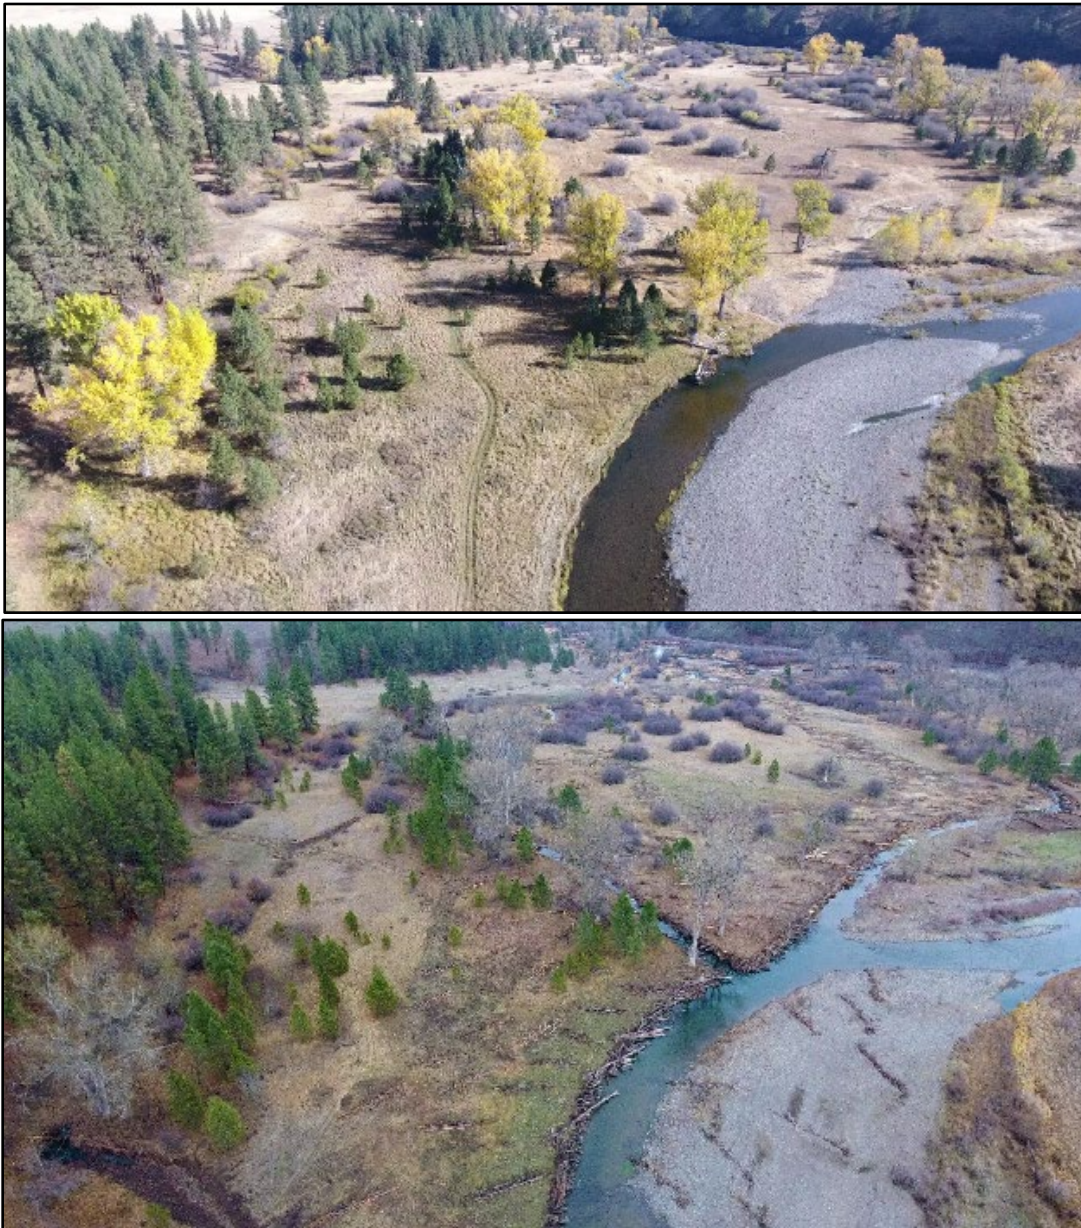
**UPPER PROJECT AREA FLOODPLAIN AND CHANNELS, VIEWING DOWNSTREAM**

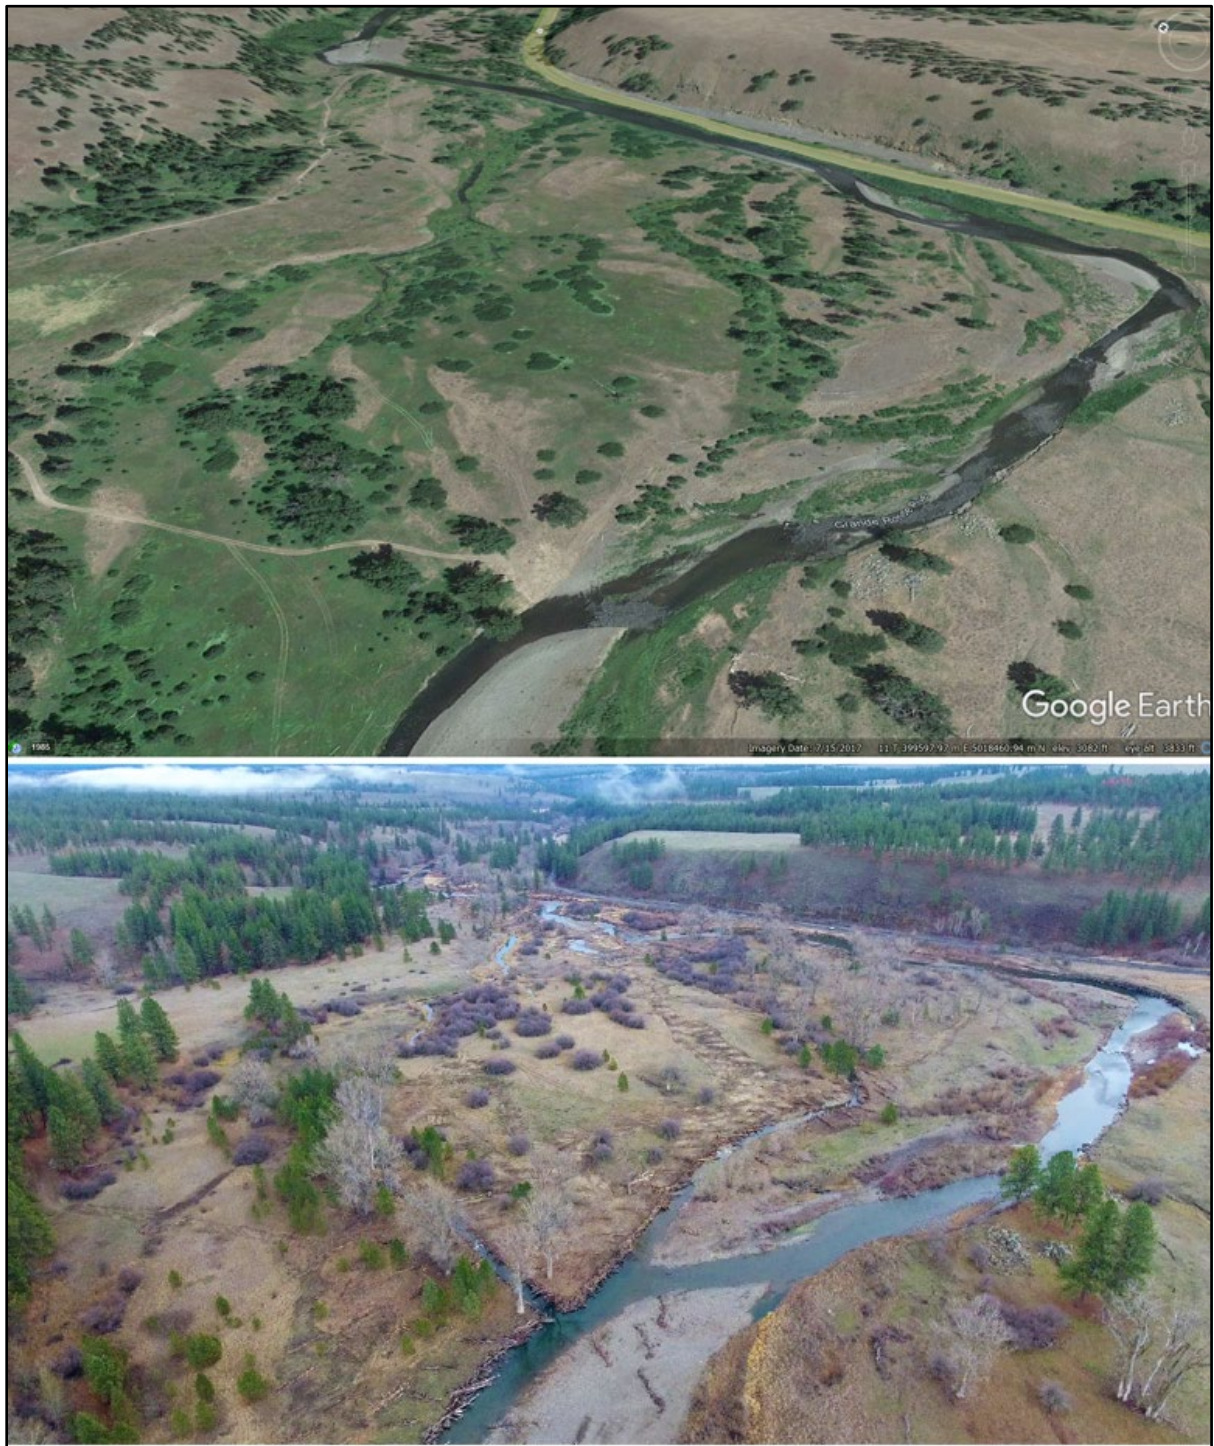
UPPER PROJECT AREA FLOODPLAIN AND CHANNELS, VIEWING DOWNSTREAM

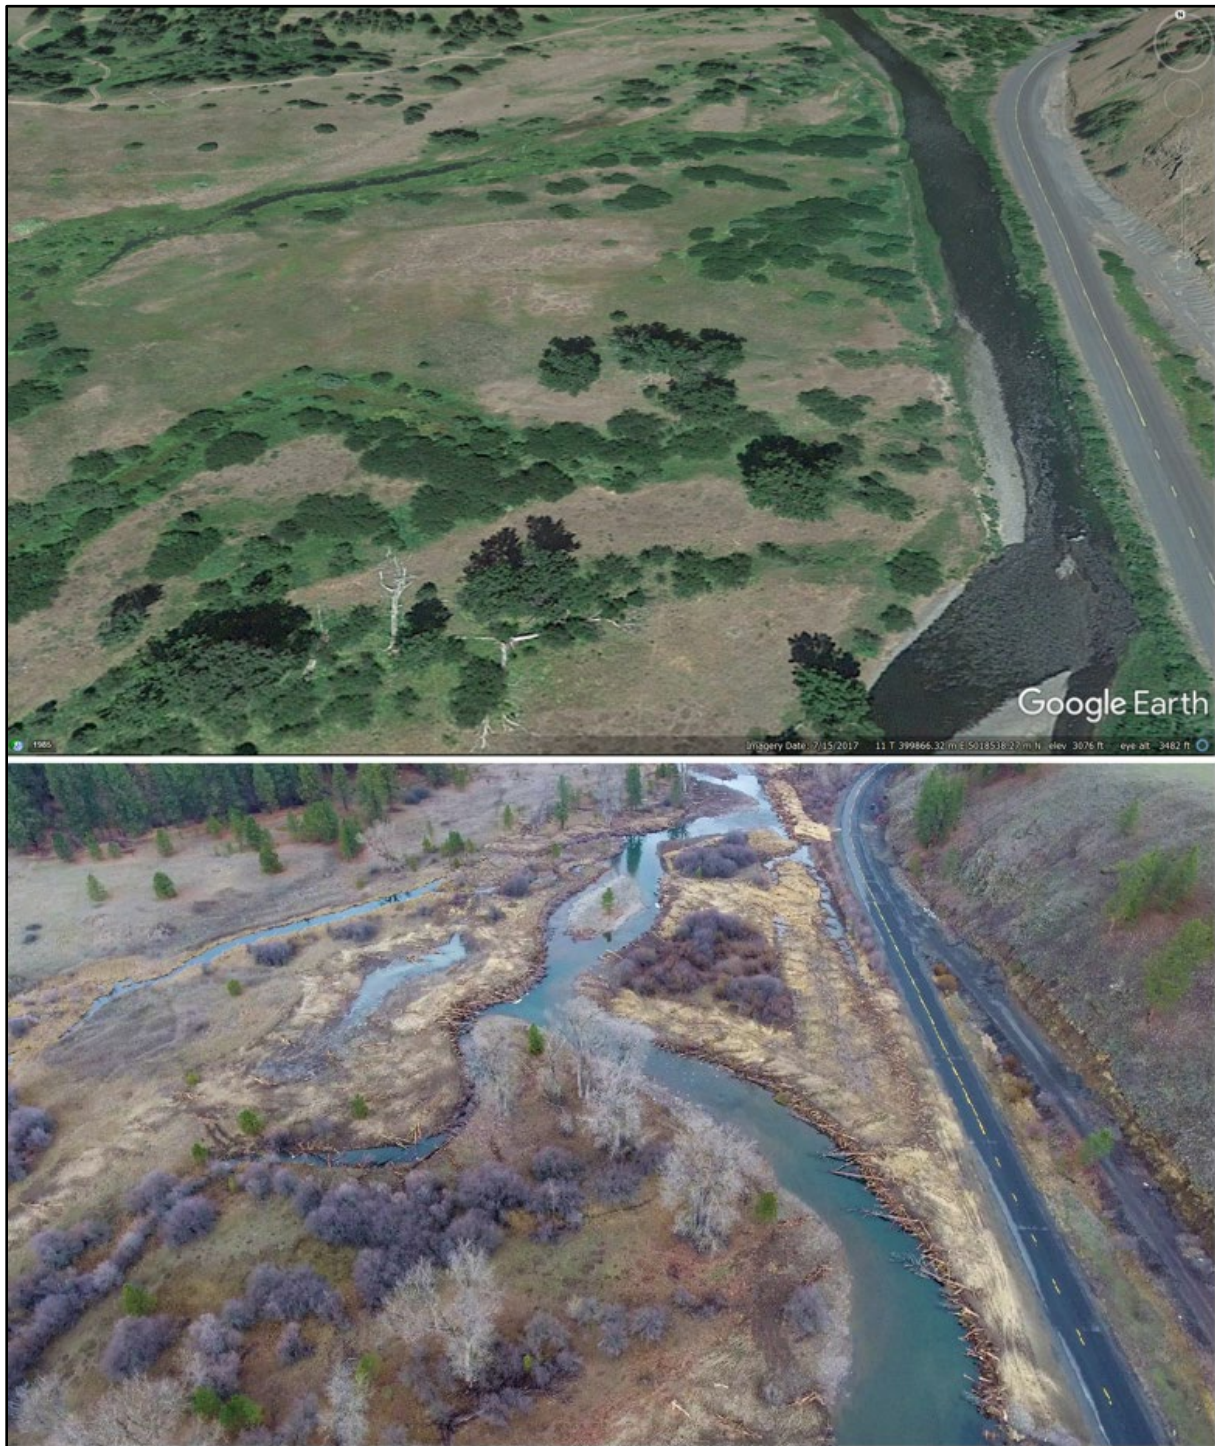
**MID-PROJECT AREA FLOODPLAIN AND CHANNELS, VIEWING DOWNSTREAM**

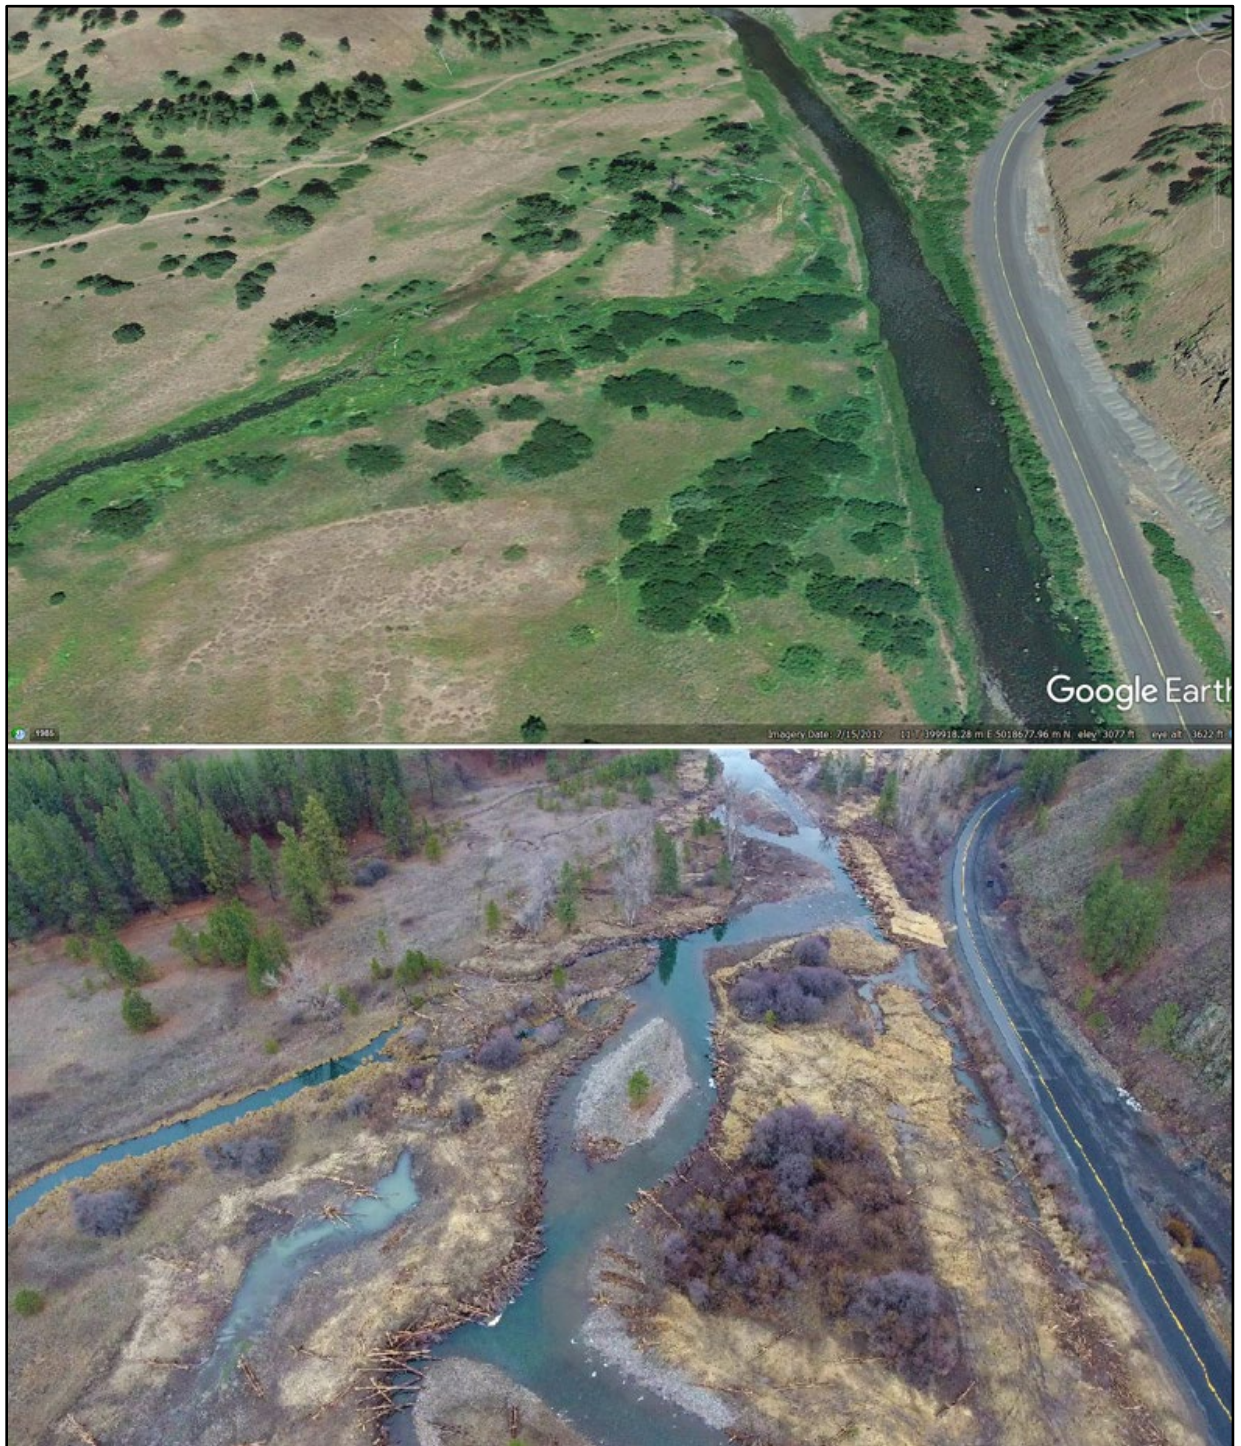
**MID-PROJECT AREA FLOODPLAIN AND CHANNELS, VIEWING DOWNSTREAM**

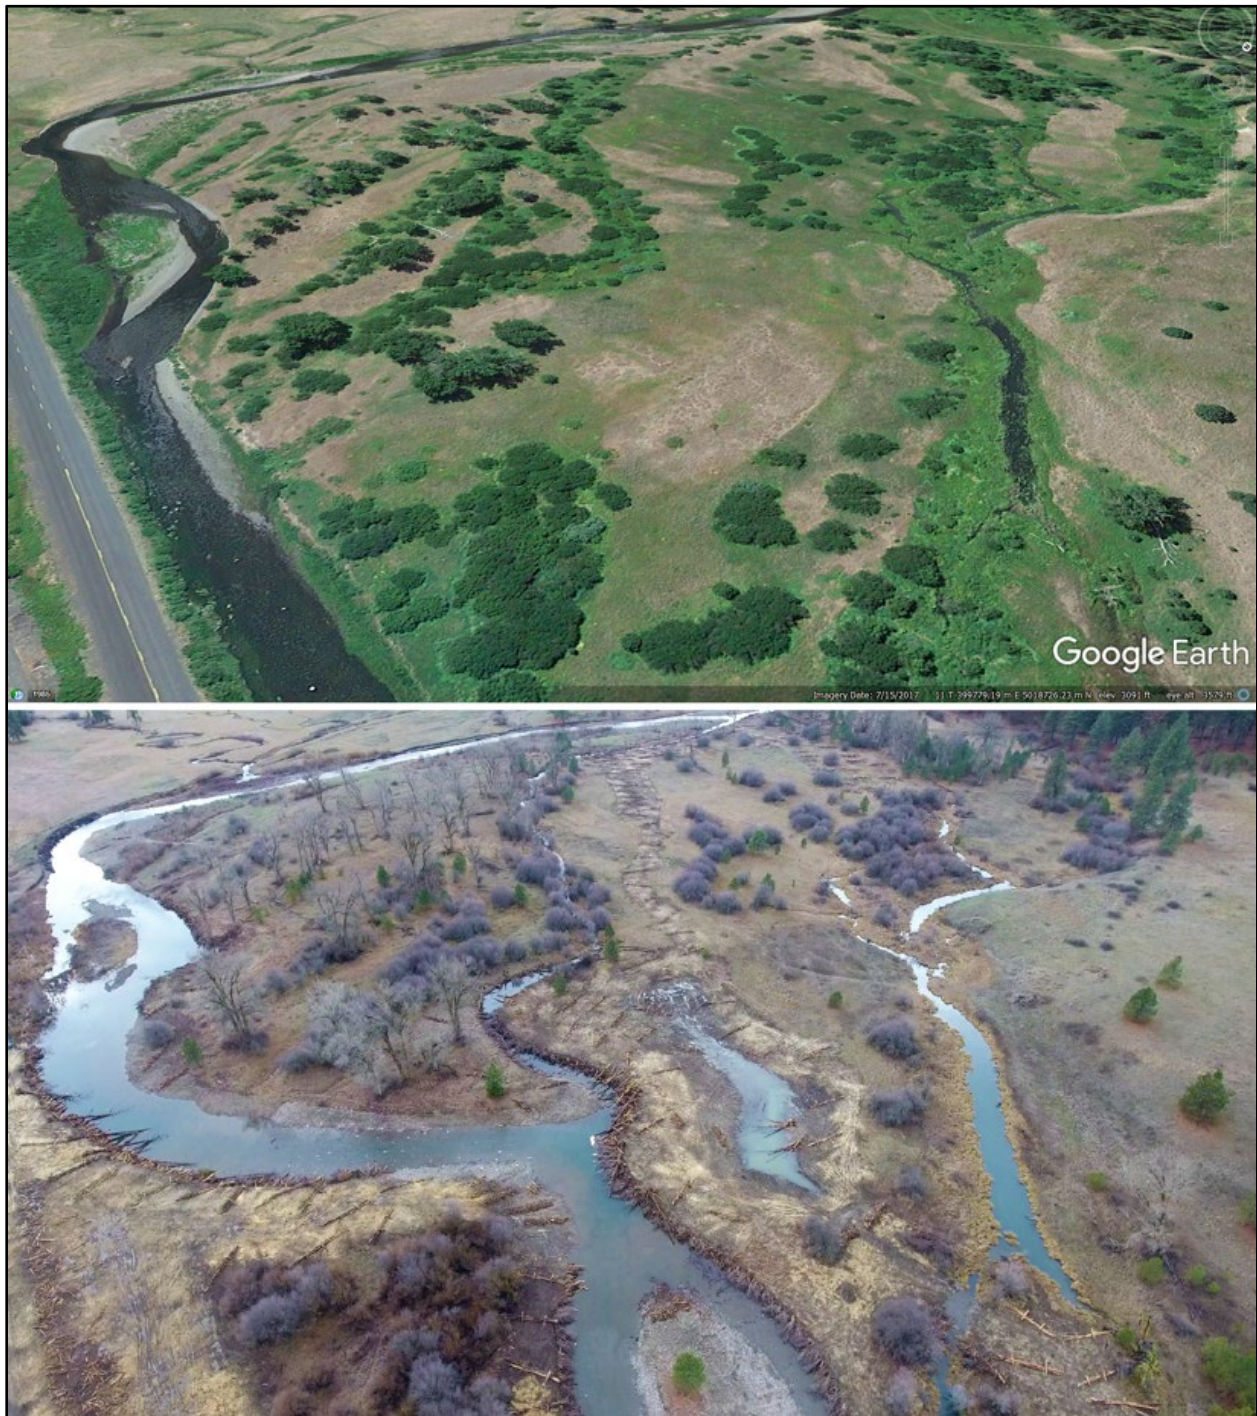
**MID-PROJECT AREA FLOODPLAIN AND CHANNELS, VIEWING UPSTREAM**

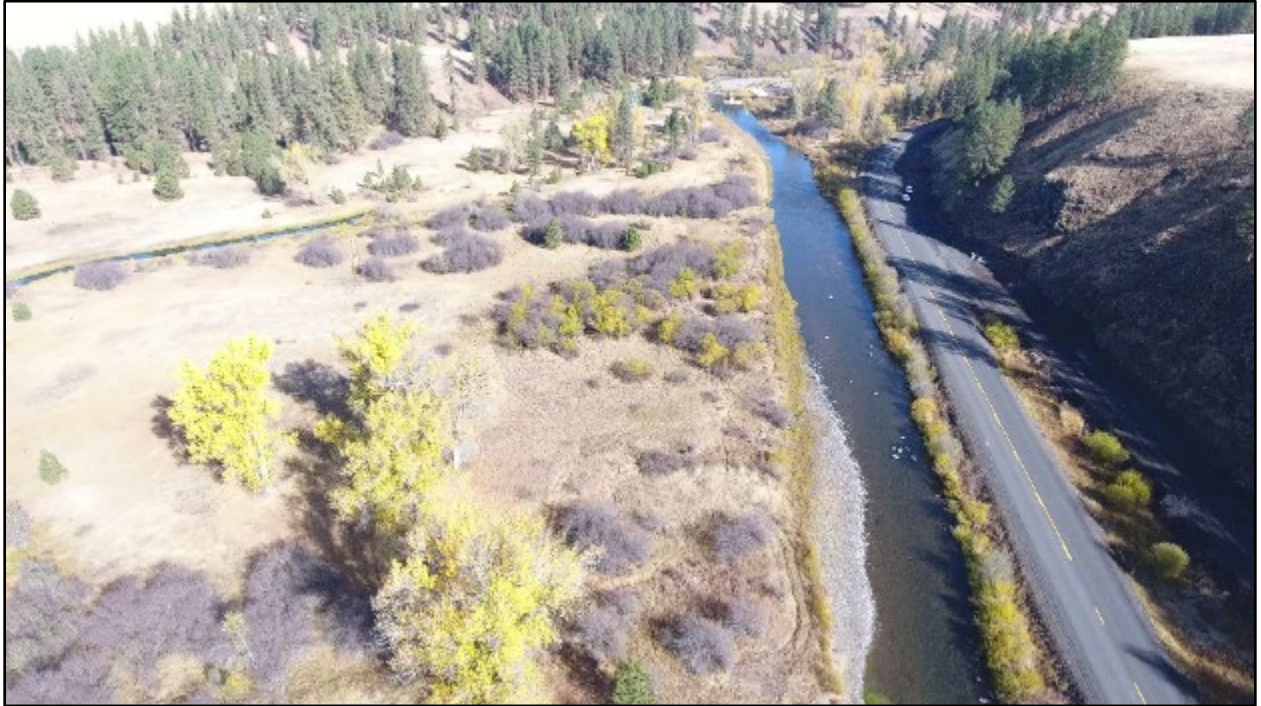
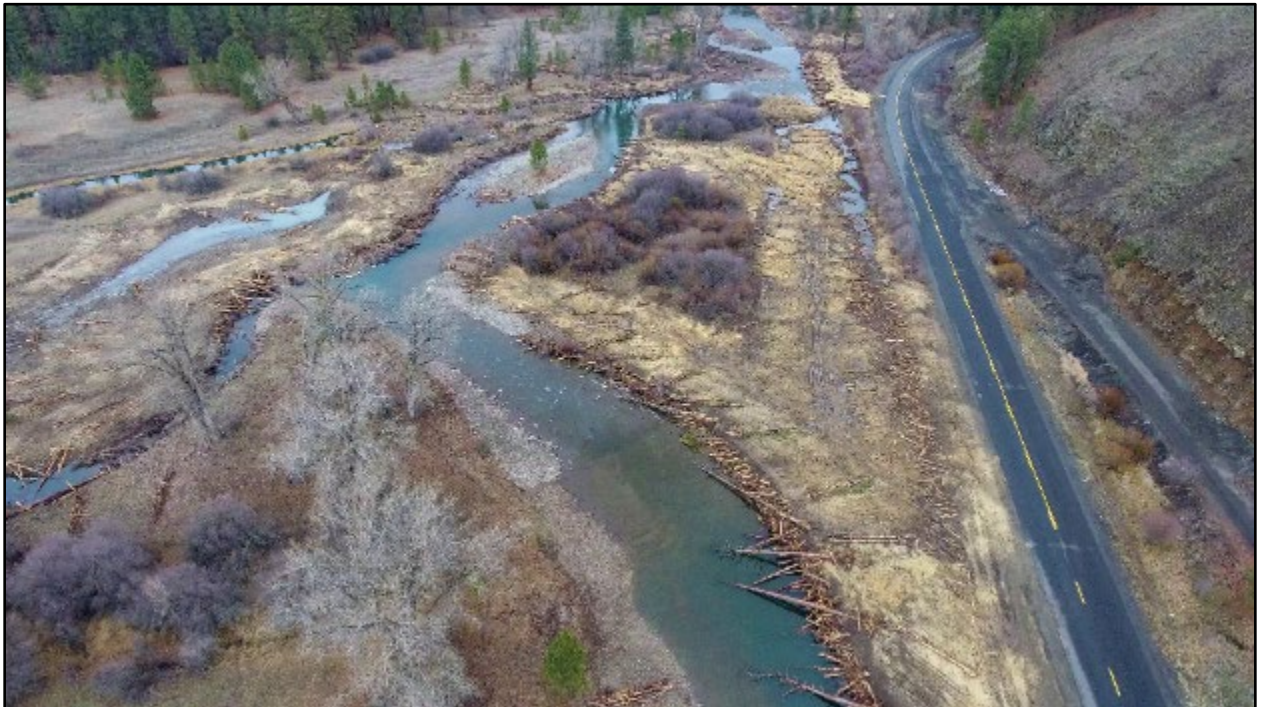
**MID-PROJECT AREA FLOODPLAIN AND CHANNELS, VIEWING DOWNSTREAM**

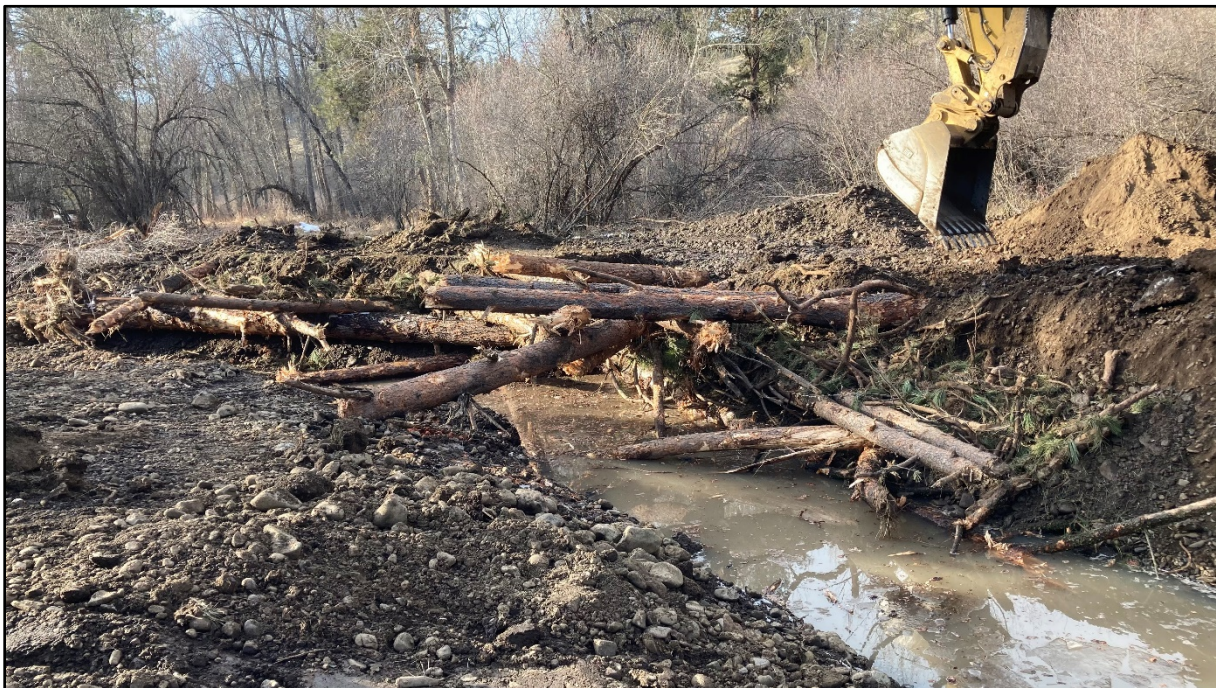
**SIDE CHANNEL 5 POOL AND LARGE WOOD STRUCTURE**

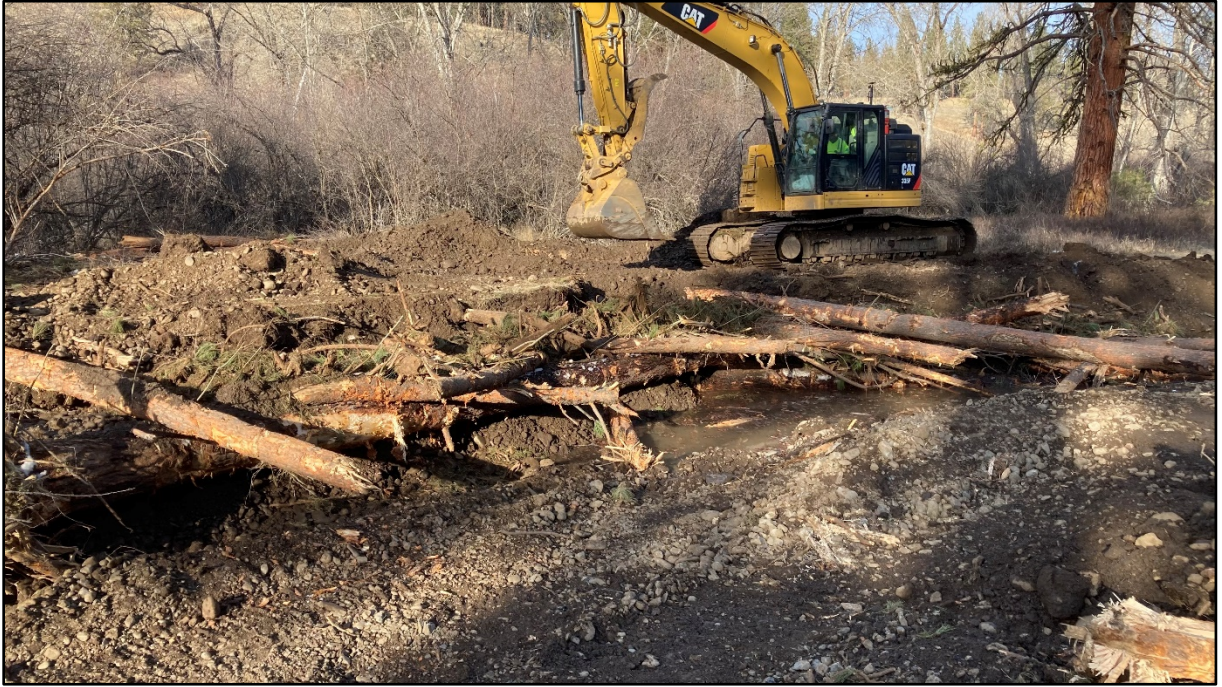
**SIDE CHANNEL 5 POOL AND LARGE WOOD STRUCTURE**

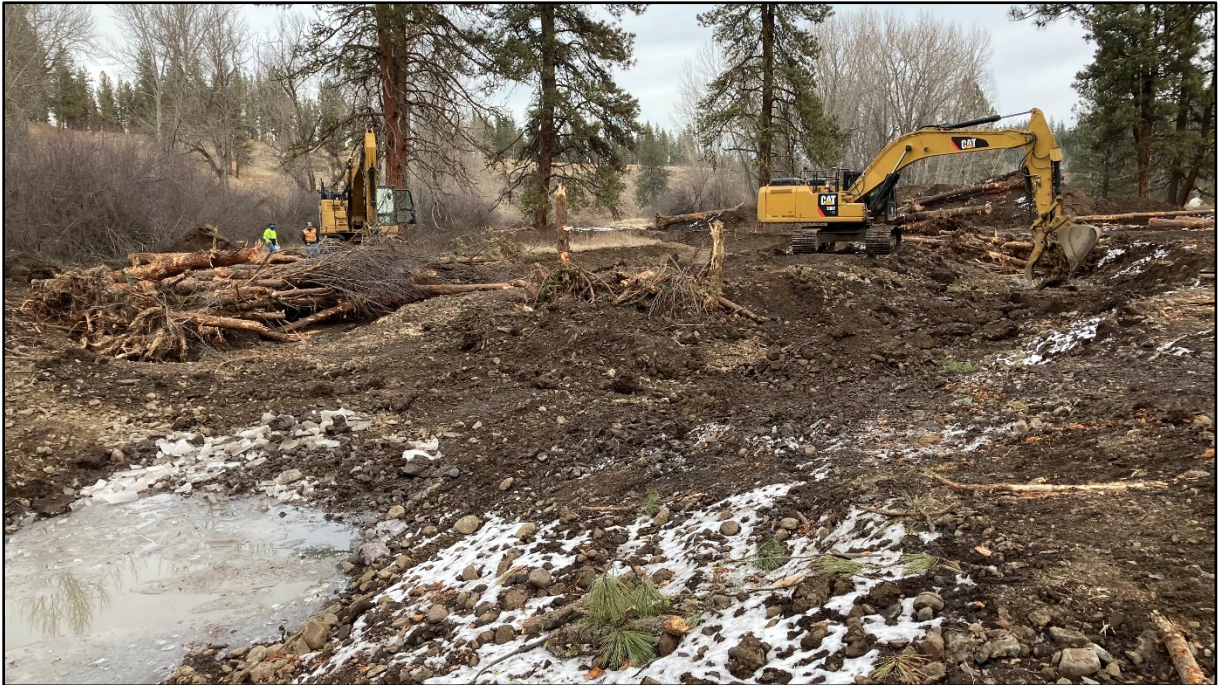
**SIDE CHANNEL 5 CHANNEL GRADING**
