UPPER FLY CREEK RESTORATION 2022

Habitat Completion Report

**United States Forest Service
Wallowa-Whitman National Forest**

December 4, 2023

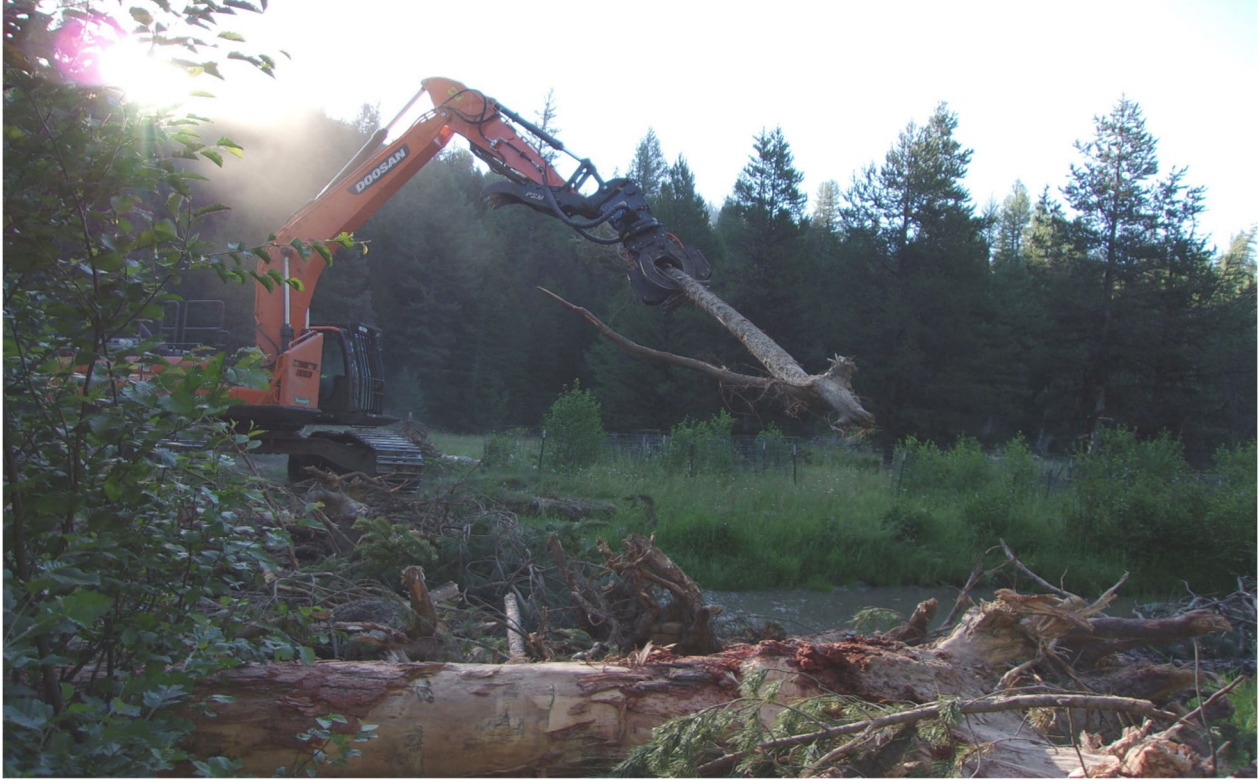
Placement of Wood into Fly Creek

The project constructed debris jams and habitat structures at 68 sites over two years within the upper 2.0 miles of Fly Creek (RM 7.0 – RM 9.0). This included approximately 1500 pieces of large wood (1300 trees) and 3,400 yards of racking material. All of the wood were placed with excavators/log loaders. There were 1-3 pieces of large wood dug into the stream bank at each structure site. In addition, 2 – 5 pieces of large wood were pinned at each site.

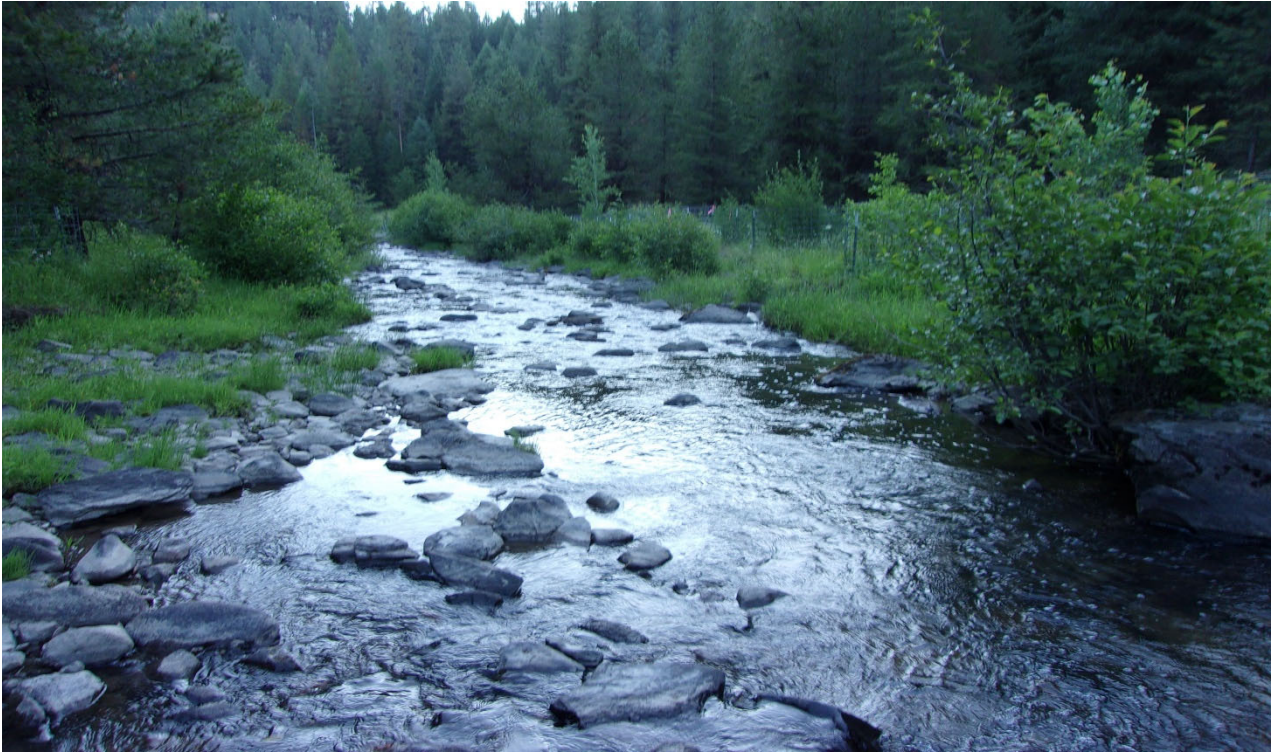
Pre Wood Placement on Fly Creek

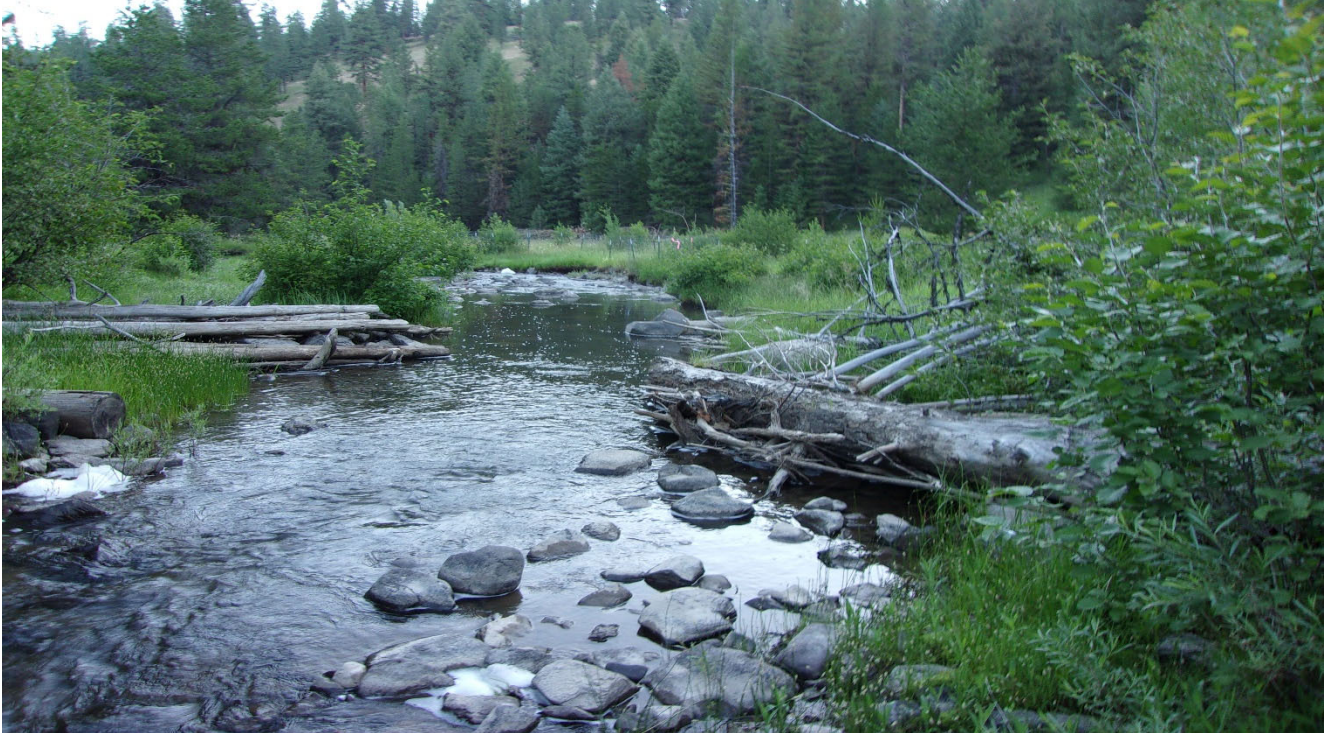
Pre Wood Placement on Fly Creek

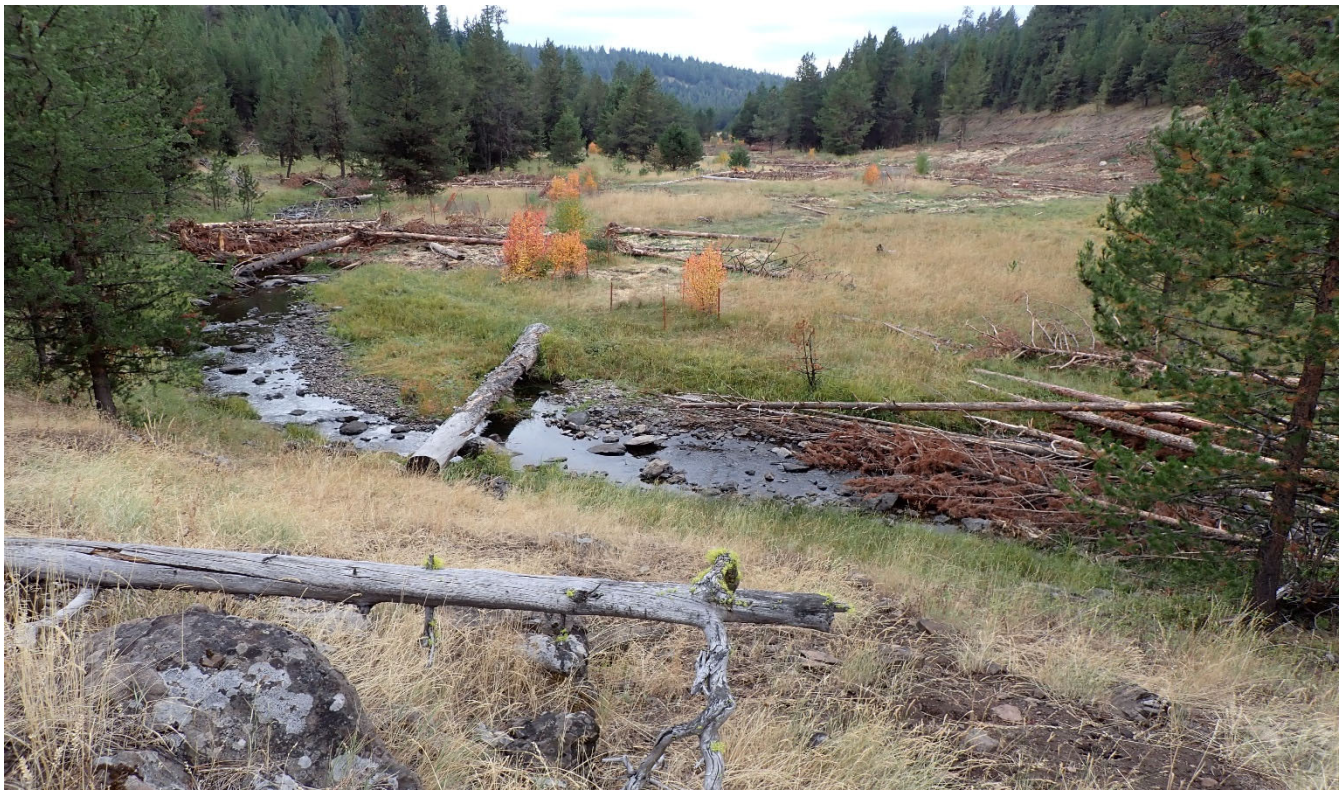
Post Implementation on Fly Creek

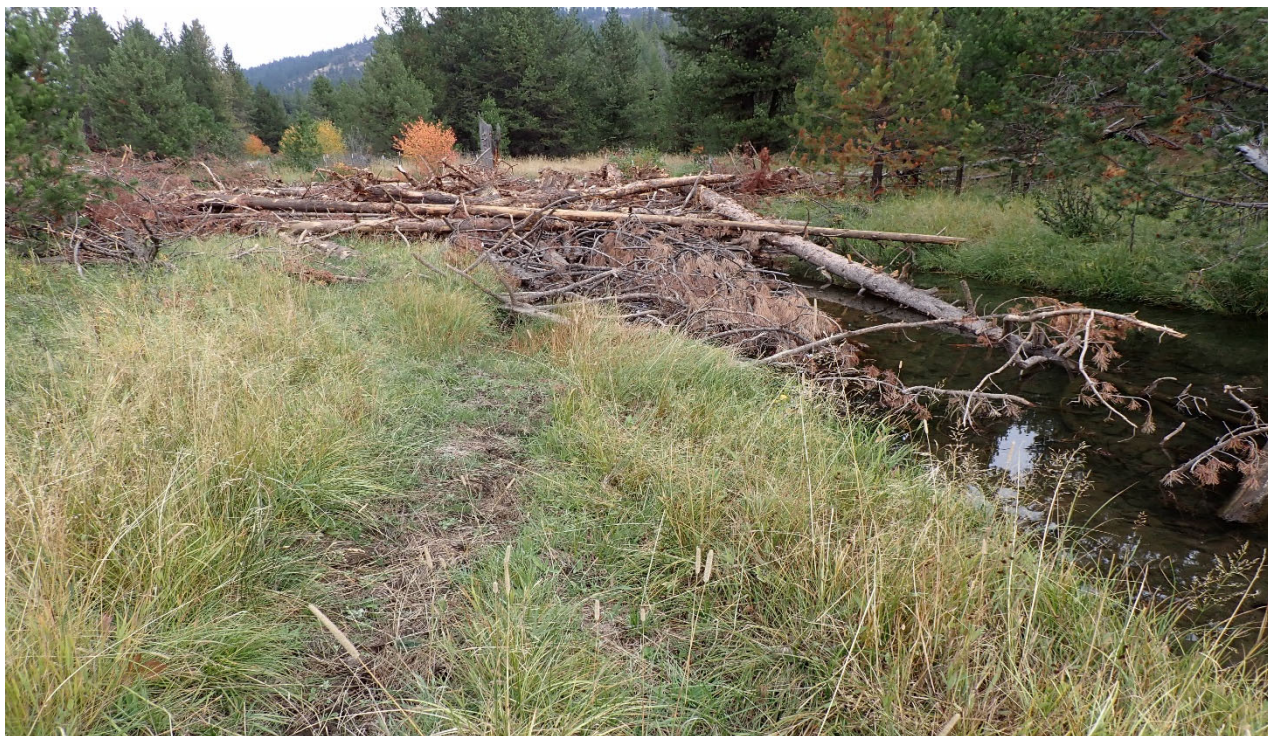
Fly Creek Structure

- The 68 debris jams will mimiced the Type A Full Spanning Log Jam (Lower Fly Creek Restoration Project, 2020), which includes 2 large trees with rootwads (> 20” dbh) & 50’ long), 4 medium trees with rootwads (14” – 20” dbh & 50’ long), 6 small trees/logs (10” – 14” dbh & 30’ – 50’ long), 2 whole trees, and 5: 10 yard loads of racking material. These structures were designed for floodplain inundation and habitat complexity.
- There were an additional 150 whole trees and 398 logs placed within the stream and floodplain to provide habitat complexity, fish cover, and floodplain roughness.
- Total of 1500 large wood pieces were placed in 2022 and 2023.

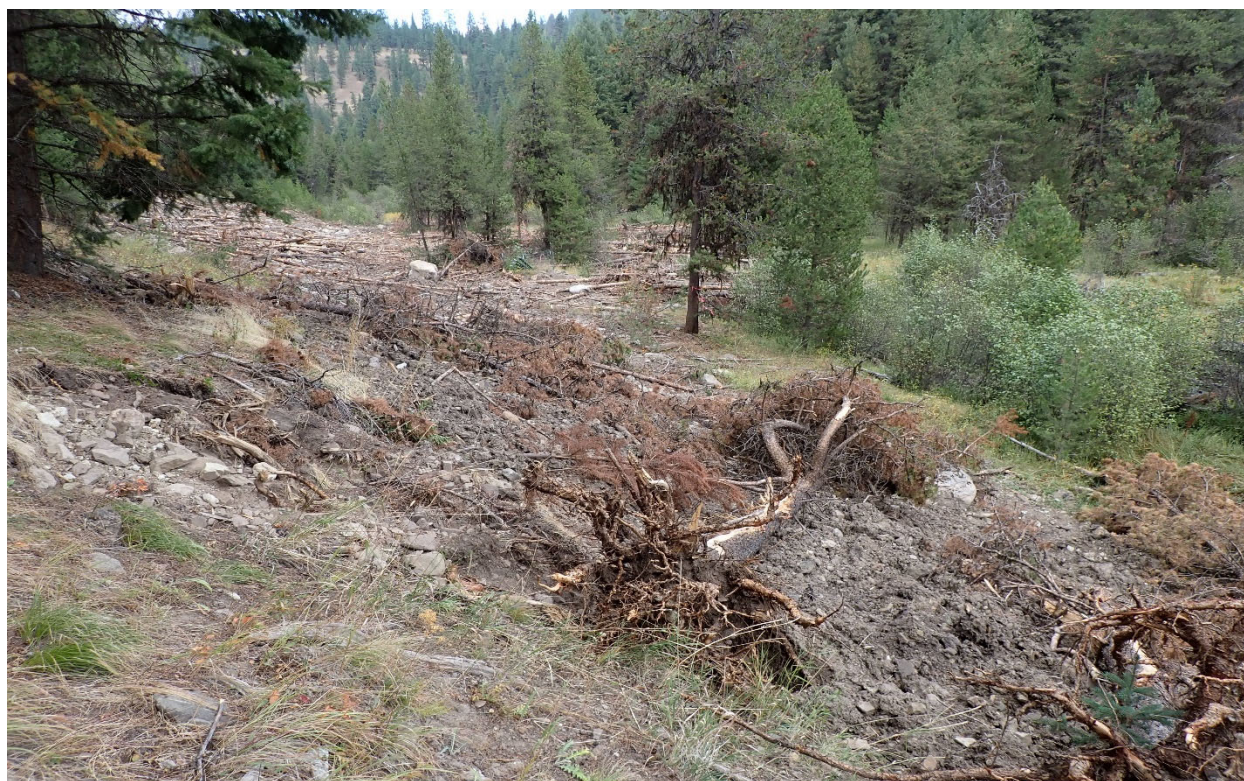
Fly Creek Streambottom Road Recontour

Approximately 1 mile of road was fully recontoured within the project area. The road was ripped prior to the recontour to break up compaction. Approximately 2/3 mile of the road recontour project consisted of a streambottom road adjacent to Fly Creek.

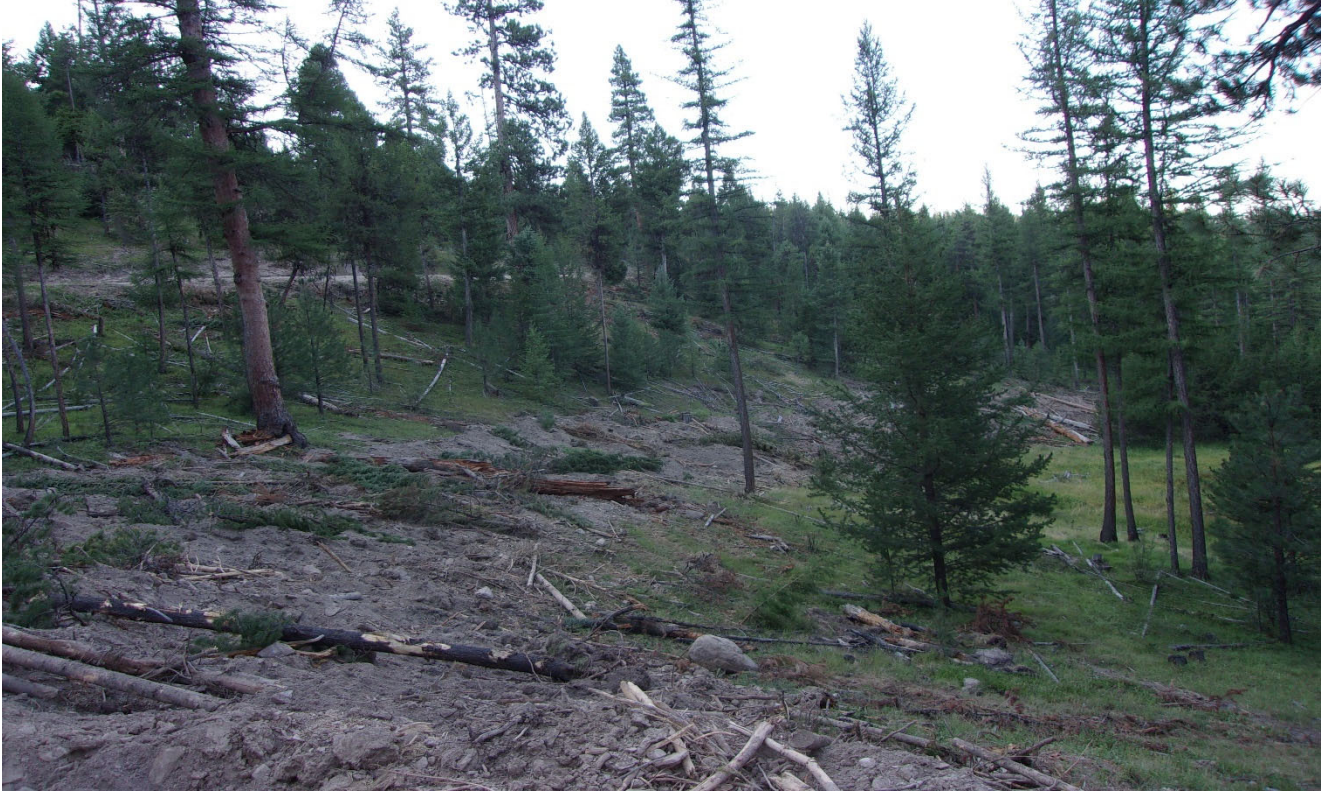
Road Recontour on Access Road to Fly Creek

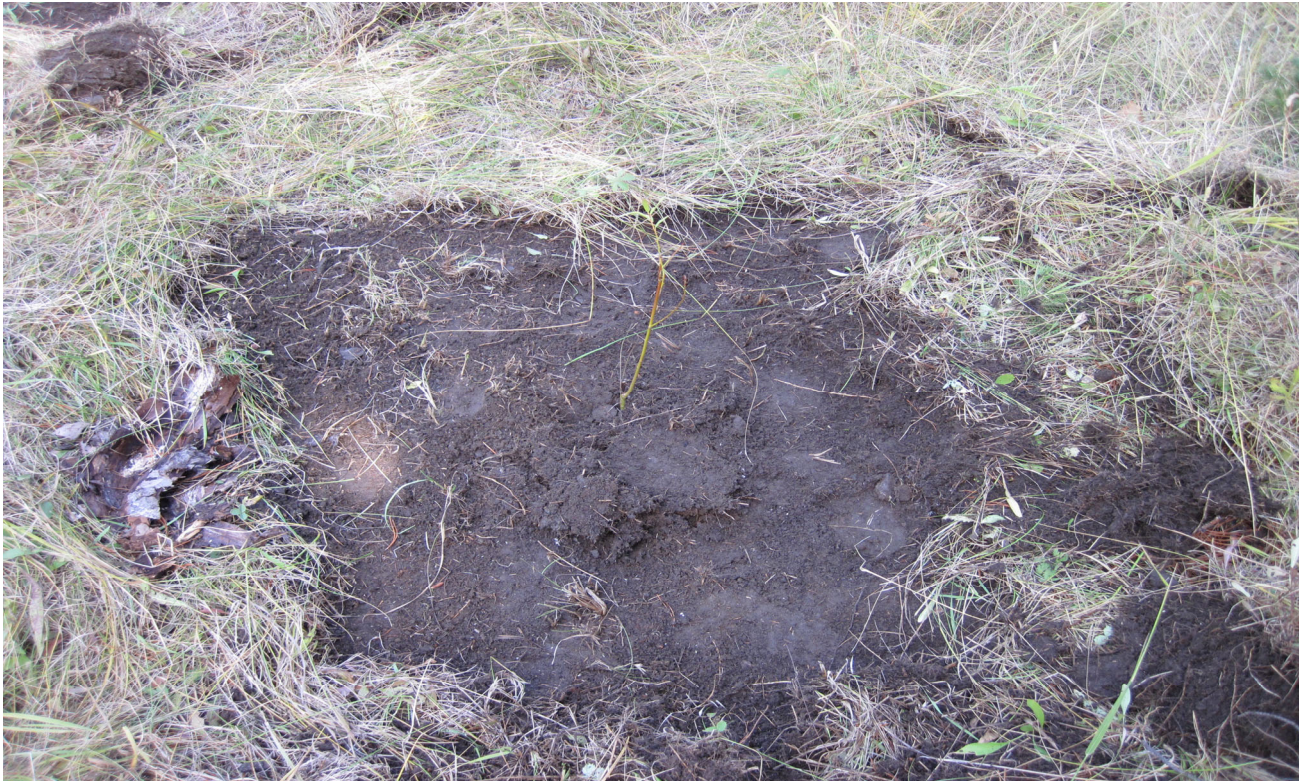
Planted Seedling

Planted 15,500 seedlings in upper Fly Creek. These were all planted by hand and consisted of 13,000 deciduous seedlings and 2500 conifers.
